Flood Investigation Report South Craven

This document has been prepared specifically for the purpose of meeting the requirements of Section 19 of the Flood and Water Management Act 2010.

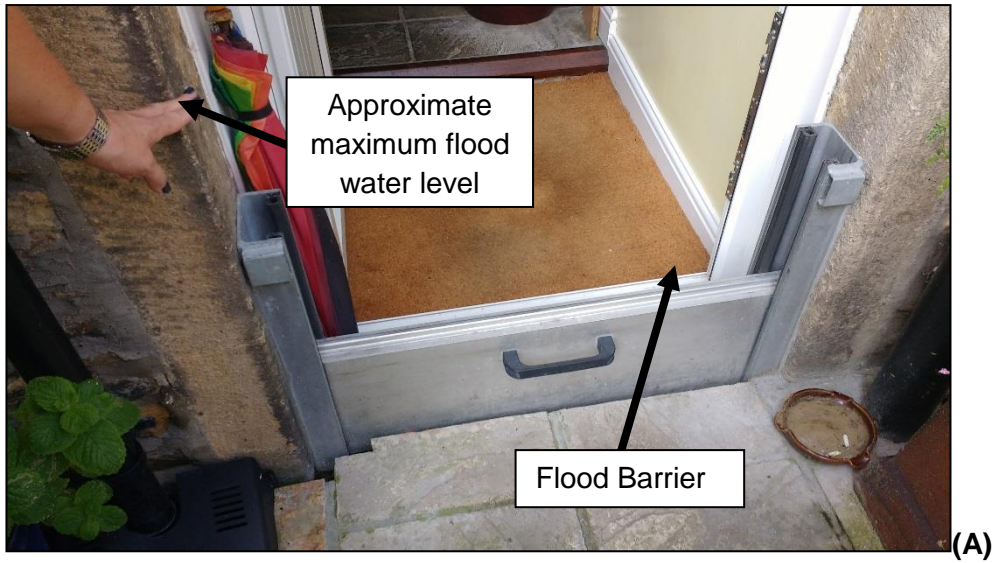
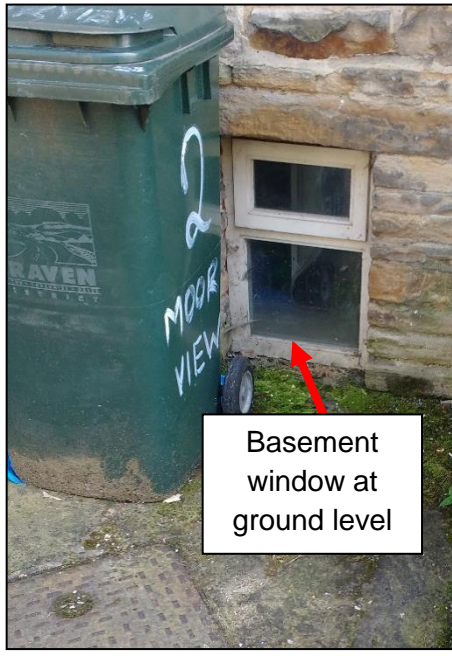
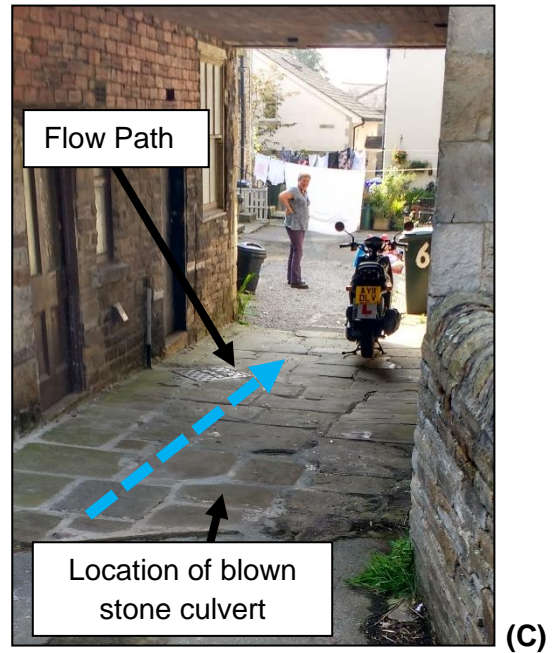
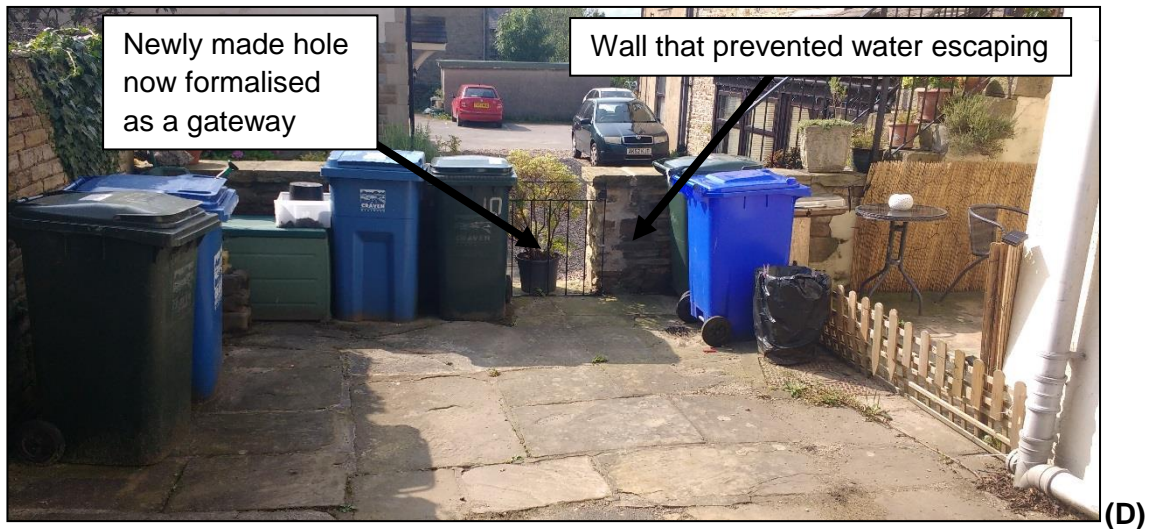
Figure 4.5 Photographs of Moor View

3. The residents attempted to stop the water flowing off Lidget Road, but found that more water was entering the courtyard from a blown culvert located under the archway entrance, as shown in Figure 4.6 (C).

4. The water continued to rise in the courtyard due to its layout. The courtyard slopes away from Lidget Road and the location of the blown culvert, caused the water to flow into the courtyard. At the far end of the courtyard there was a boundary wall that acted as a dam, shown in Figure 4.6 (D), which held the water in the courtyard.

One Moor View resident described the water level having reached an approximate depth of 300mm by 4am and to a max depth of 600mm, at Moor View on Boxing Day 2015.

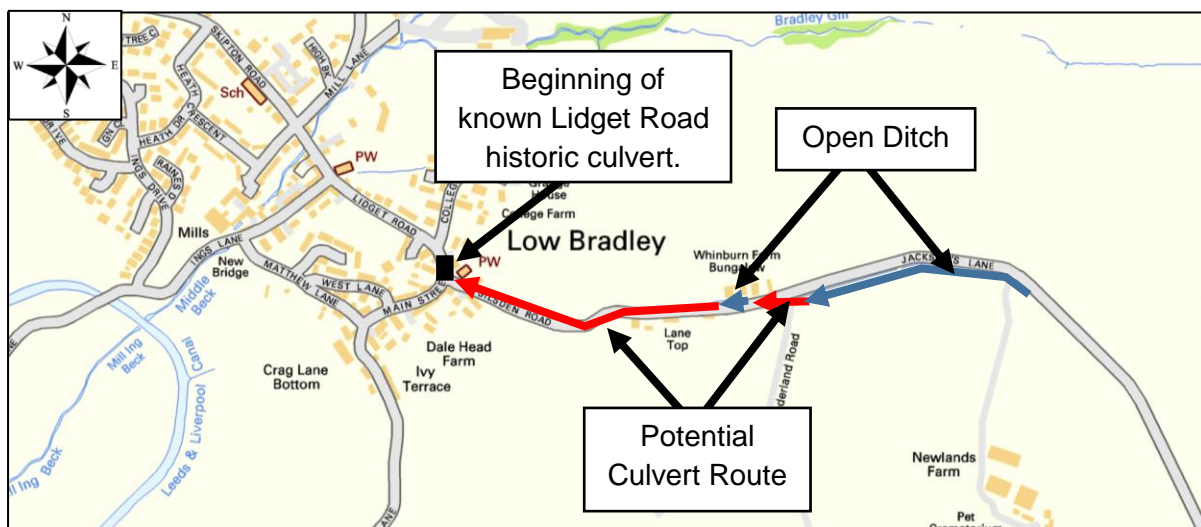
Figure 4.6 Watercourse running down Jackson Road

In addition the culvert was observed to be flowing in dry weather when the CCTV inspection was carried out in the summer of 2016. This suggests that this may be more of a culverted watercourse being fed from a larger catchment area rather than a local drain. This is supported by OS Mapping where it can be seen that there is a watercourse running down Jackson’s Road which is culverted under the road and then disappears from the map, as shown in Figure 4.6. It is suggested that this could be connected into the Historic culvert system. The significant surface water flows overwhelmed the highway drainage resulting in the excess surface water flowing down Lidget Road as well as that being delivered underground by the culvert.

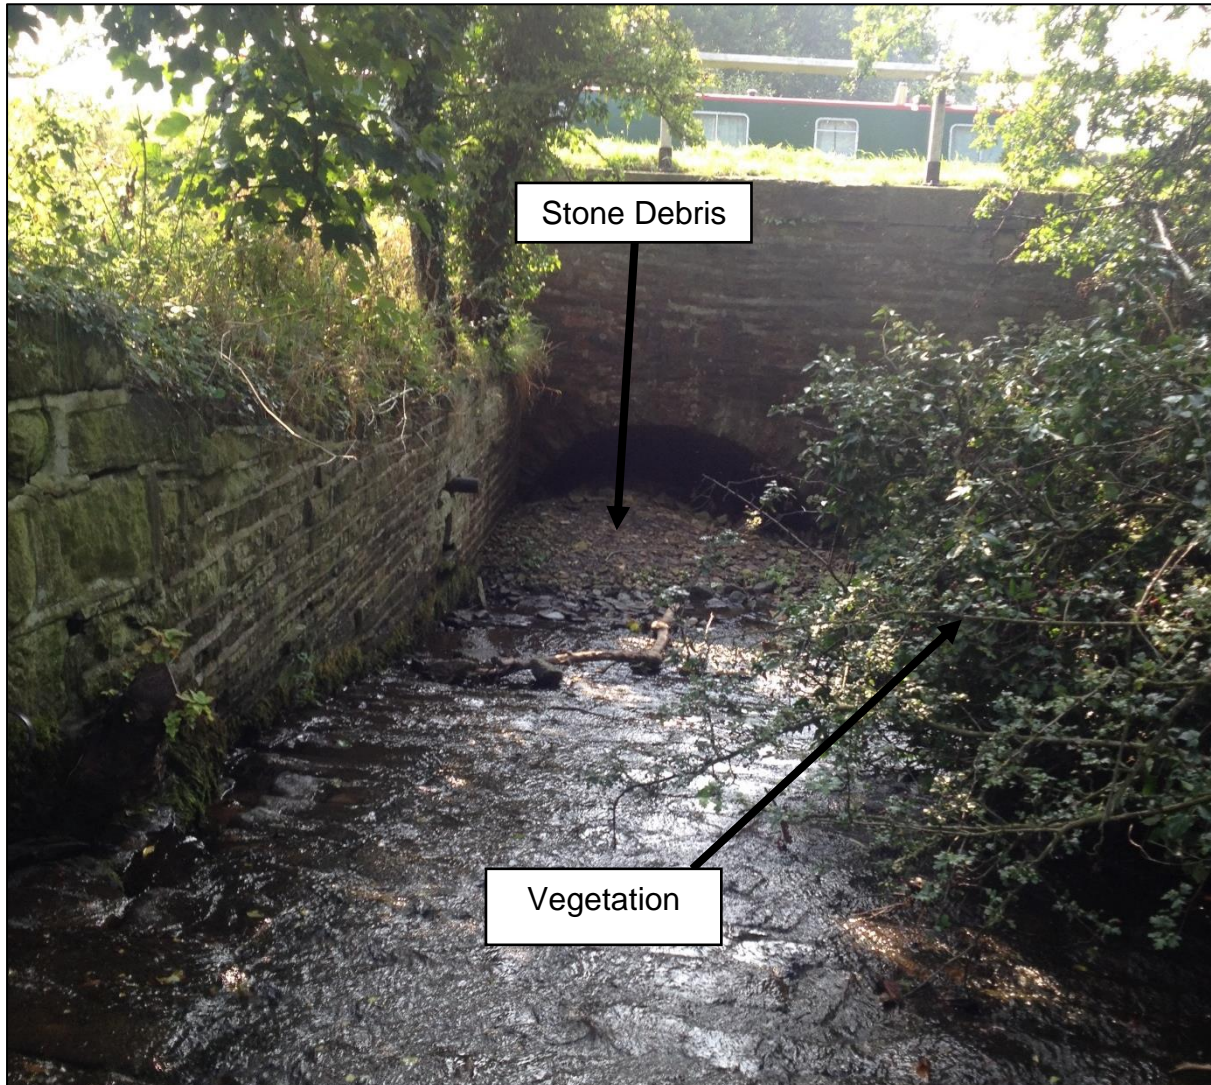
Figure 4.7 Photograph showing deposits in canal

The flood waters from Low Bradley and the surrounding catchment entered the Middle Beck and the Mill Ing Beck. As the flood waters progressed downstream they overtopped the banks of Mill Ing Beck, this combined with highway surface water resulted in flooding of the A629. The fire brigade removed the A629 wall to alleviate the flood waters. During the site inspection a significant amount of debris was observed in the channel under the Leeds and Liverpool Canal³¹, as shown in Figure 4.7. It cannot be determined how much of this accumulated during the December 2015 event, however the significant build-up of debris under the canal has the potential to restrict the Mill Ing Beck syphon, which would:

- Increase the restriction to flow for Mill Ing Beck and Middle Beck;
- Cause more extensive flooding, in the immediate vicinity and in Low Bradley;
- Potentially damage the structural integrity of the canal.

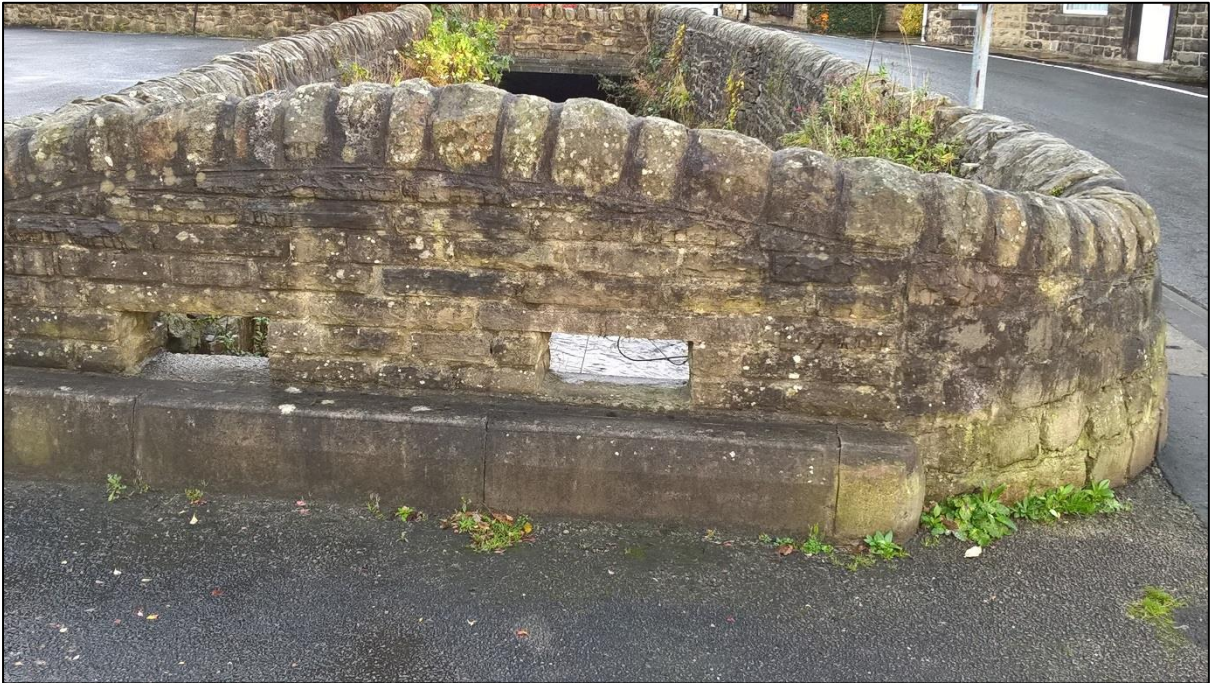
Figure 5.11 photograph showing Cononley Beck Bridge wall

11. The levels of water in the Cononley Beck increased almost resulting in overtopping through the holes in the bridge wall, shown in Figure 5.11. There have been no reports of the Cononley Beck over topping its banks.

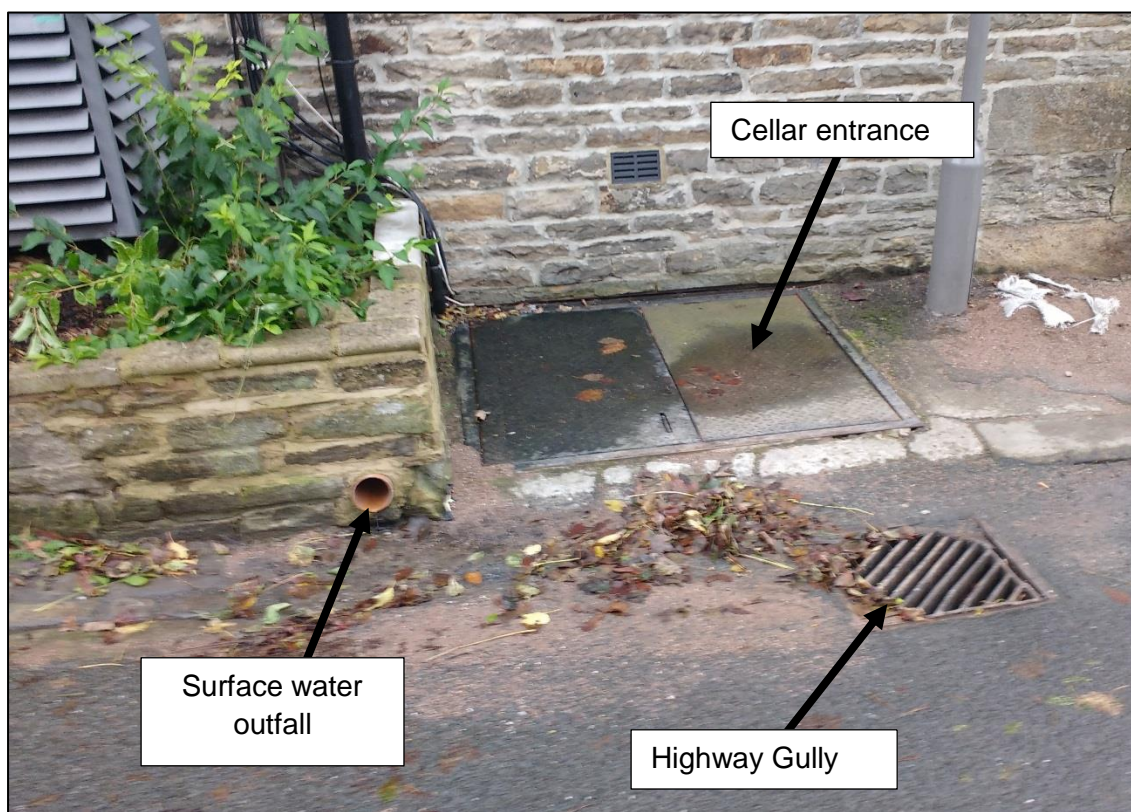
Figure 6.9 Photograph showing the point of entry of the surface water

9. The surface water then entered the cellar of the property via an entry hatch close to the road, as shown in Figure 6.9.
10. A highway gully outside this property was the collection point for all surface water flows coming down Priest Bank Road. However, the speed and the volume of flow is likely to have overwhelmed the capacity of both the surface gully grate and the underlying drainage system. Surcharge at this point added to the flooding of the property through the cellar hatch adjacent to the road.

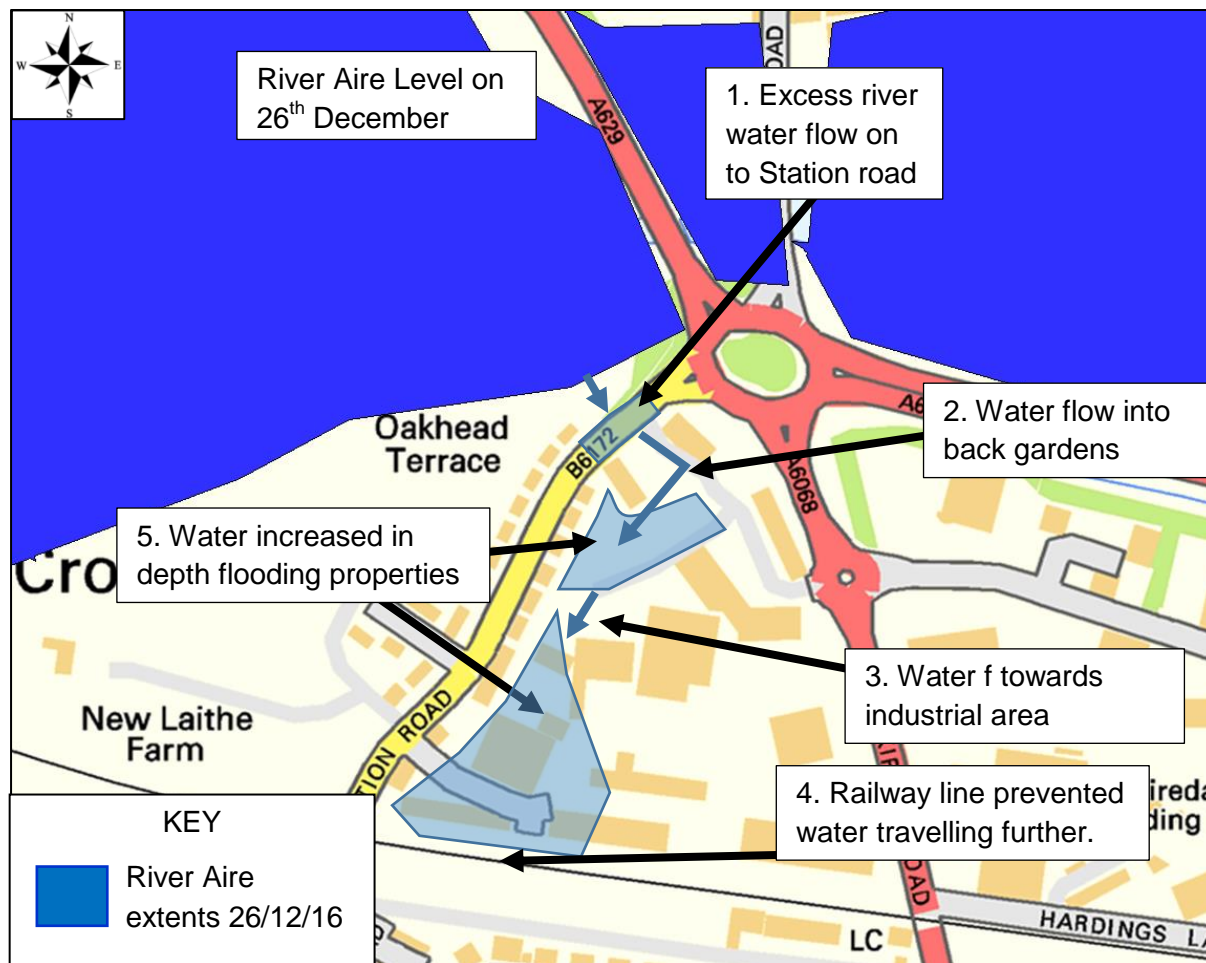
Figure 7.7 Mechanism of flooding on Station Road

6. The river water spilled onto Station Road and increased in depth resulting in the closure of station road⁵².
7. The water flowed to the lowest point, the rear gardens of Saint Andrews terrace, from here the water propagated towards the industrial area, as shown in Figure 7.7. The water depth increased in depth resulting in the flooding of six properties in the industrial area, as shown in Figure 7.8, and four residential properties via the rear gardens⁶.

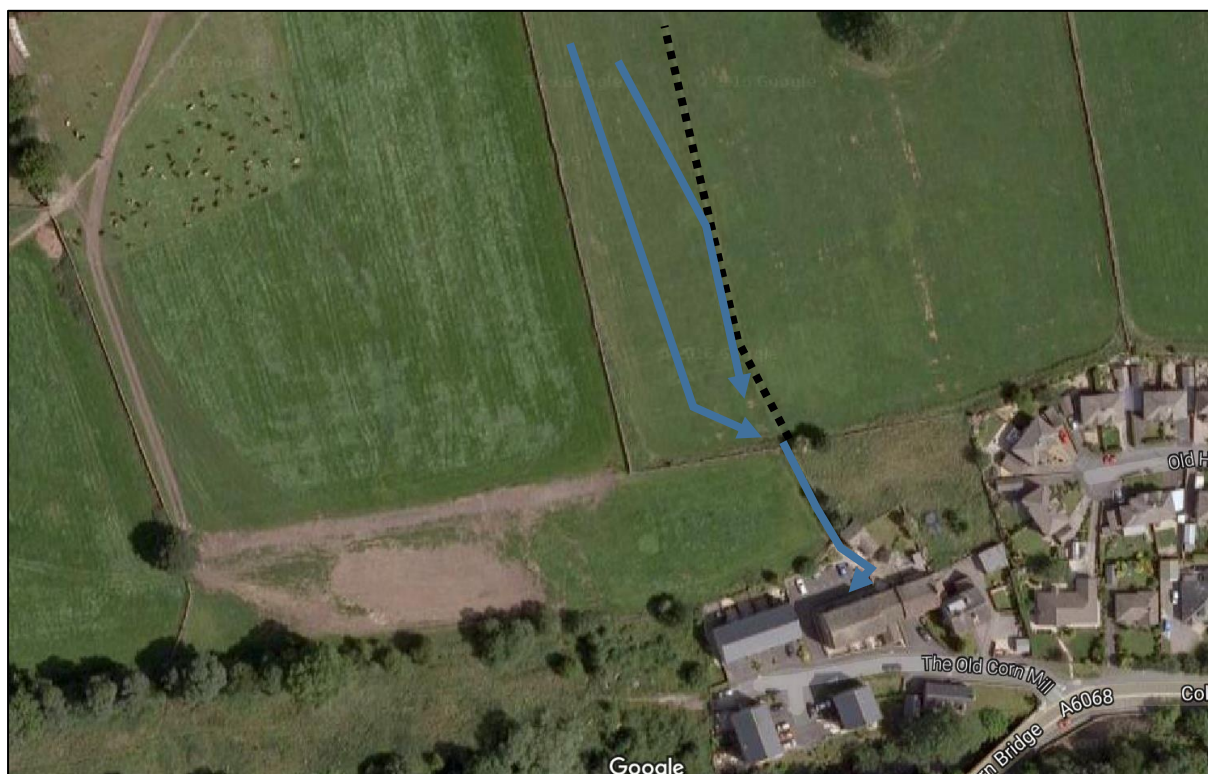
Figure 8.7 Mechanism of flooding at The Old Corn Mill

7. It is thought that due to the hydraulic pressure in the culverts water was forced up through the ground into two properties resulting in internal flooding. This could indicate that there is little cover to the culvert beneath the properties. It is also worth noticing that the condition of the culvert is at present unknown.

8. In the vicinity of The Old Corn Mill there is a footpath, which is believed to have a culverted watercourse running beneath it. It is unknown whether this watercourse impacted the flooding on Boxing Day. During the site visit a ridge was observed in the land which is thought to indicate the course of a historic culvert that channels flows from the agricultural land towards the Old Mill Building.

10. Beyond the footpath the course of the historic culvert is uncertain. However two outfalls were observed on the northern bank of Glusburn Beck upstream of Glusburn Bridge. One was a small diameter outlet discharging through the wall, and the other was a larger diameter flapped outfall within a concrete outfall structure. If the historic culvert discharged to the smaller outlet it appears that the small diameter would restrict flow. YWSL have confirmed that the larger outfall is from the public surface water sewer system. Both outlets would become submerged during high flows and lead to backing up, although the flap on the public sewer will avoid river water egress into the system.

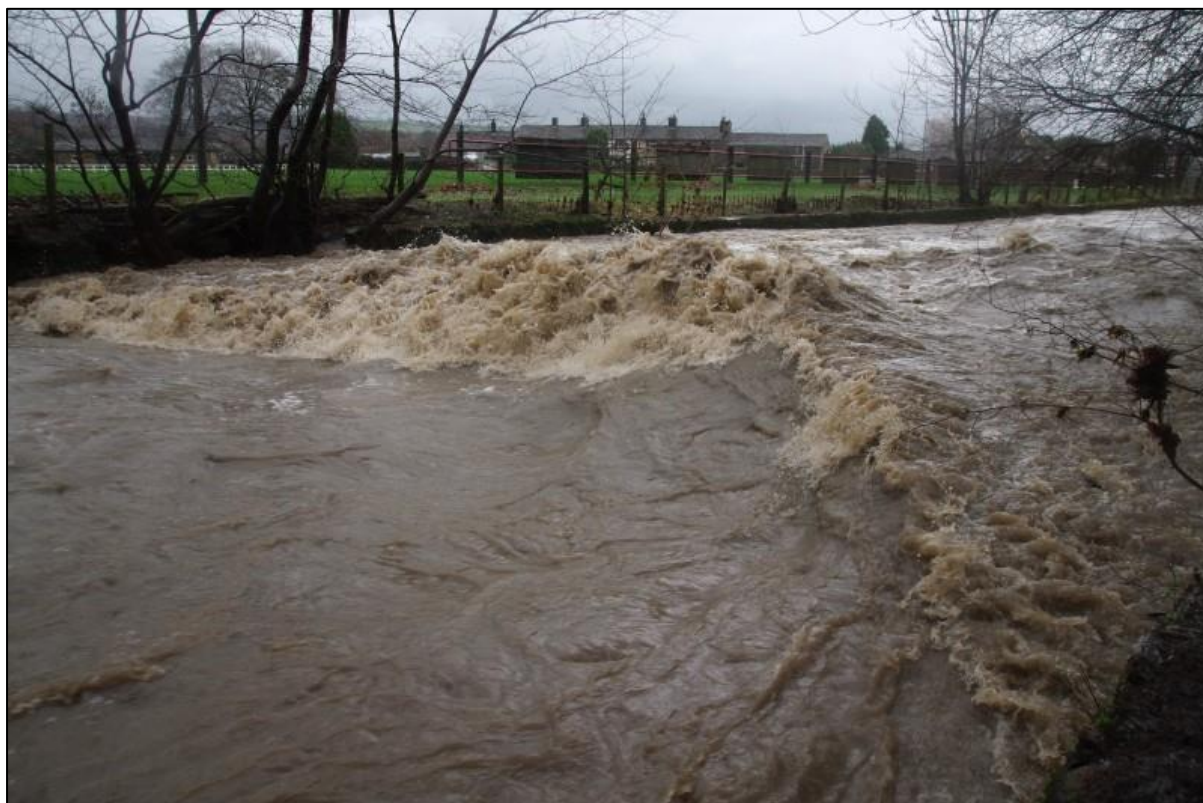
Figure 9.8 Photograph showing river levels adjacent to football pitch

2. The second rainfall event on the 26th December caused Holme Beck levels to increase further resulting in the banks being overtopped and flows discharging onto the football pitch. The river flow in Holme Beck adjacent to the football pitch are shown in Figure 9.8.

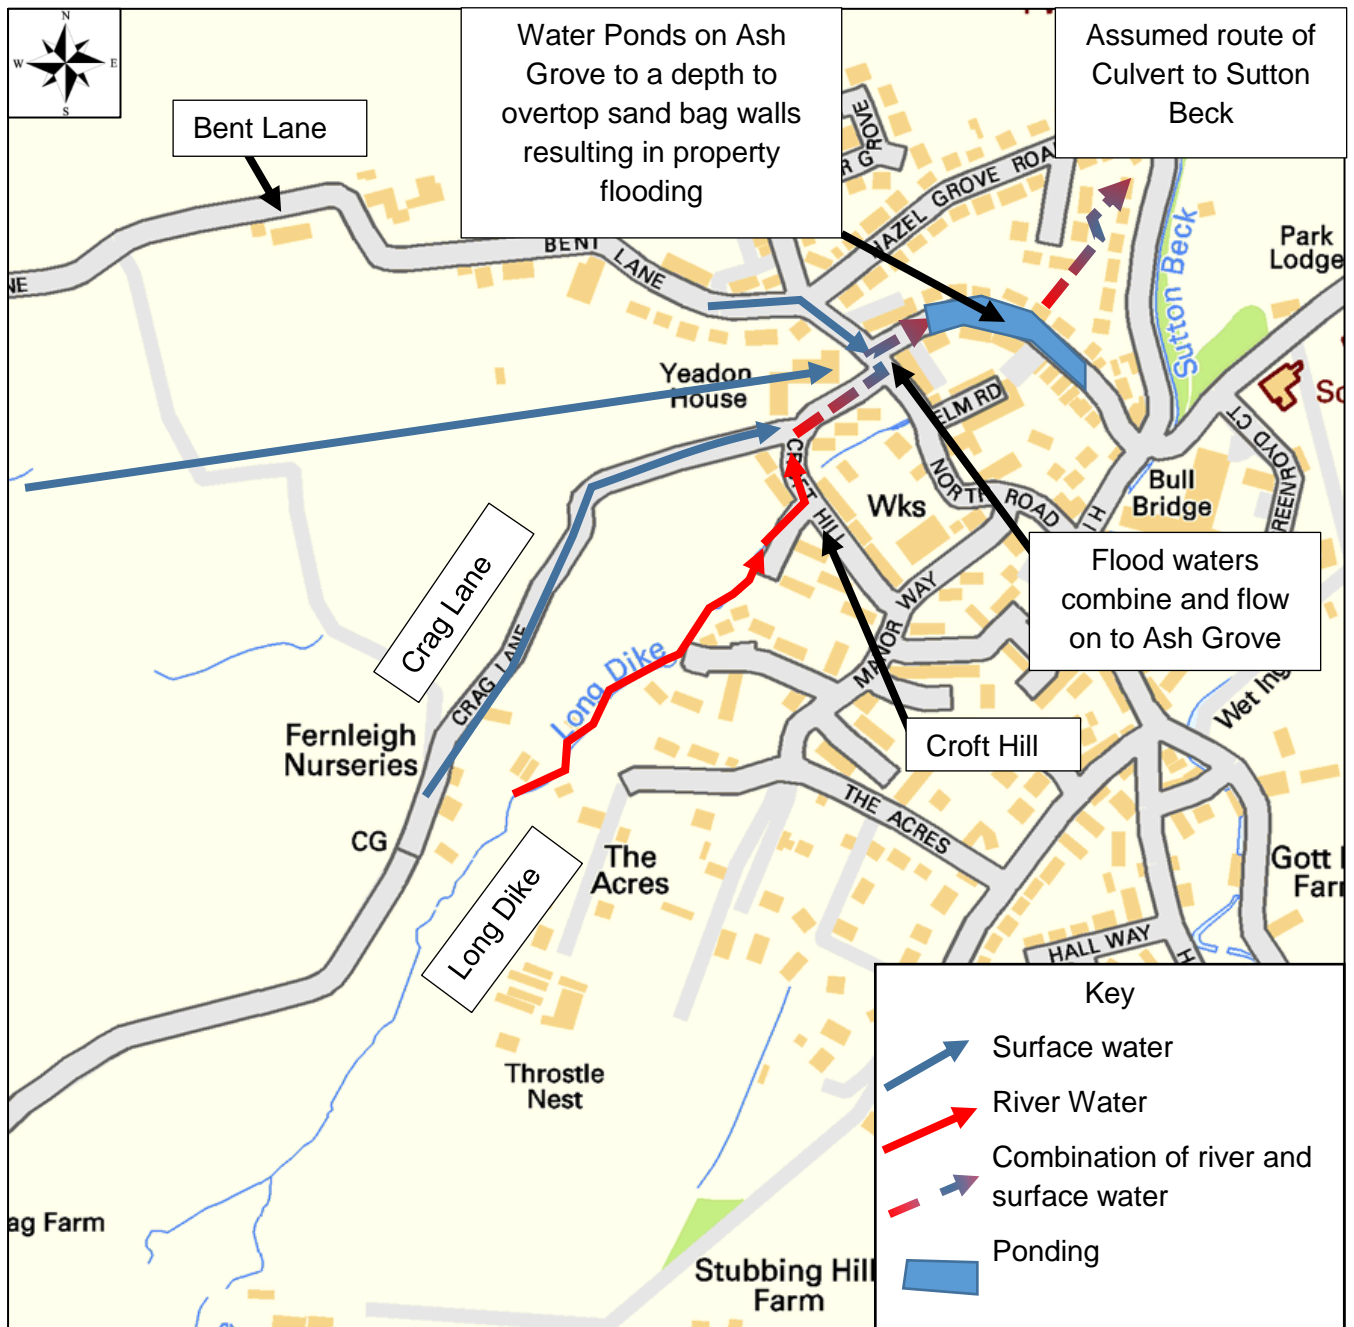
Figure 9.11 Flooding mechanisms at Ash Grove

3. Flow Path 2, is not shown by rolling ball analysis, but reflects the reports made by local residents and the waterborne debris observed during the site inspection. It appears that surface water from surrounding agricultural land resulted in a considerable flow down Crag Lane, described as 'looking like a river' by some residents. The volume of water coming from Crag Lane also brought a considerable amount of gravel and finer material onto Croft Hill from the un-made surface of this private road. This caused the highway gullies to become blocked and debris to be carried a considerable distance downstream by surface water.

5. The combination of above ground flow paths entering the highway system, gravel and fines entering the gully pots chocking the drainage system during the event, and the historic culvert discharging directly into the surface water system, caused the surface water system to become overwhelmed.

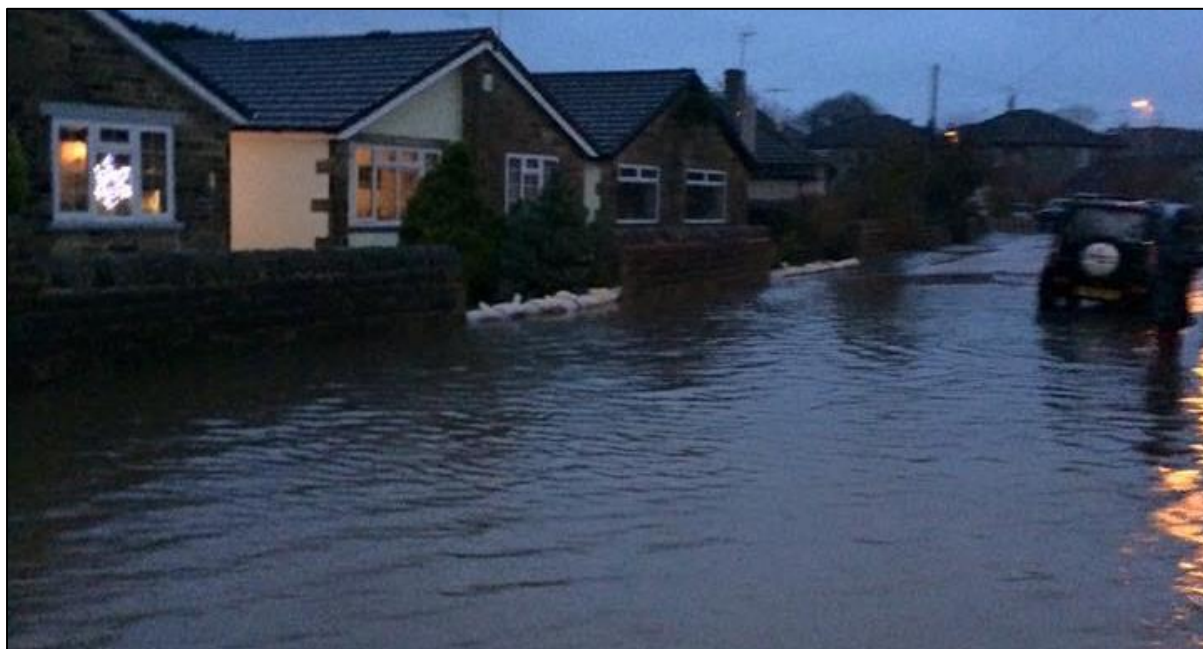
Figure 9.12 photograph showing flooding and sandbagging on Ash Grove

7. Based on previous experience and the conditions on the ground local residents took action to prevent water flooding their properties. It is understood that they were assisted in the provision of sandbags by Craven District Council and that the emergency services helped to install these across their driveways as shown in Figure 9.12.

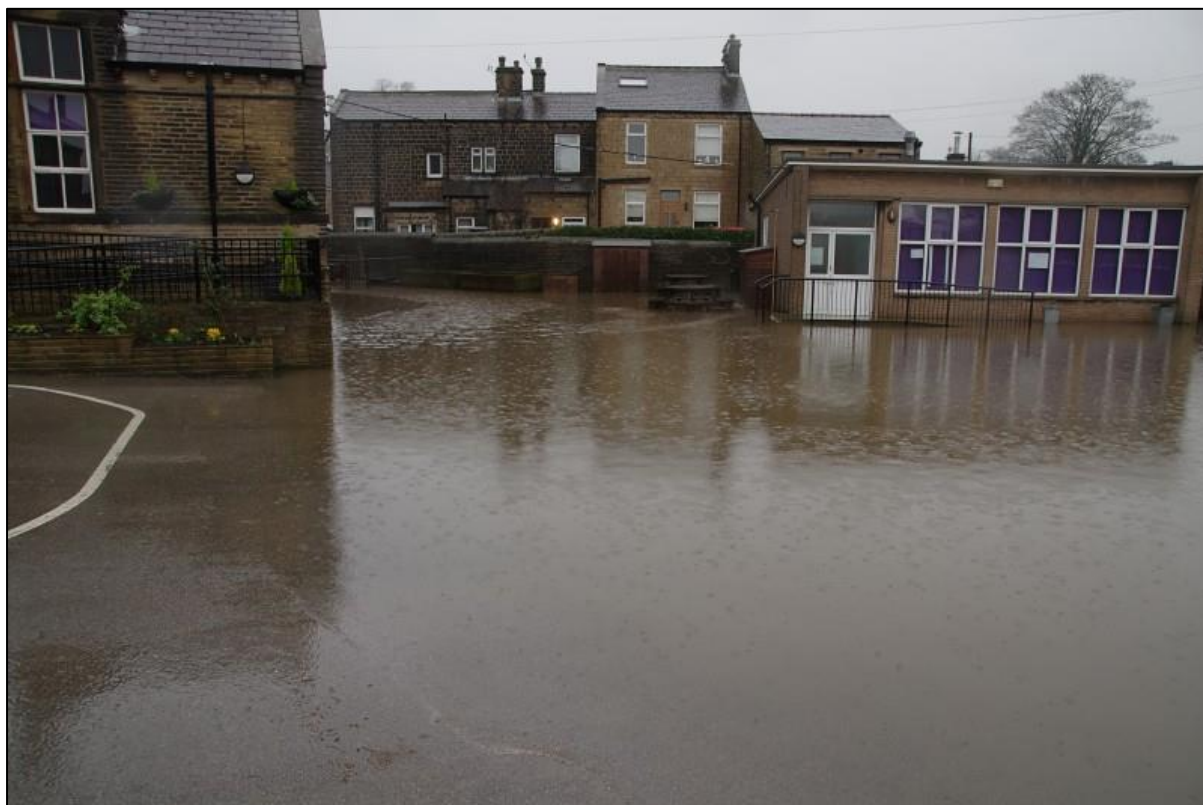
Figure 9.15 Photograph showing the ponding on the playground at the School

14. By the 27th December the water on The School's playground had subsided.
15. The School was checked on the 31st of December and there was no additional flood damage and no flooding of the cellar.
16. However, at the beginning of the school year, it was noticed that the cellar of the building had been flooded, the maximum depth of the water was judged to have be between 900mm and 1200mm. The flood waters damaged The School's boiler forcing the school to close for a week until the heating system could be repaired.
