North Yorkshire
County Council

Flood Investigation Report Tockwith

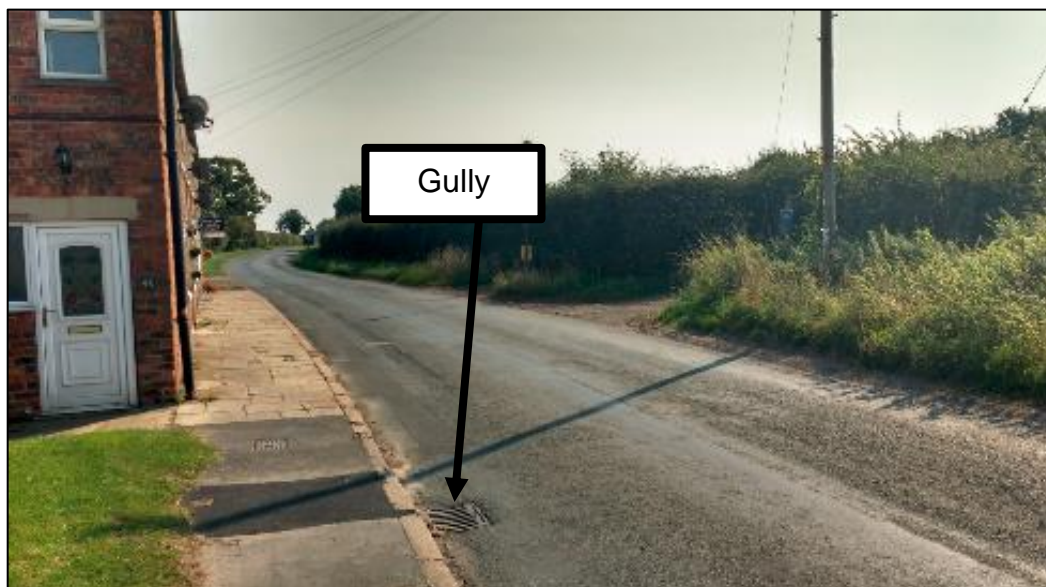
Figure 2.7 Road Gully on Marston Road outside New Row Cottages

Highway surface water drainage for Marston Road is taken by conventional road gullies, as shown in Figure 2.7.

The gully was overwhelmed, which exacerbated the flooding in this location.

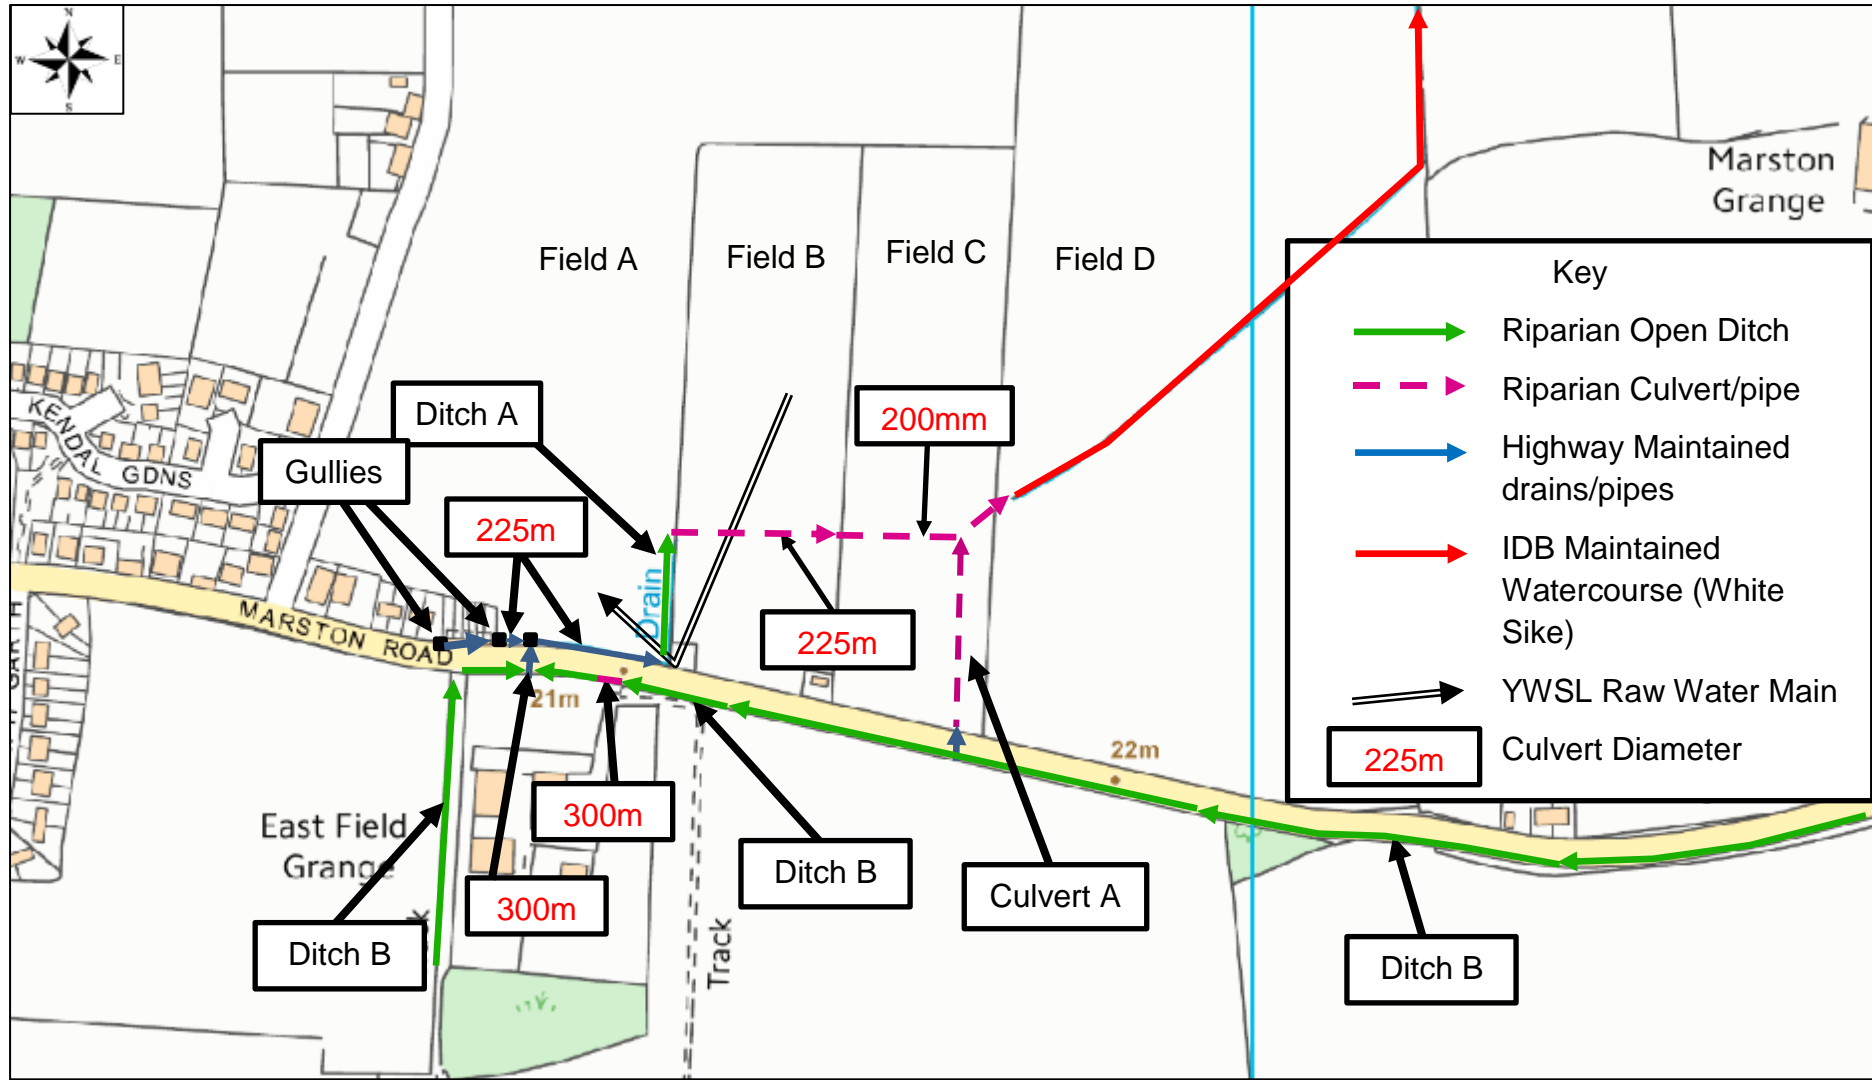
Figure 2.9 Drainage at eastern end of Marston Road

From Manhole A the flows are carried via a 225mm diameter pipe to Ditch A ¹¹. Ditch A is then carried via a 225mm culvert across 2 further fields (B & C below), reducing to 200mm diameter. This then discharges into White Sikes drainage ditch, as shown in Figure 2.9 which is Ainsty IDB maintained.

Note: The culvert routes in Field B and C have been predicted from CCTV inspection.

- Culvert A¹² was found to run between Marston Road and the culvert system that crosses field B and C, as shown in Figure 2.9. NYCC highways have confirmed this culvert flows from south to north.

From the examination of maps and sewerage drawings it has been deduced that the YWSL raw water main crosses the surface water drainage culvert in Field B, but no evidence of any damage is evident from the CCTV surveys.

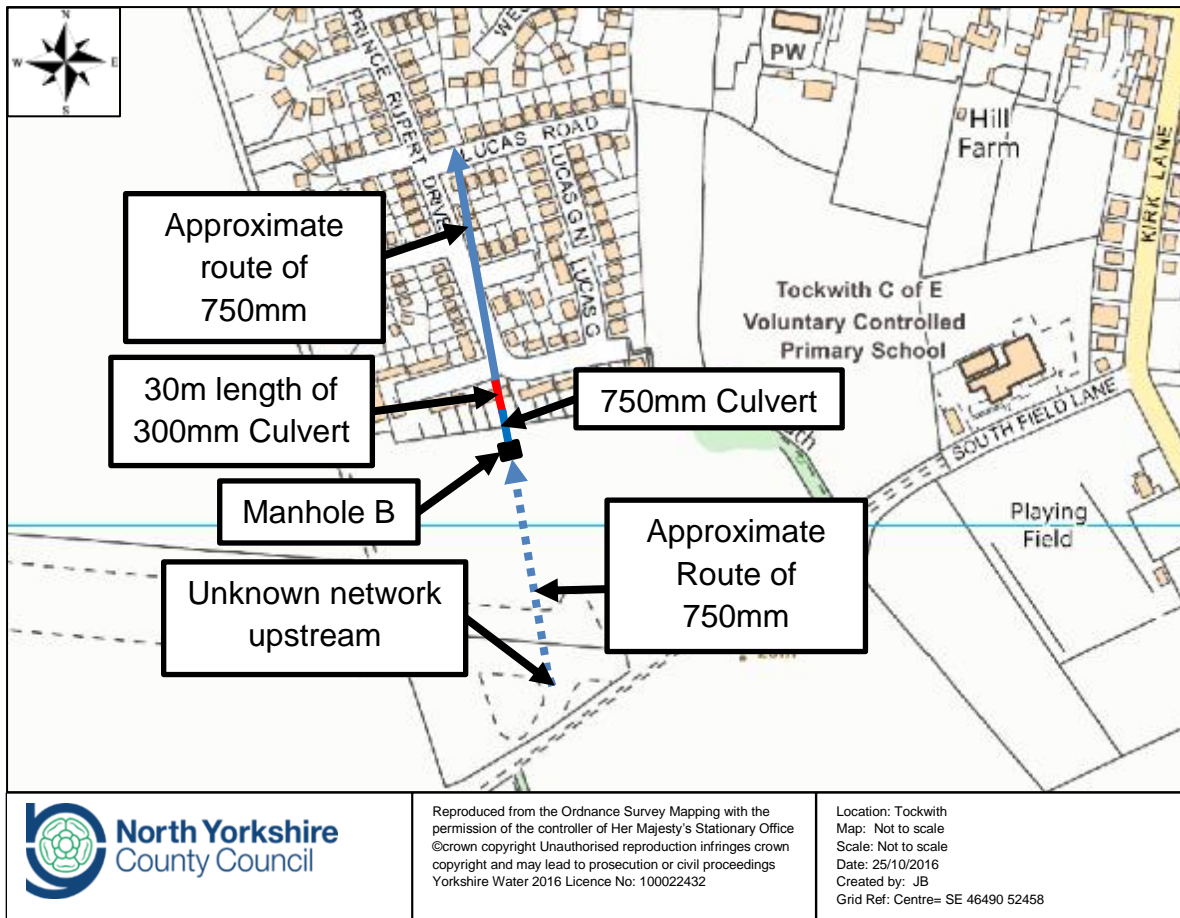
Figure 2.10 Route of historic culvert

Through the interpretation of historic maps (Pre 1960), it has become clear that Duckpond Plantation Dyke has been culverted under developments constructed after 1968. It is this section that has been excluded from the IDB watercourse network, as shown in Figure 2.6.

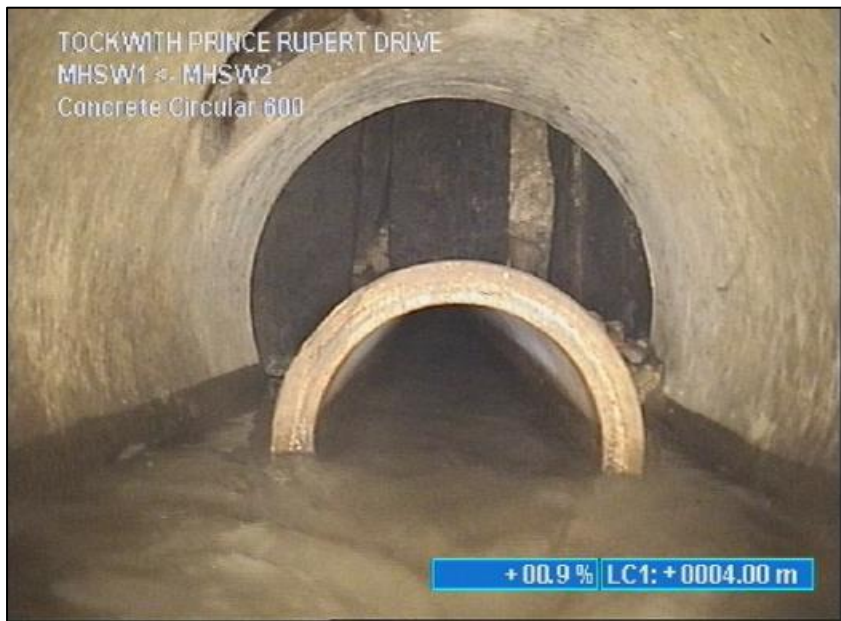
Figure 2.11 Photograph of surface water culvert reduction

A CCTV¹³ survey has been carried out by a local developer to determine the connectivity and condition of the system following the flooding in December 2015. This showed that the culvert running from the south to Prince Rupert Drive is approximately 750mm in diameter. The culvert is then reduced down to 300mm under a property at the south of Prince Rupert Drive for approximately 30m, as shown in Figure 2.11, after passing under this property the culvert is increased back

to approximately 750mm. The condition of the 300mm culvert is unknown. The CCTV survey report stated that 750mm diameter culverts were in poor structural condition with numerous longitudinal fractures along their lengths.

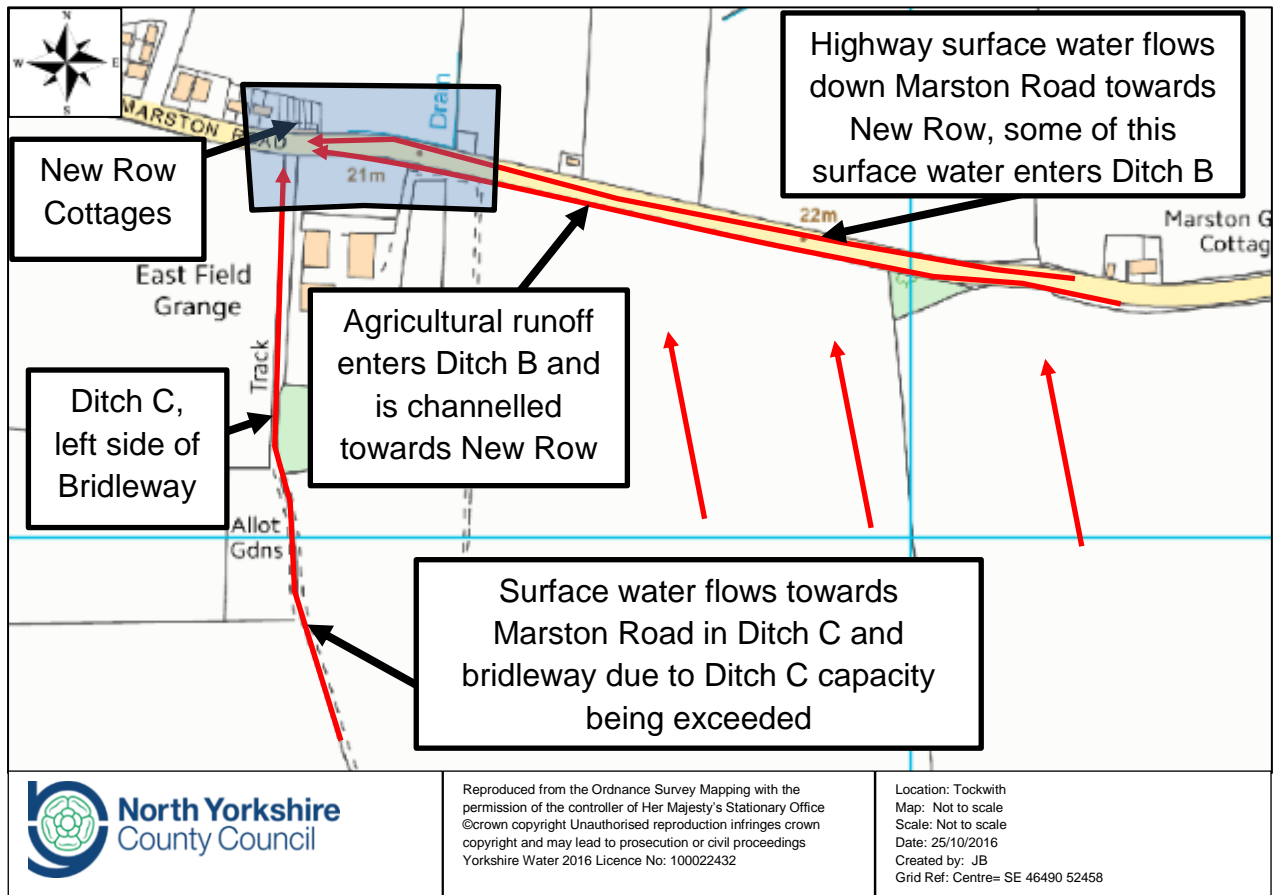
Figure 3.4 Flow paths to New Row from surrounding area

Surface water flowed on to Marston road, via the bridleway and surrounding agricultural land, as shown in Figure 3.4. Drainage Ditch C along the Bridleway could not contain the excess surface water¹⁹. In addition the culvert under the bridleway (discovered after the event and found to be blocked) could not effectively discharge flows from Ditch C to Ditch B, which exacerbated the flooding on Marston Road.

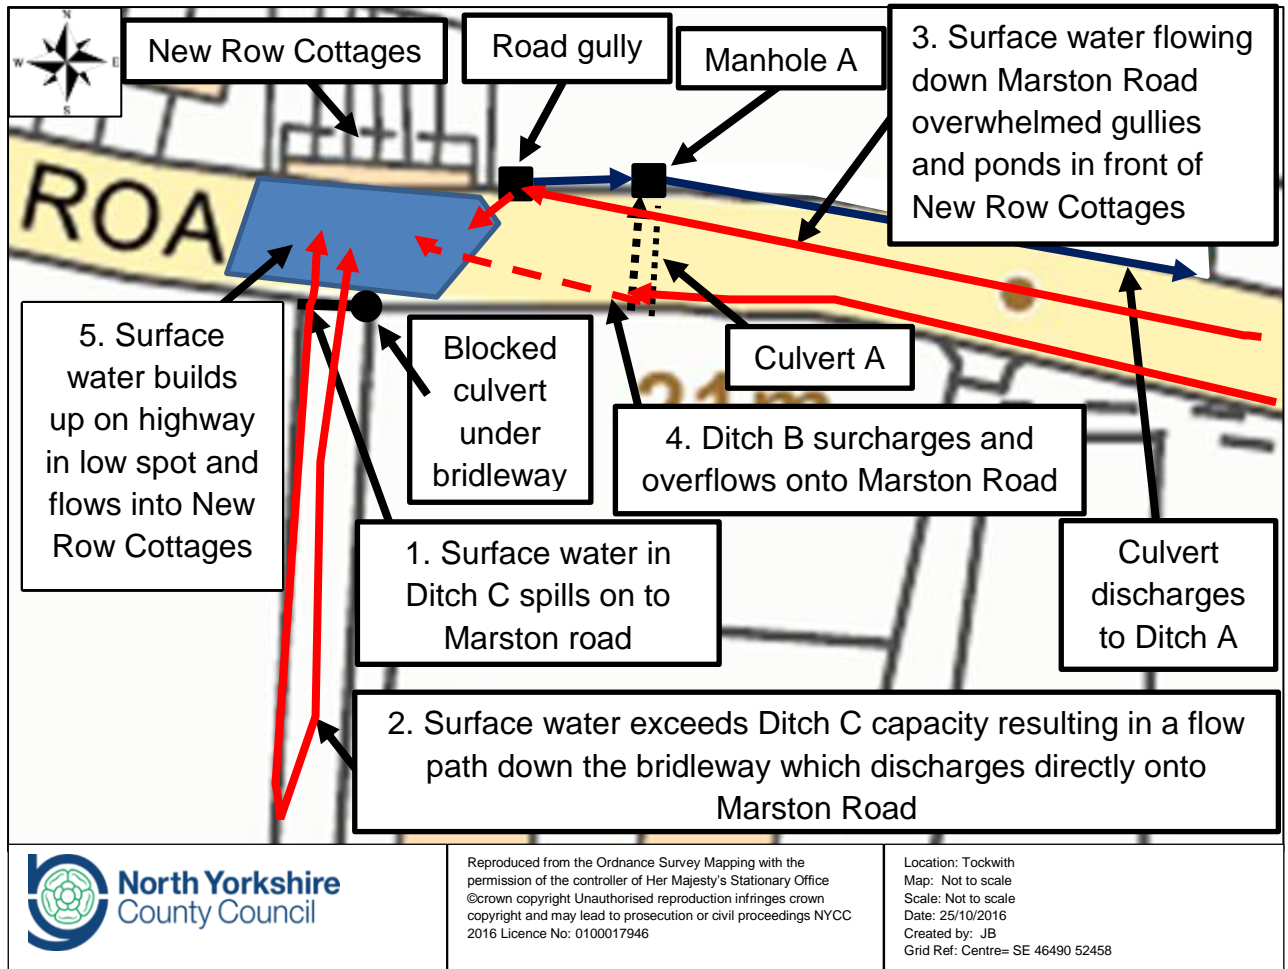
Figure 3.5 Flow paths intercepting at New Row Cottages

The combination of surface water from the Bridleway, Ditch B overflowing and highway runoff caused the ponding of flood water outside New Row Cottages. The properties at New Row Cottages have low thresholds. Surface water overtopped the footpath from Marston Road and flooded the properties, as shown in Figure 3.5. The majority of surface water runoff comes from the agricultural land with the highways providing a pathway for the flow once it has breached the ditches.

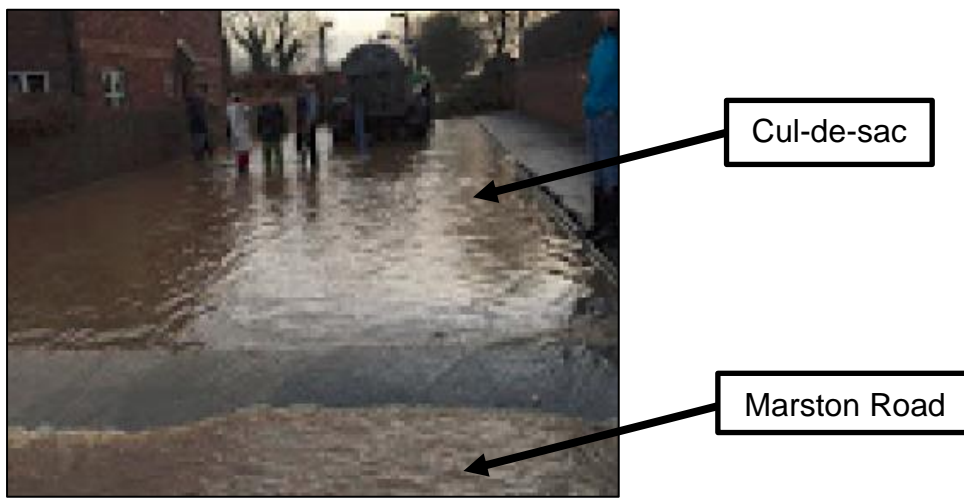
The surface water then followed the gradient of the land, passing through a gateway onto the cul-de-sac next to 44 Marston Road, as shown in Figure 3.6 and 3.7. The flood waters entered the rear gardens from the cul-de-sac and the adjacent field, resulting in the properties and road flooding.

Figure 3.6 Photograph of flooding of cul-de-sac

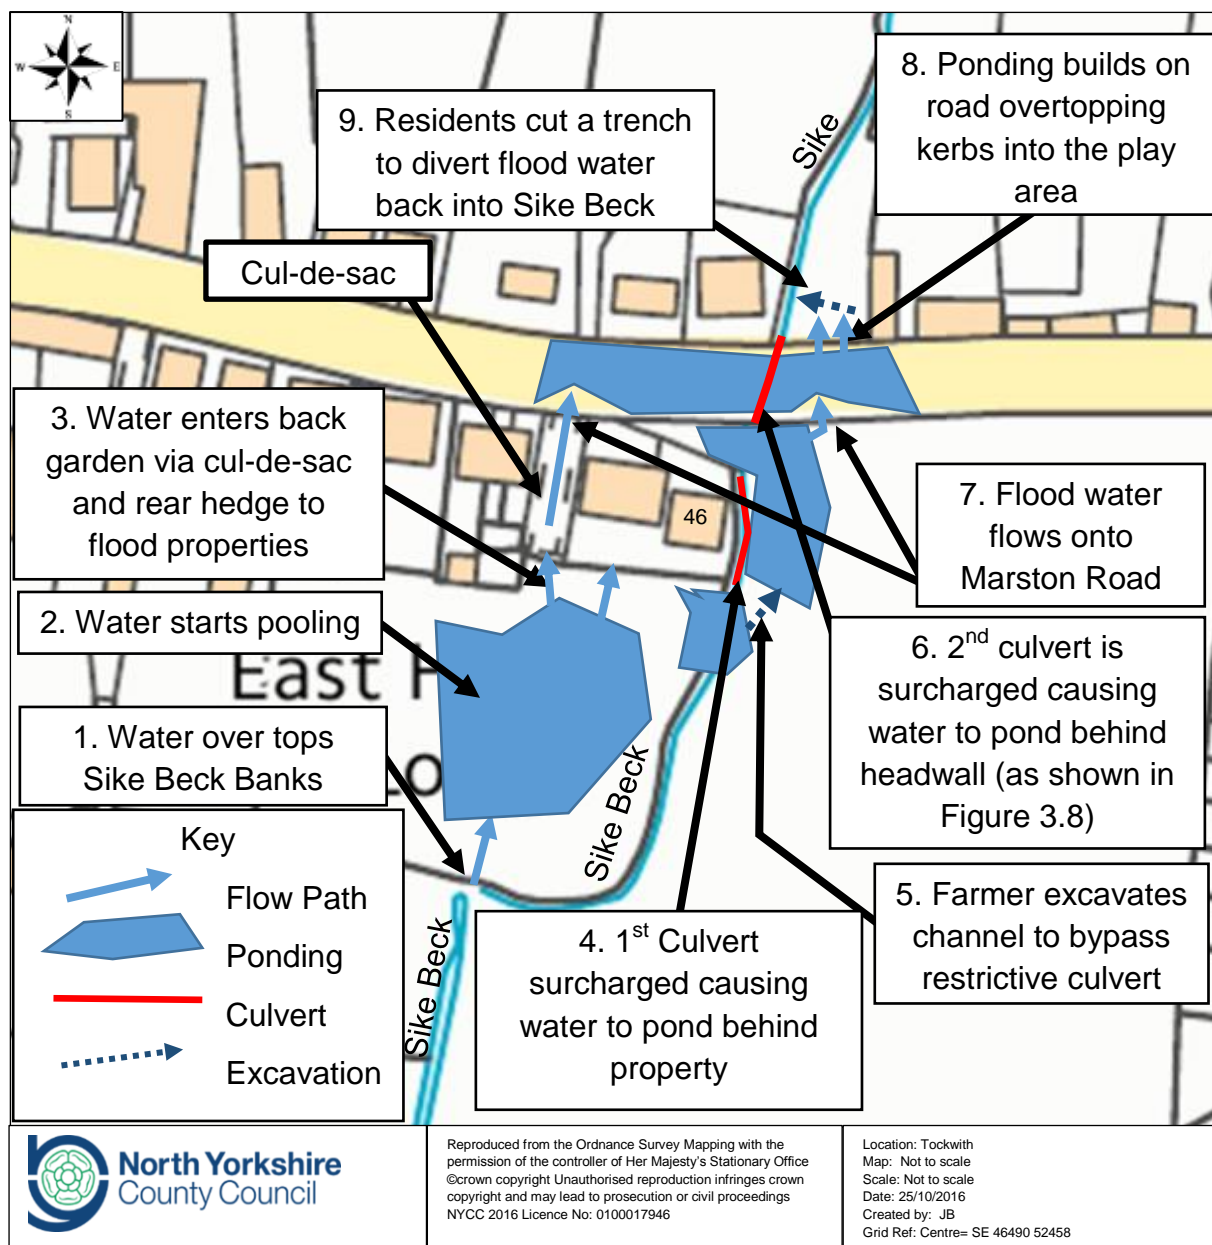
Figure 3.7 Flow paths at Marston Road from surrounding area

The majority of agricultural runoff to the south of this location enters the Sike Beck²⁰. Sike Beck has a right angle bend 70m south of Marston Road. During the rainfall event, beck levels rose and overtopped into an adjacent field at the right angle bend.

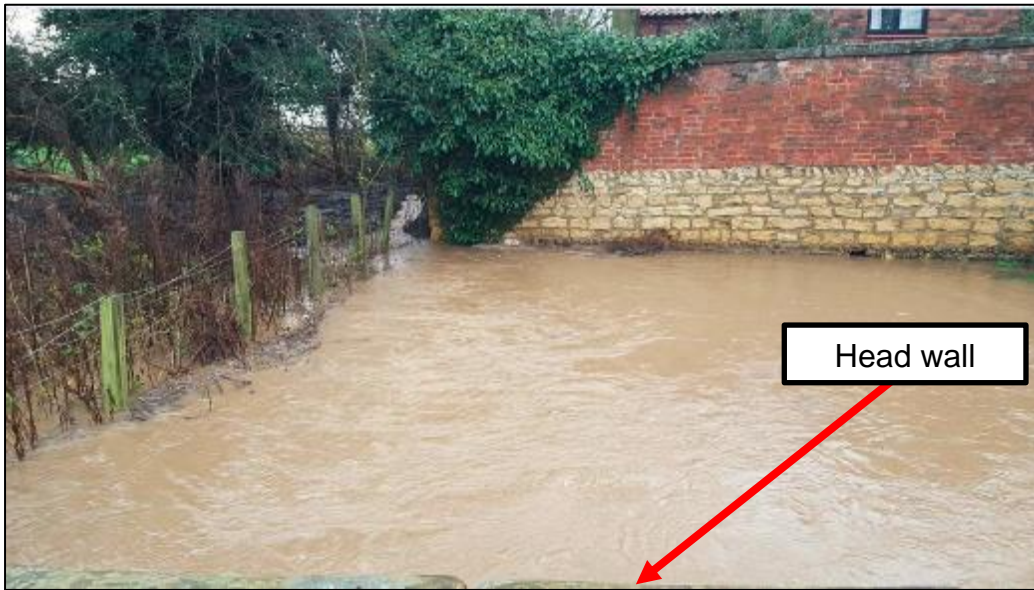
The 1st inlet to the culvert, located towards the south east corner of the grounds of No.46 Marston Road, surcharged during the rainfall event. Excess flood waters built up onto adjacent land.

Figure 3.8 Photograph showing flood water behind headwall

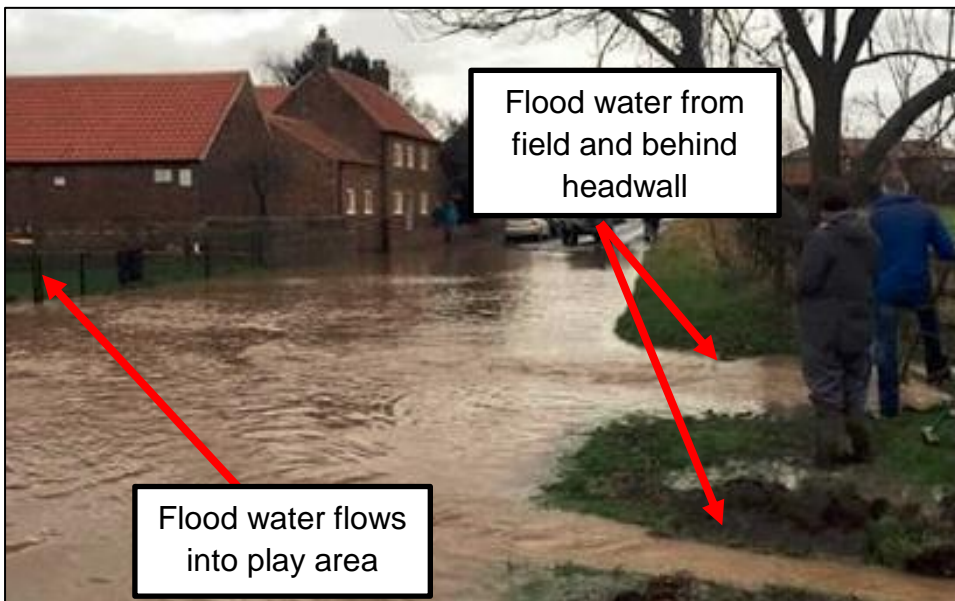
Figure 3.9 Photograph showing flood water on Marston Road

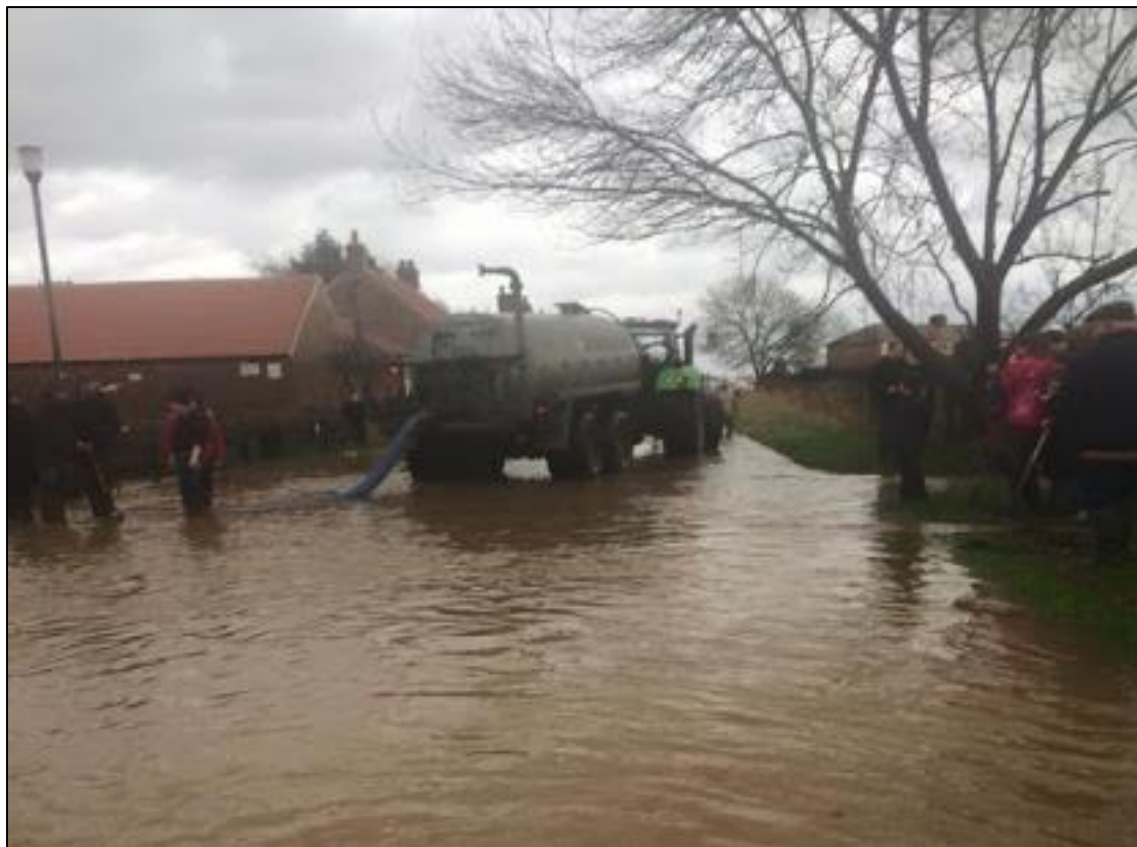
When surface water was building up on Marston Road, residents used sandbags to protect their properties from being flooded. At the time of the flood, local farmers pumped flood water into tankers in an attempt to reduce flood waters, as shown in Figure 2.10.

Figure 3.10 Photograph showing farmer tankering flood waters

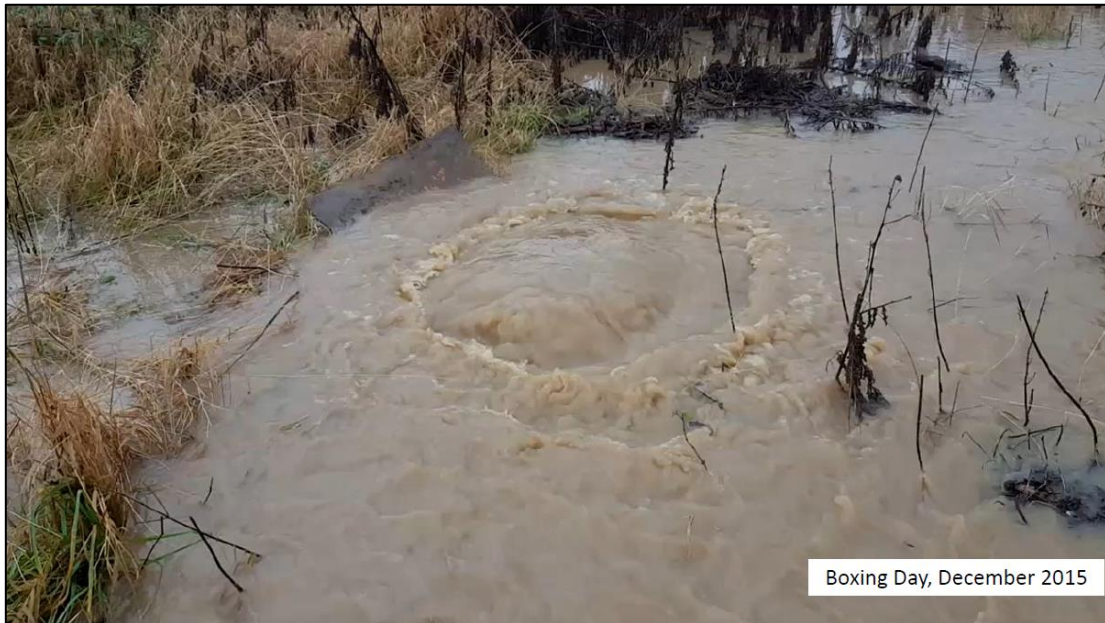
This resulted in large volumes of water being discharged out of a manhole located in the airfield, as shown in Figure 3.11. Concerns were raised at the time that loose concrete slabs put on top of the manhole in place of a formal cover had slipped into the chamber and caused the flooding. However, it is unlikely that given the volumes

of water concerned and the restriction subsequently discovered lower in the system, that this would have had any significant impact on the flooding that occurred.

Figure 3.11 Photograph showing surface water discharge from manhole

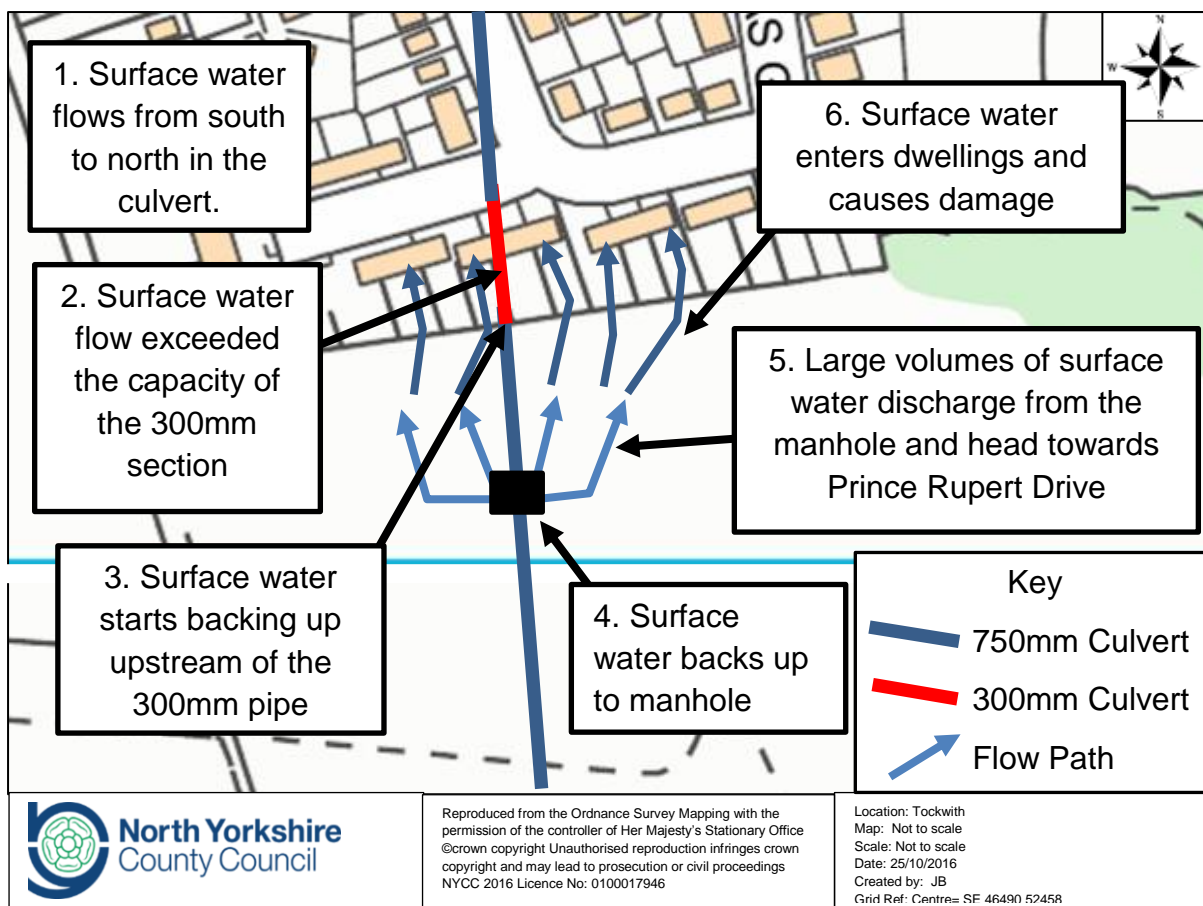
Due to the heavy rainfall experienced on the 25th and 26th December 2015 the surface water inundated the system. The combination of heavy rainfall and the bottle neck, caused by the reduction in pipe diameter from 750mm to 300mm under properties on Prince Rupert Drive (assumed to be a legacy from their original construction in the 1980s), caused backing up in the system. The water in the historic culvert backed up until it stopped inflows from the catchment area.

The water bursting out from the over loaded culvert joined with other overland flows to inundate properties at the southern end of Prince Rupert Drive, resulting in internal flooding, as shown in Figure 3.12.

Figure 3.12 Prince Rupert Drive mechanism of flooding, culvert shown in approximate position.

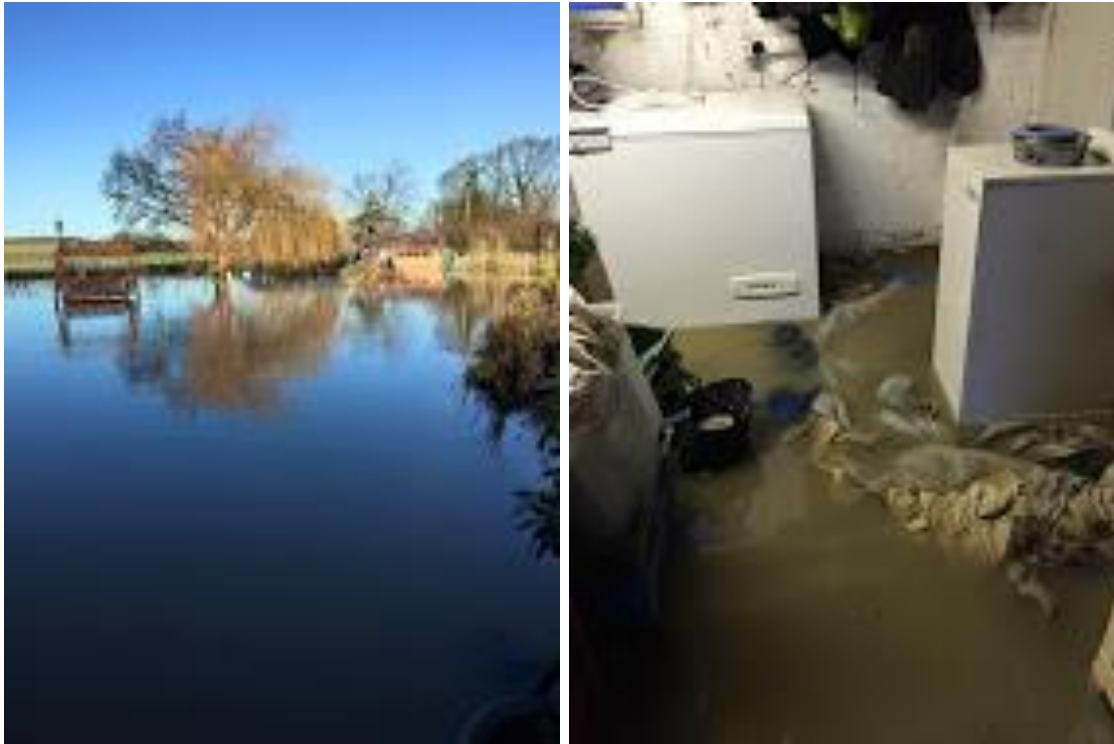
Properties on Blind Lane experienced surface water flooding resulting from agricultural land runoff, with no appropriate outfall or discharge point. Significant build-up of water caused extensive flooding to gardens and internal damage, as shown in Figure 3.13.

Figure 3.13 Photographs showing flooding at Blind Lane
