A59 Kex Gill Diversion Scheme

Options Assessment Report

APPENDIX 1 – Accident Cluster Analysis

March 2017

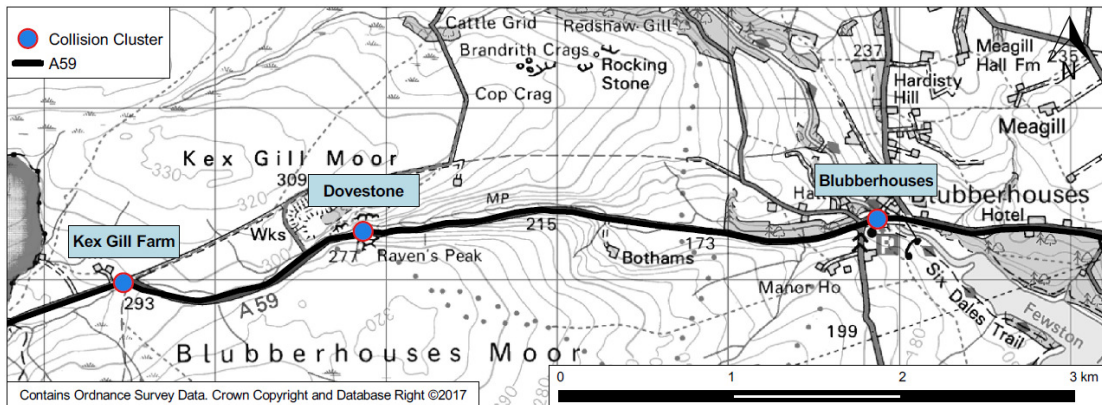
Figure 1 – Accident Cluster Locations

Using the above methodology a total of three accident clusters have been identified within the study area, see Figure 1 and Table 1.

Cluster Site	Slight	Serious	Fatal	Total
Kex Gill Farm	3	3	0	6
Dovestone	3	1	0	4
Blubberhouses	6	0	1	7
Total	12	4	1	17

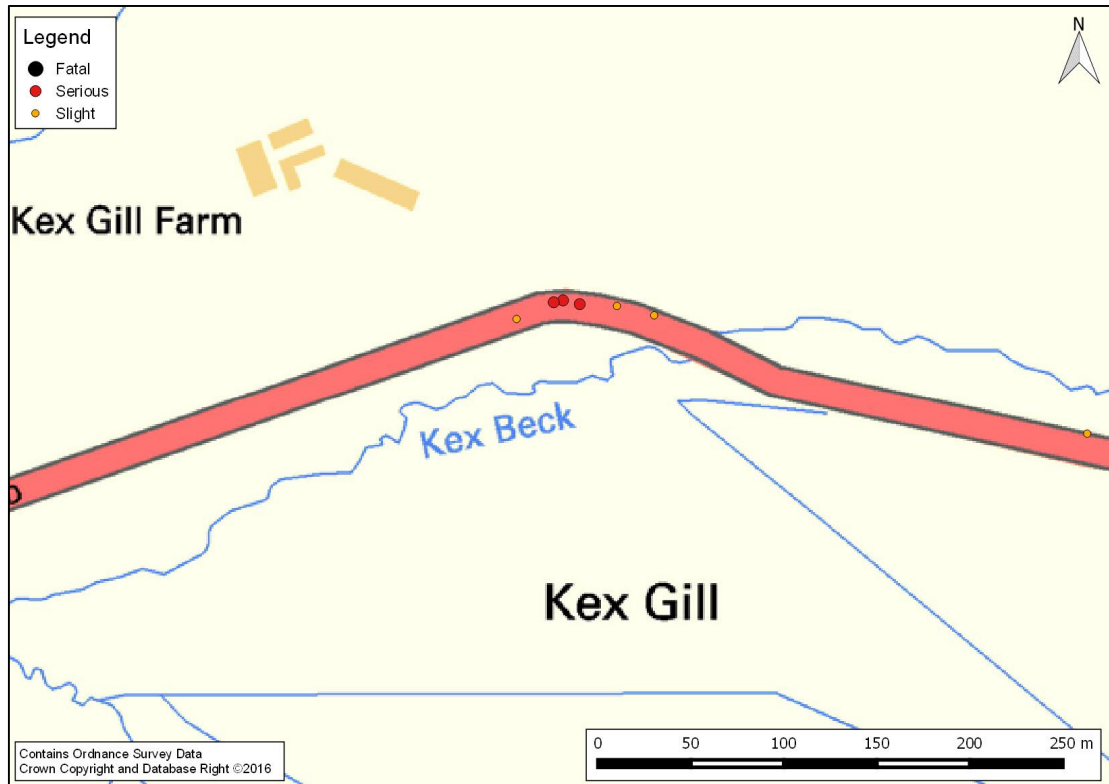
Figure 2 – Kex Gill Farm Collisions

There was a total of six collisions in the cluster on the bend on the A59 next to Kex Gill Farm (see Figure 2). Three of the collisions caused serious injuries with the

remainder causing slight injuries. All of the collisions occurred as a result of the driver losing control of their vehicle on the bend. In two cases the road surface was compromised by flooding or snowfall.

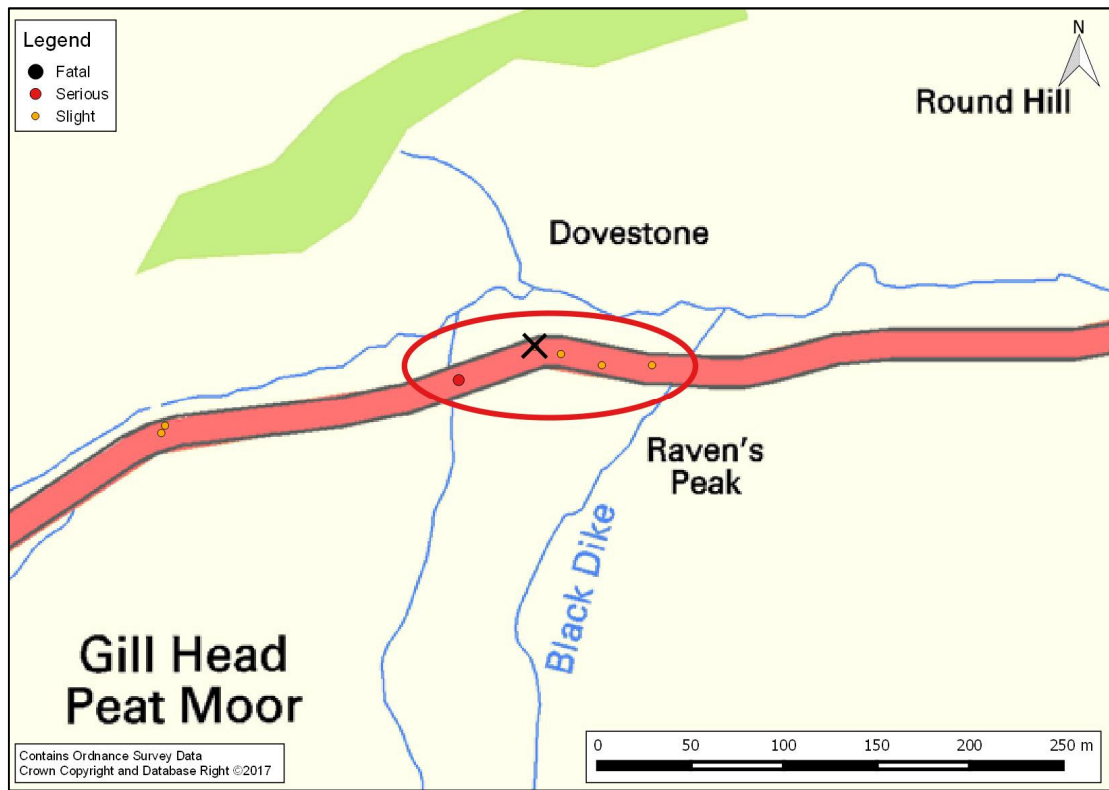
Figure 3 – Dovestone Collisions

There were four collisions at the Dovestone cluster site (see Figure 3) one of which resulted in serious injuries to a motorcyclist heading east who veered to the nearside of the carriageway and struck a large boulder in the road, possibly due to illness. The rest of the collisions resulted in slight injuries. The prevailing reason for the collisions was vehicles failing to negotiate the bend, with travelling too fast for the conditions a contributing factor in two collisions. Two accident reports stated that large stones were in the carriageway.

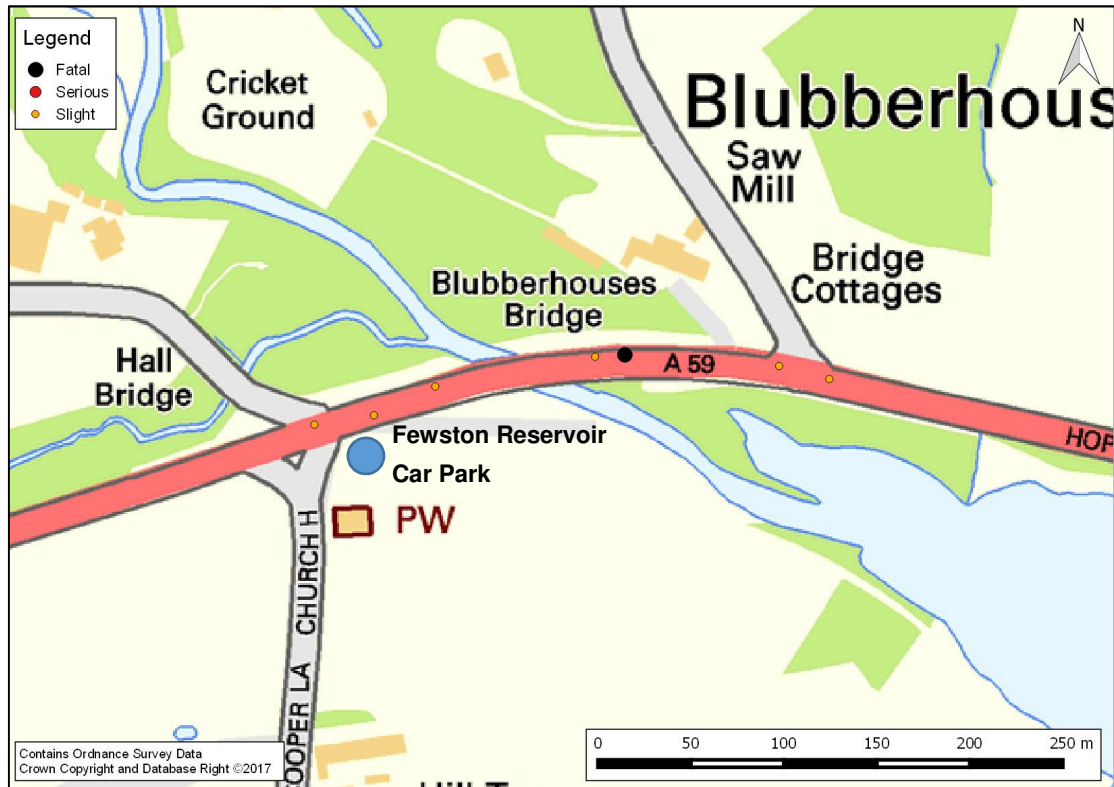
Figure 4 – Blubberhouses Collisions

A total of seven collisions occurred over the stretch of the A59 at the Blubberhouses cluster site (see Figure 4), this included one collision that resulted in fatal injuries when a vehicle attempted to overtake on a blind bend and became involved in a head-on collision with a vehicle travelling in the opposite direction. The remaining slight collisions were predominantly caused by either drivers failing to stop in time when approaching stationary traffic, or vehicles failing to look properly whilst entering the A59 from side roads. One collision occurred as a result of a tyre blow out. Visibility is poor at the Hall Lane junction, as there is a steep ascending approach to the A59. One collision occurred as a vehicle attempted to turn right from Fewston Reservoir car park onto the A59 and pulled into the path of a vehicle heading west towards Skipton. However, the road markings at this location suggest that vehicles should always exit the car park left onto the side road Church Hill and manoeuvre onto the A59 from here as visibility looking over a driver's right shoulder when exiting onto the A59 directly from the car park is poor.
