Flood Investigation Report

Sleights

1 Executive Summary

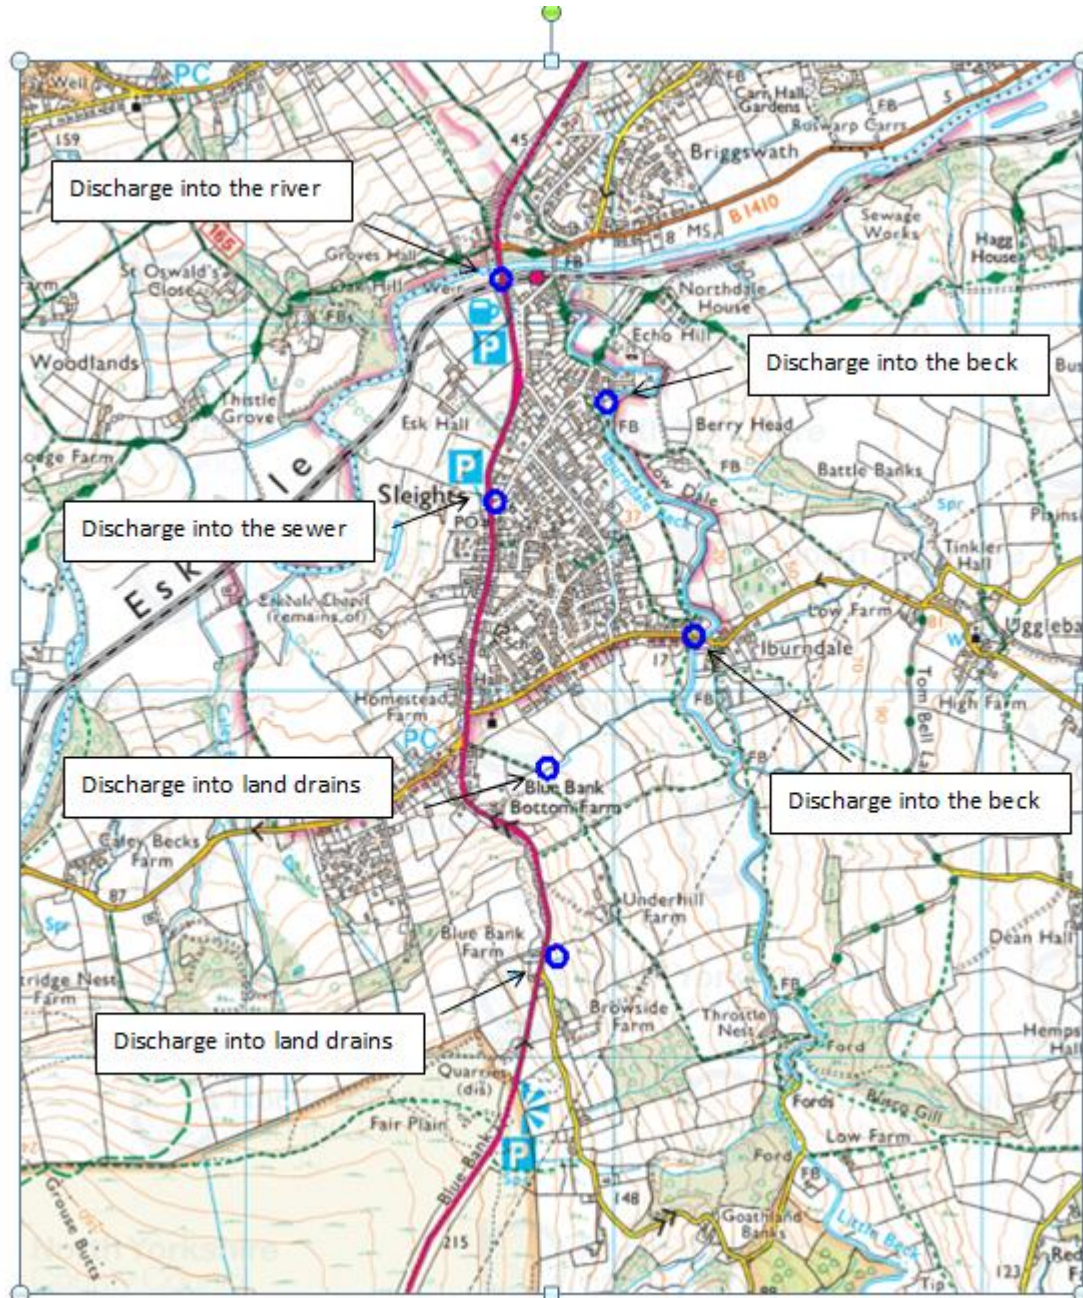
Figure 2.4 Approximate position of highway surface water drainage discharge points.

Highways gullies in the south of the village were blocked quickly by the large volume of material from the arrestor bed which caused additional water to continue its run off down the roads in Sleights.

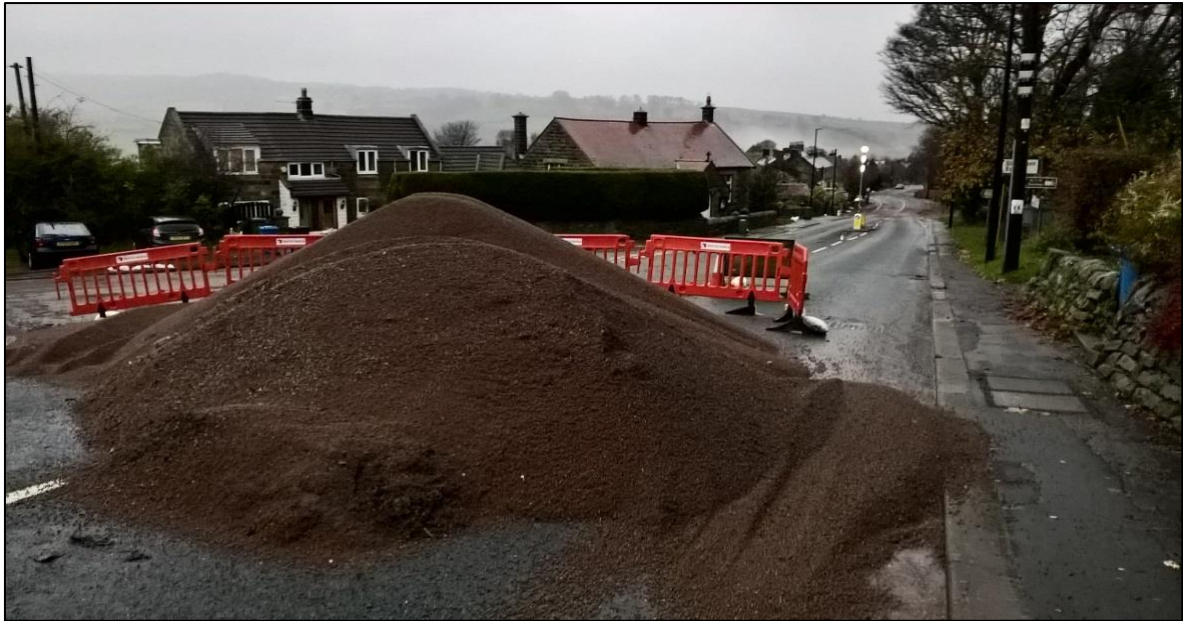
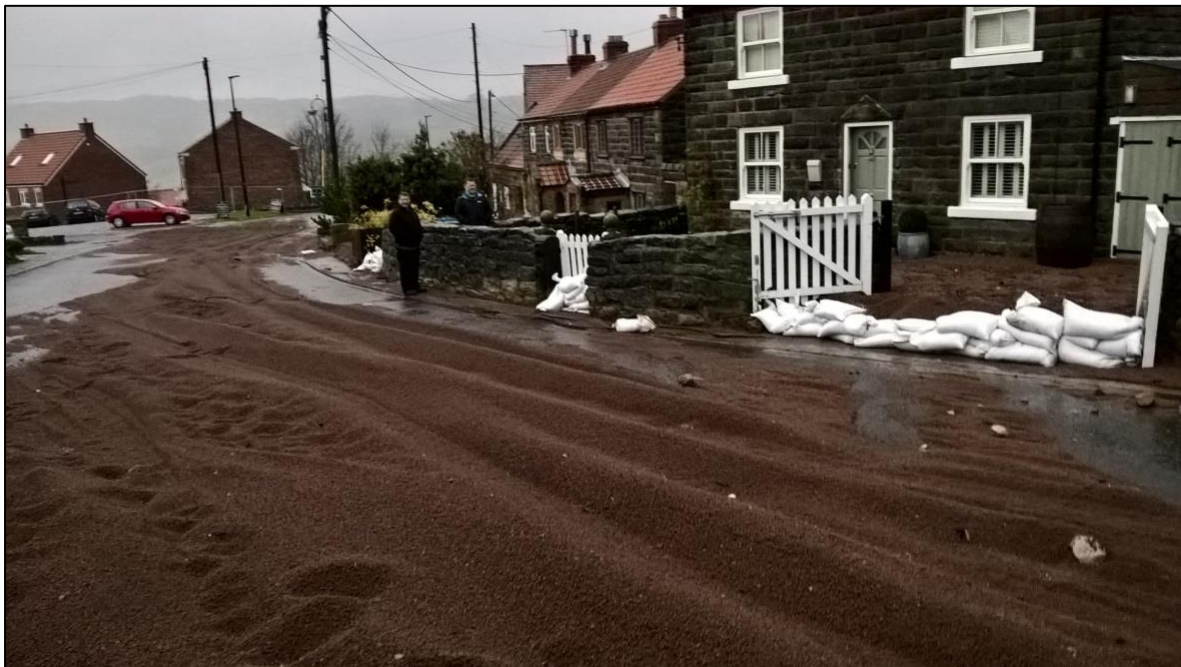
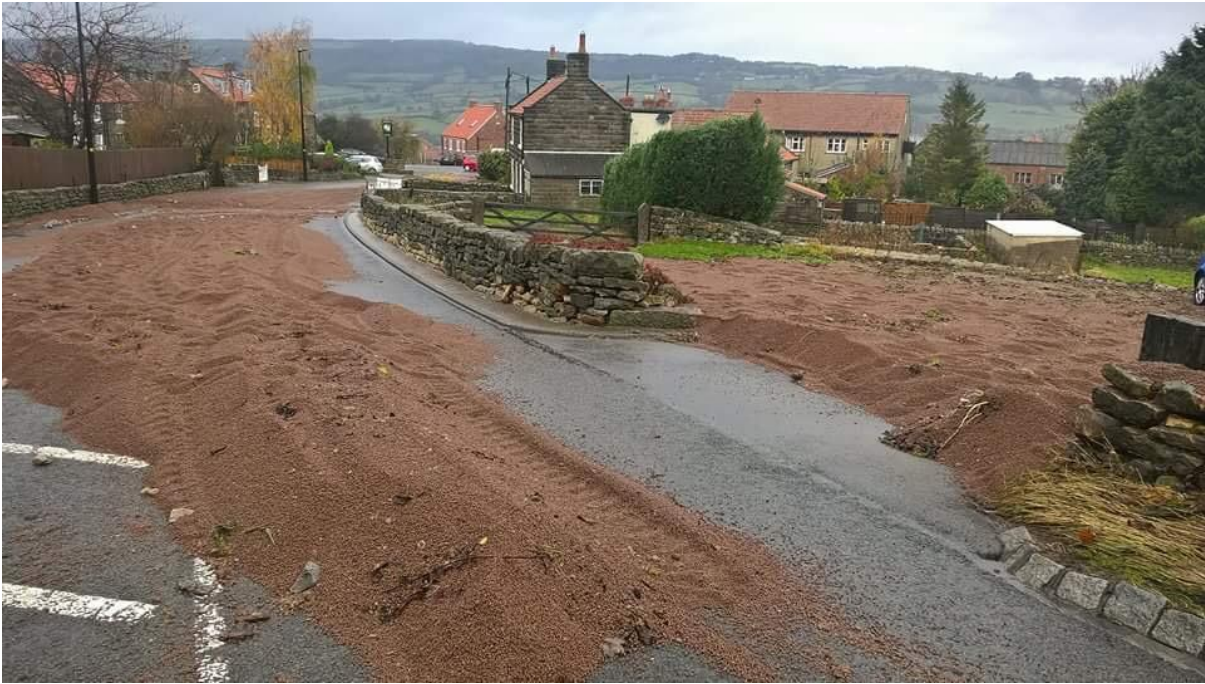
The Lytag was carried some distance down the steep gradients, and eventually deposited on the highway and in gardens and land adjacent to the highway from Blue Bank Farm for about 200 metres.

The Lytag filled drains and trapped travelling cars on the bank, creating channels on the carriageway which resulted in areas of deep surface water tracking down the bank.

The photographs above show the arrestor bed material in the street.

The arrestor bed had to be refilled with about 600 tonnes of new material which required 15 wagons to transport it from Drax Power Station.

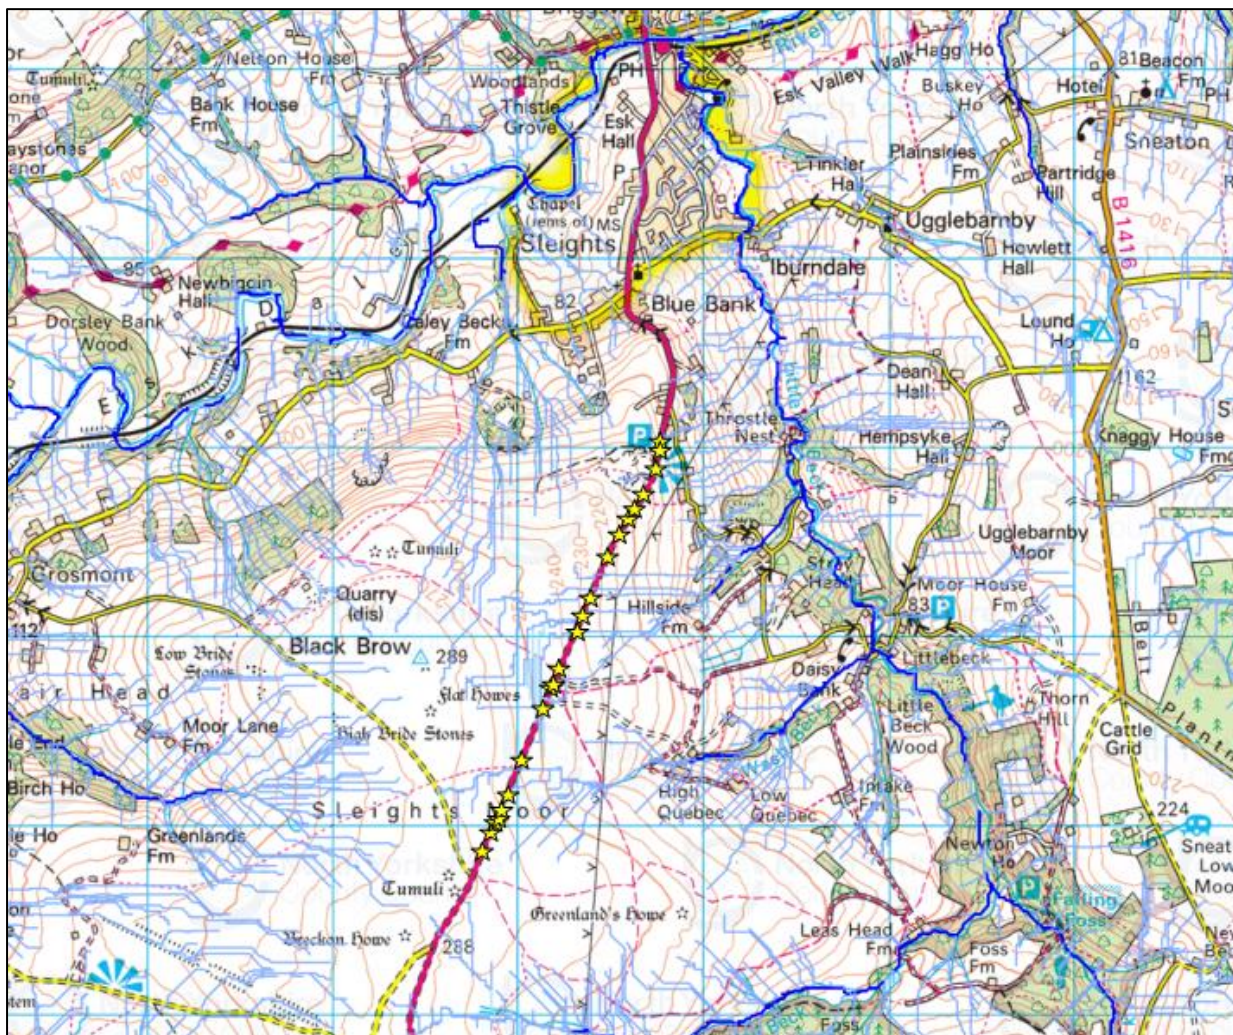
Figure 3.6 Approximate Locations of Damaged and Blocked Culverts and “rolling ball” flow path analysis (Source: NYCC)

The obstruction of culverts on Sleights Moor, between the A169 Fairhead junction and Blue Bank demonstrated on the map above are considered to have been the most significant contributor to the flood.

The blue lines on the document above represent the rolling ball flow paths across the moor. Rolling ball analysis uses the Environment Agency LIDAR Digital Terrain Model and simulates the path of water across the terrain, identifying where it is most likely to flow as a result of topography (the flow-paths).

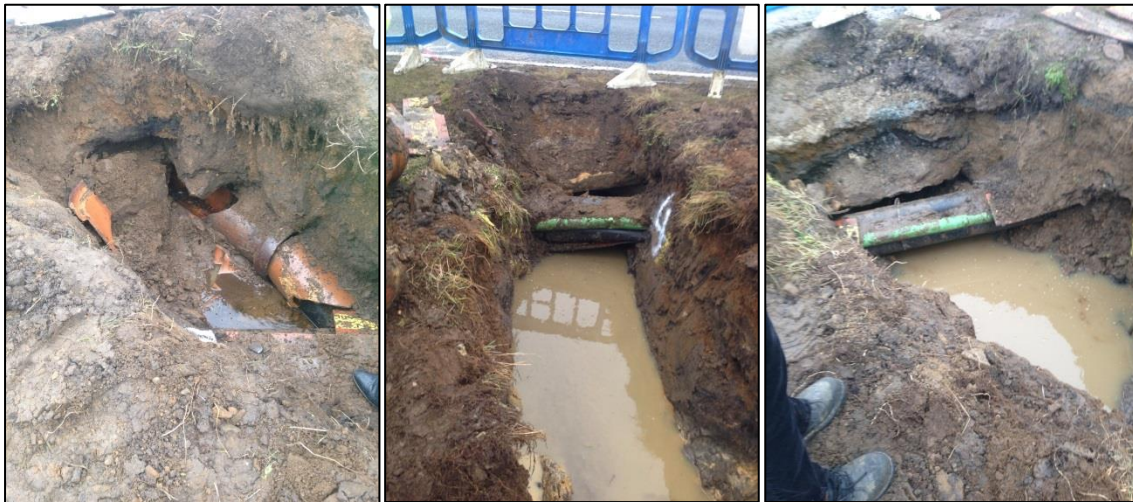
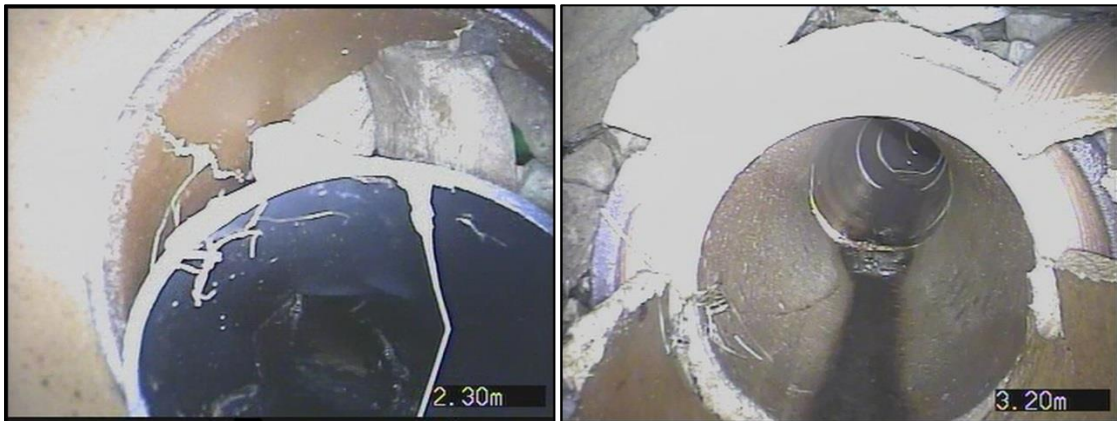
Figure 3.7 Photographs demonstrating damage to the culverts under the A169. (Source: NYCC)

This report finds that the volume of water which conveyed down Blue Bank was as a direct result of damage and obstruction to a series of culverts along the moor above Blue Bank, resulting from inadequacies in utility work that had been undertaken in the months prior to the event.

During the summer of 2016 utility works had been undertaken on the moors; whilst not associated with drainage, the works caused unintended damage and

obstruction to many culverts that pass under the A169 between Pickering and Sleights.

It is not considered that obstruction to one individual culvert would cause significant flooding but the accumulation of the series of obstructions to the intended flowpaths caused a significant flood to be directed down the A169 instead of traveling on its designed route towards Littlebeck and Iburndale beck.

- Assisted in the emergency response to the event.
- Undertaken maintenance activities such as jetting and repair of gully pots post flood event.
- Ensured the replacement and reinstatement of damaged culverts along Blue Bank.
- Undertaken kerb realignment on the A169 to direct the flow of highway surface water away from Blue Bank
- Proposes to install two additional culverts under the A169 to increase the overall capacity of the drainage system

Works have now been undertaken to rectify the damage caused and return the system to its designed operation. The utility company has agreed in principle to paying the costs. The County Council Highways Service will conduct routine annual inspections of the culverts to ensure they are adequately maintained.

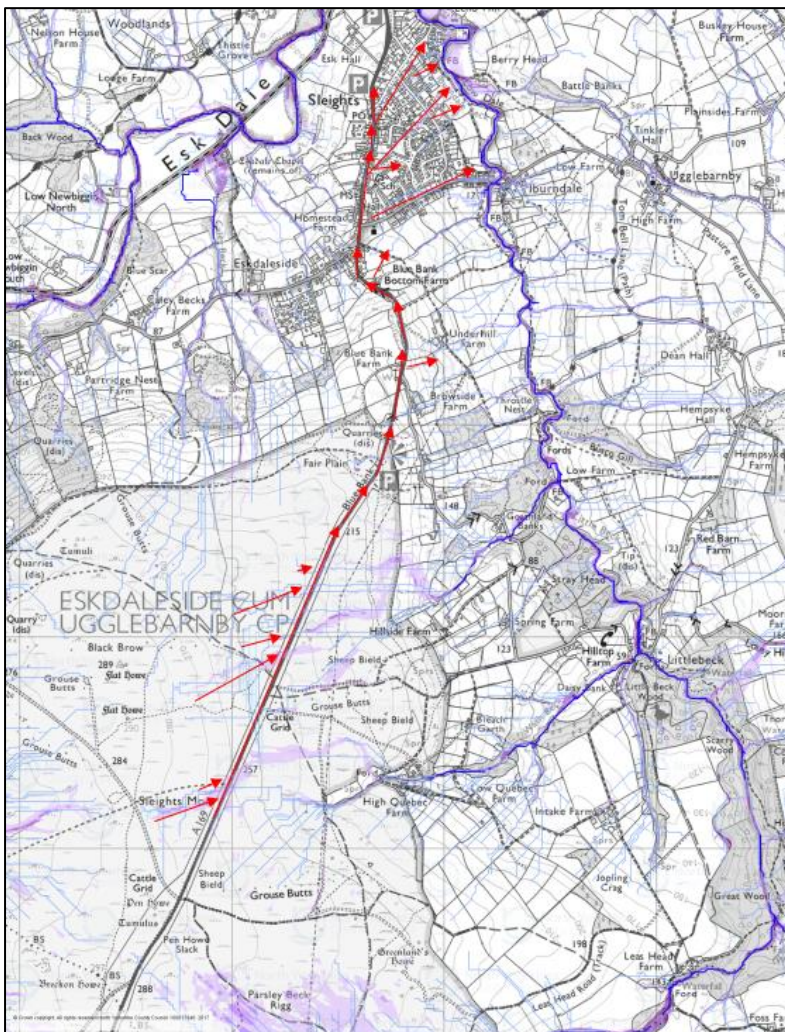
Figure 3.8 Approximate Flow Paths during the Event (Source: NYCC)

As the content of the arrestor bed was carried down the carriageway, and filled many land drains further down Blue Bank, this quickly caused additional obstruction to the drainage systems and meant water also could not convey along land drains further down Blue Bank.
