FLOOD INVESTIGATION REPORT

Storm Darragh Flooding on Rye Tributaries December 2024

Report Issued December 2025

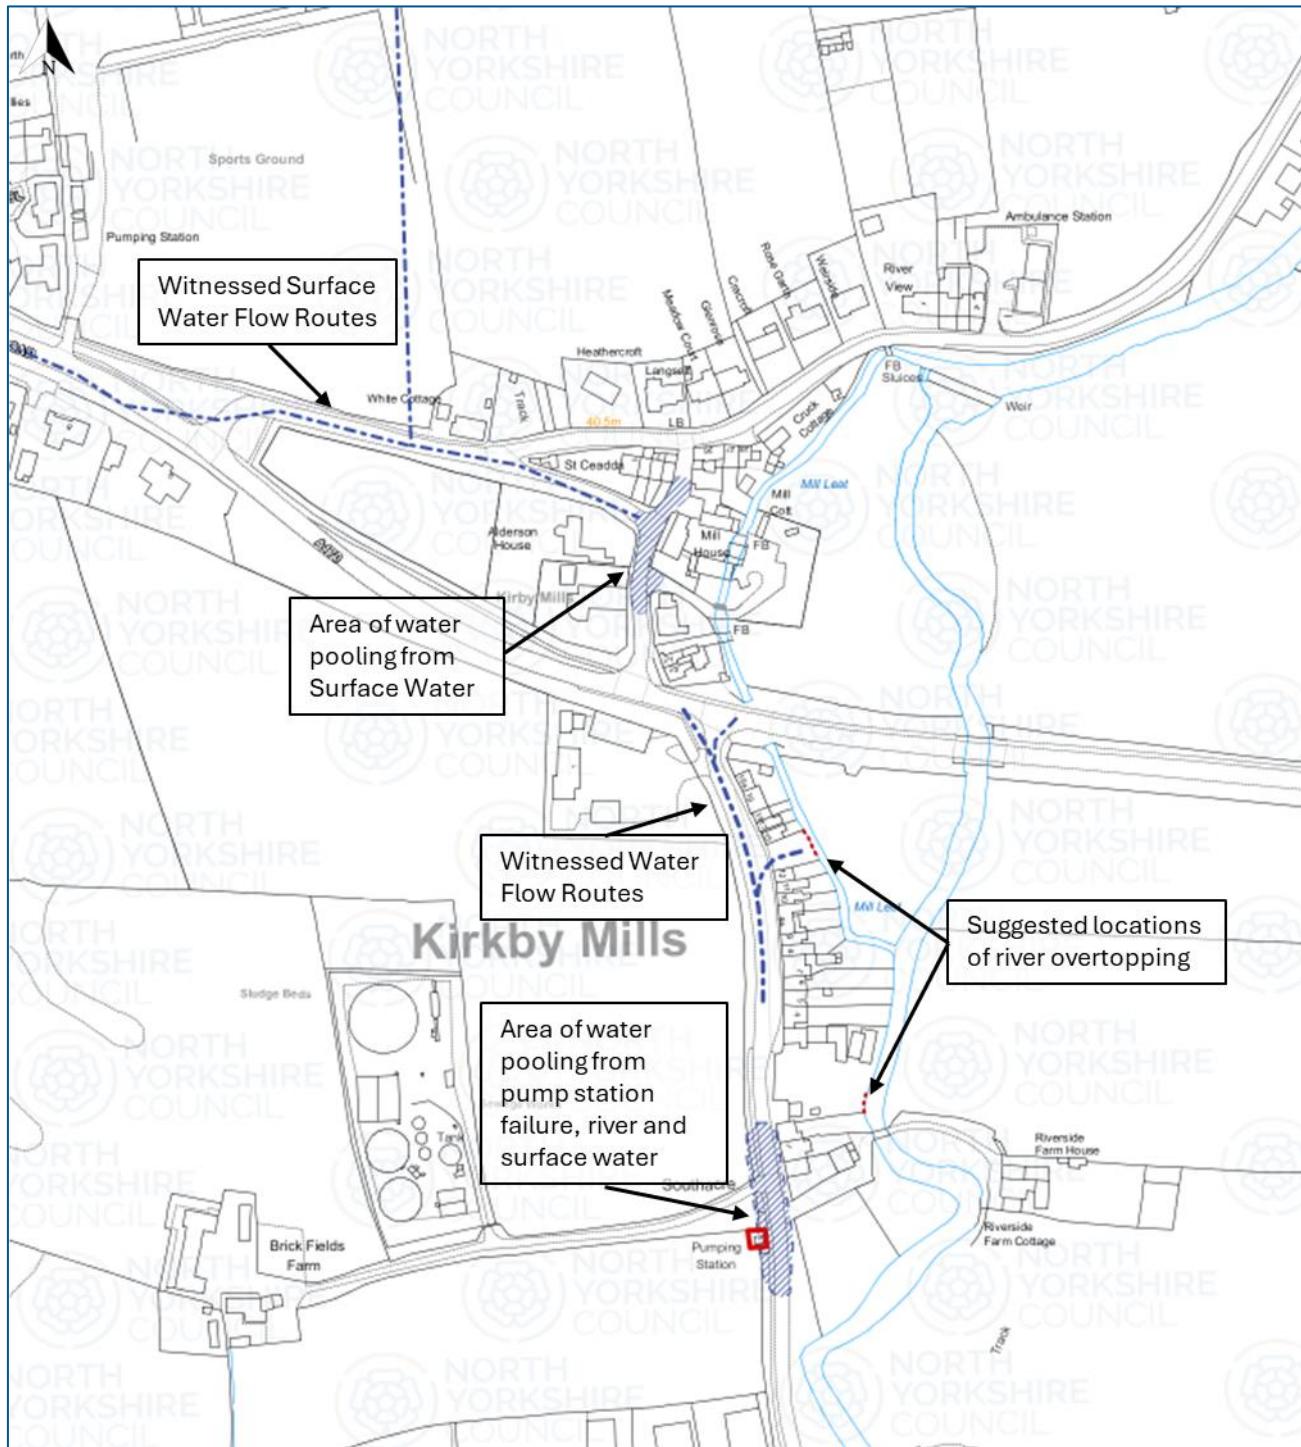
Figure 12 Map detailing observed events in Kirkby Mills

Surface water flows were observed travelling from Kirkbymoorside towards Kirkby Mills along the A170 and the access road to Kirkby Mills and Keldholme. These flows accumulated in a topographical low point on Kirkby Mills Road, adjacent to the access road to The Cornmill. In this location, three highway gullies were reported to have surcharged. Residents raised concerns regarding the quantity of surface water runoff they witnessed coming from Swineherd Lane, past the Cricket Ground and into Kirkby Mills, with several residents stating the quantity of surface water during Storm Darragh was more than had been witnessed recently. North Yorkshire Council Highways noted in their Section 14 response that the gullies in this area are cleaned annually and were last cleaned due to a response to Storm Darragh on 23/12/2024.

Yorkshire Water reported telemetry data indicating a power failure at their pumping station south of Kirkby Mills at 17:22, with a second failure occurring at 23:11. The latter event also affected the backup system. During pump failure, excess water was diverted to the River Dove via an overflow pipe. Yorkshire Water have noted that this pipe has a low outfall elevation. At 23:11, river levels were recorded at approximately 2.4 metres, likely submerging the outfall and causing surcharge in the vicinity of the pumping station.

Discussions with residents and Yorkshire Water identified a potential hydraulic restriction on the Mill Race caused by a Yorkshire Water Combined Sewer Overflow (CSO) pipe, which crosses in front of a small bridge over the Mill Race. Residents noted seeing water overtop at this location. This pipe may affect conveyance, however, the Dove will have been high and backing up the Mill Race, therefore water would be backing out of channel, nonetheless. A report from the North Yorkshire Council Bridges Team also indicated the presence of silt at this bridge. These two factors may have contributed to a reduction in channel capacity at this location, however, the impact would have small on the overall flooding.

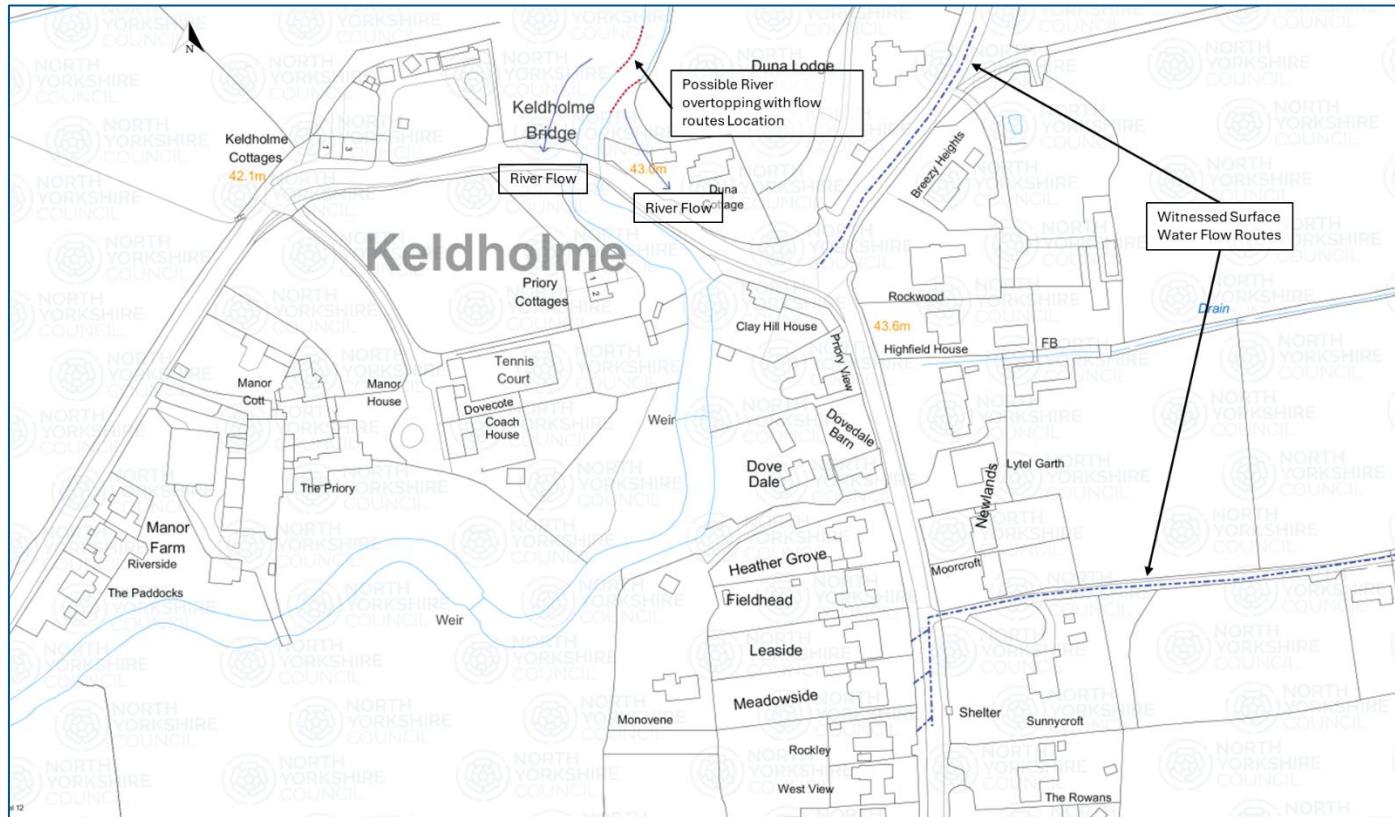
Figure 13 Map detailing observed events in Keldholme

Eight residential properties in Keldholme were reported to have experienced internal flooding during Storm Darragh. Residents indicated that a flood alert was received at approximately 17:00, followed by a flood warning at around 22:00. The River Dove was observed overtopping its banks between 22:00 and 23:15, with internal property flooding following shortly after. Additionally, surface water was witnessed collecting on the highway at approximately 19:30.

Concerns were raised by residents regarding the condition of Keldholme Bridge and the potential impact of silt accumulation. A review of North Yorkshire Council Highways Bridge inspection reports confirmed that there has been no recorded increase in silt levels over the past six years. Each bridge in the area is subject to inspection on a biennial basis.

Further concerns were expressed regarding surface water flows originating from the north and east of Keldholme, as identified in figure 13. The North Yorkshire Council Highways has acknowledged awareness of flows from the east. Funding is being sought to investigate the issue and where possible, remediate.

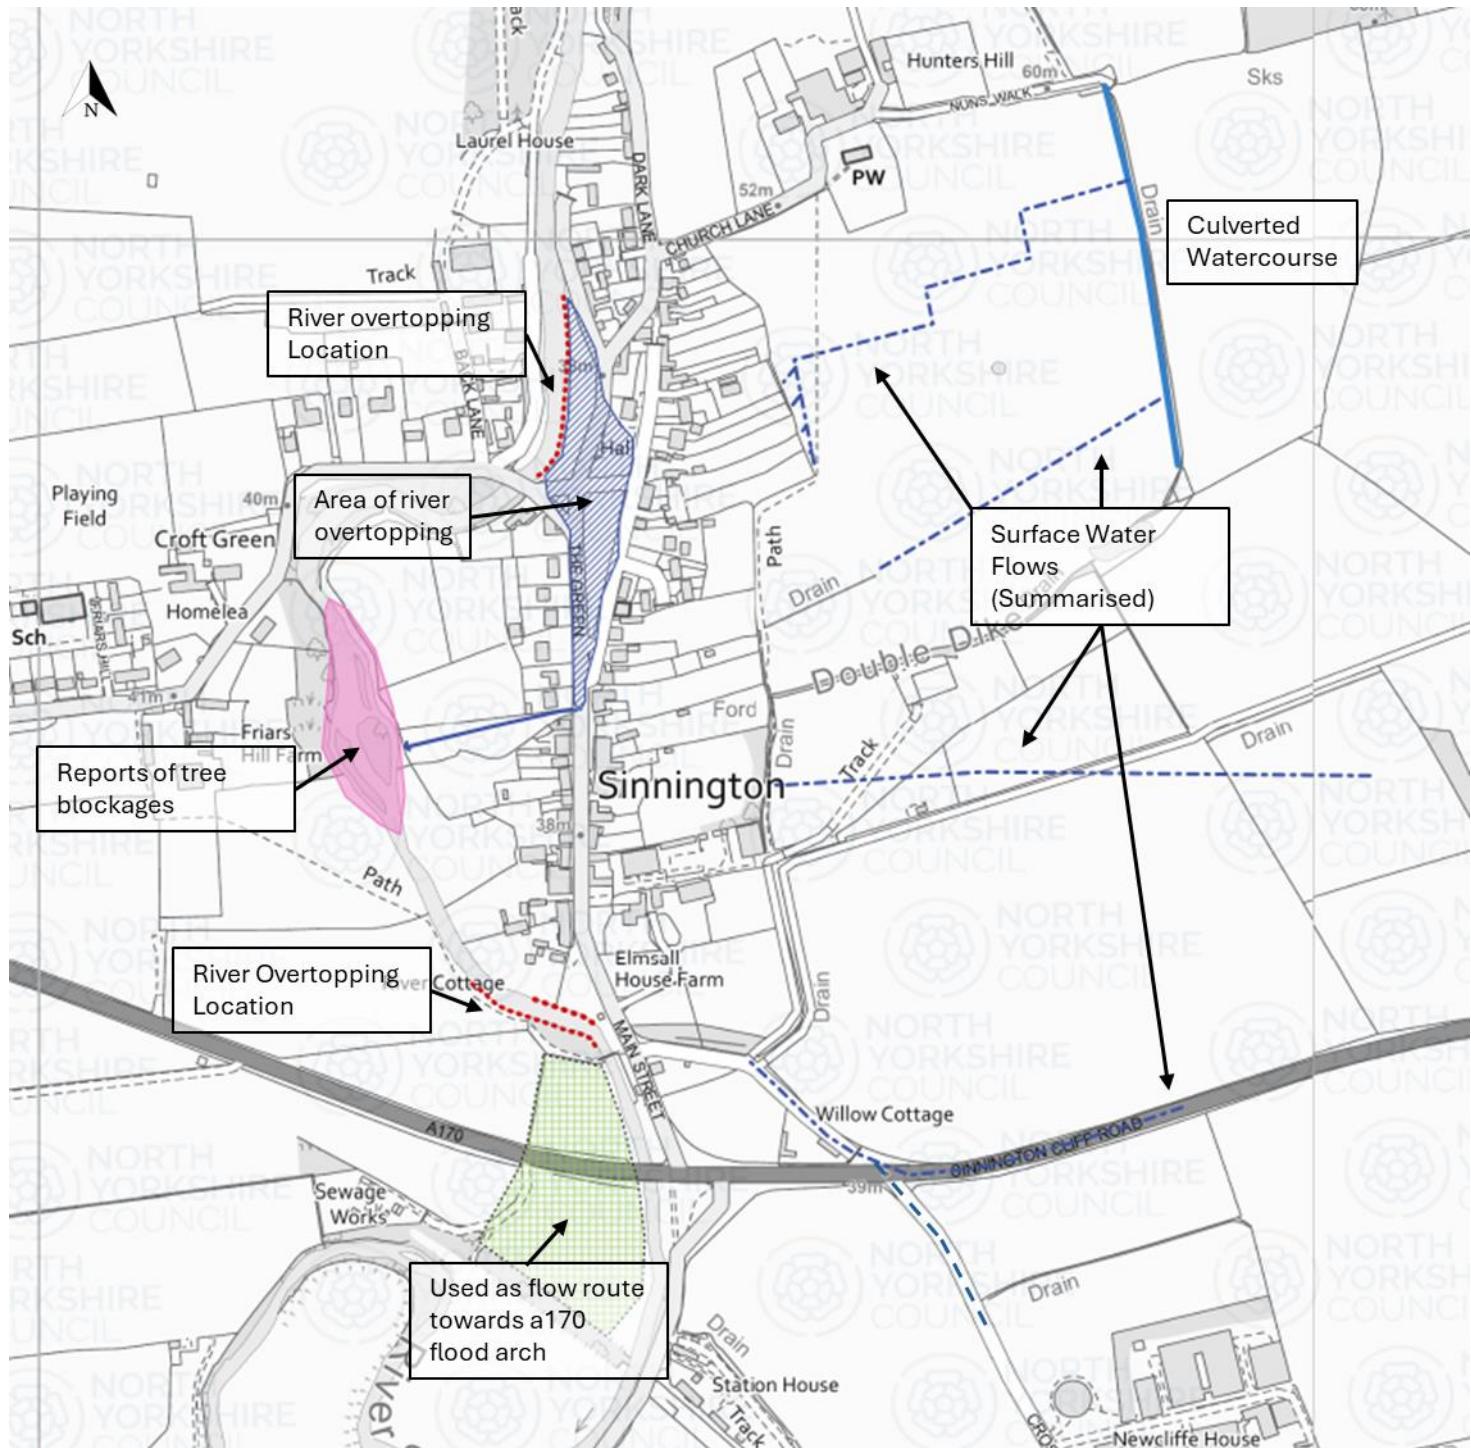
Figure 14 Map detailing observed events in Sinnington

The initial overtopping of the River Seven was observed at approximately 17:30 along Main Street. A resident reported a flood warning, followed by a flood alert reported by residents at 19:30. The Lead Local Flood Authority noted that many residents in Sinnington were not signed up to the

The local pub, situated on higher ground, served as a refuge for some residents and visitors, who relocated vehicles to its car park and sought shelter there. A handful of residents noted that a tractor transported individuals through floodwaters from the pub down Main Street at a speed sufficient to generate a bow wave, which contributed to flooding at nearby residential properties.

A frequent issue raised by residents was the quantity and frequency of surface water travelling down to Sinnington from the gently sloping land to the east. The watercourse Double Dike is partially culverted, and therefore does not capture surface water flows in that location. Surface water flows accumulate and travel towards properties, contributing to one known reported incident of internal flooding, and several cases of garden flooding. Some of these flows then fall into the open sections of double dike, before out falling into the River Seven at the south of the village. Engagement with landowners has begun involving Natural England, Environment Agency and NYC. The aim of this engagement is to explore opportunities for reducing surface water runoff from adjacent farmland, potentially through modifications to farming practices and improvements to watercourse management.

Concerns were raised by residents regarding the condition of Sinnington Bridge and the potential impact of silt accumulation. A review of North Yorkshire Council Highways Bridge inspection reports confirmed that there has been no recorded increase in silt levels over the past six years. Each bridge in the area is subject to inspection on a biennial basis.

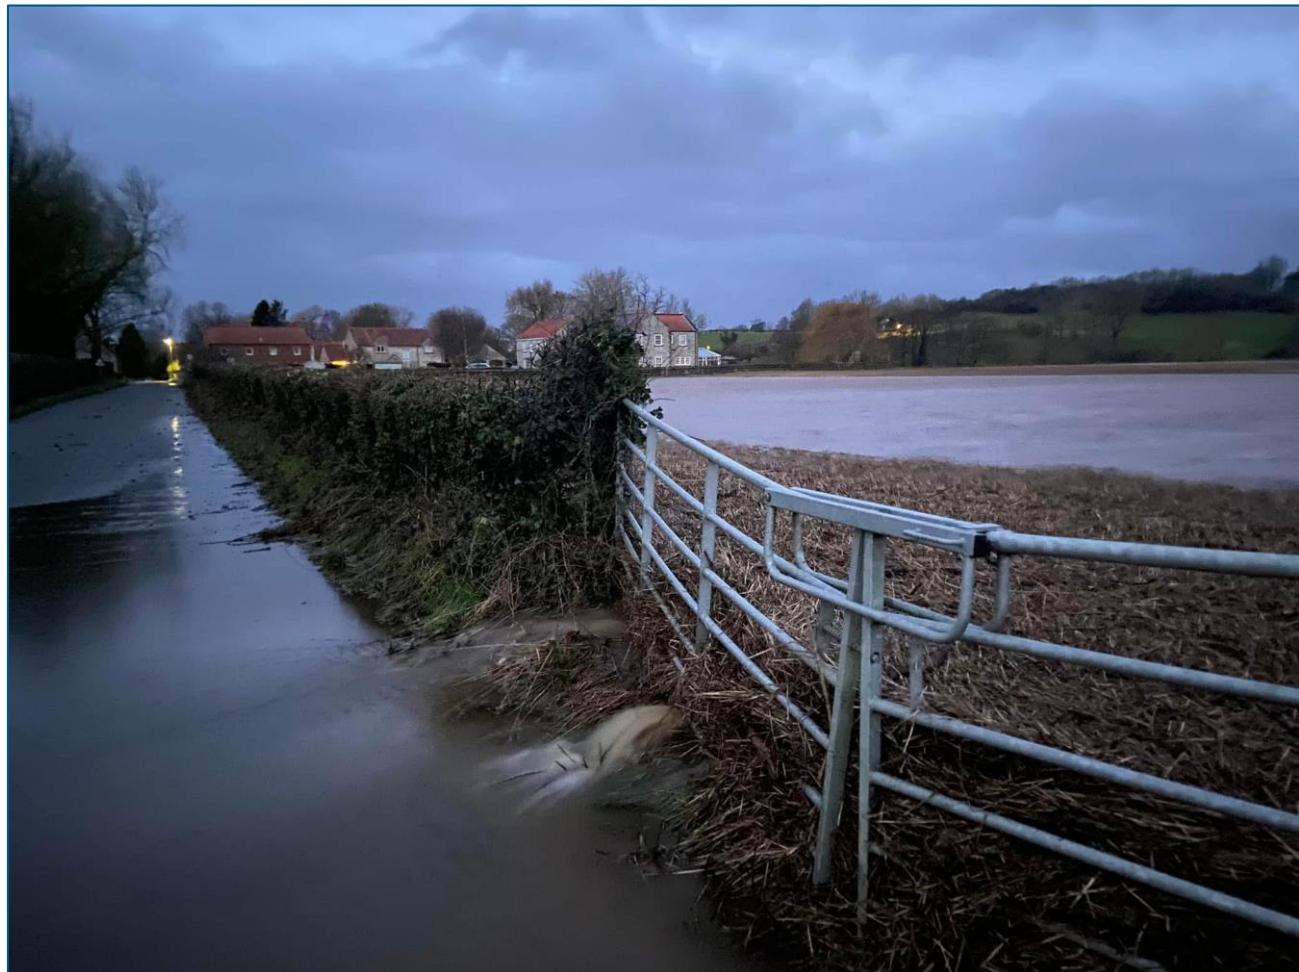
Figure 15 Photo of gate with vegetation blockage in Marton

Back Lane before re-entering the watercourse to the south of the village. Prior to Storm Darragh, the field had recently been worked and was covered in loose vegetation. From the image below, it is apparent flood water mobilised the loose vegetation, which in turn blocked the gate, causing the water to further rise within the field.

At some time after 01:00, the water level rose to a height that caused it to find a different flow route nearer the village side of Marton Road, causing the flood waters to travel into the village. At a similar time, near to Marton Bridge, two trees were blown down. Unfortunately, one of the trees was located within the flood bank, which went on to cause a 7m wide breach of the flood bank. This caused flood water to damage a house and continue to spill into Marton Road near the bridge. Reports state that flooding along Marton Road reached around 1m in height. The high level of flood water in the village was further pushed into houses on the south of Marton Road by the northerly wind.

- 1) Environment Agency to review flood defence and tree management regime, work with landowners on educating riparian responsibility and undertake enforcement where needed.
- 2) Environment Agency to submit funding bids to further repair the breach and carry out other maintenance of the flood embankments and river channel where a business case for investment can be made and where funding is available. This includes bank surveys to assess for low spots, embankment repairs and tree and vegetation clearance to aid conveyance.
- 3) Yorkshire Water to demonstrate how separating out the surface water from the Combined system will not increase surface water flood risk if the river level is high and reduce bad connections as an output of the CCTV survey.
- 4) North Yorkshire Council Resilience and Emergencies Team to help set up a community action group with the assistance of Marton Parish.

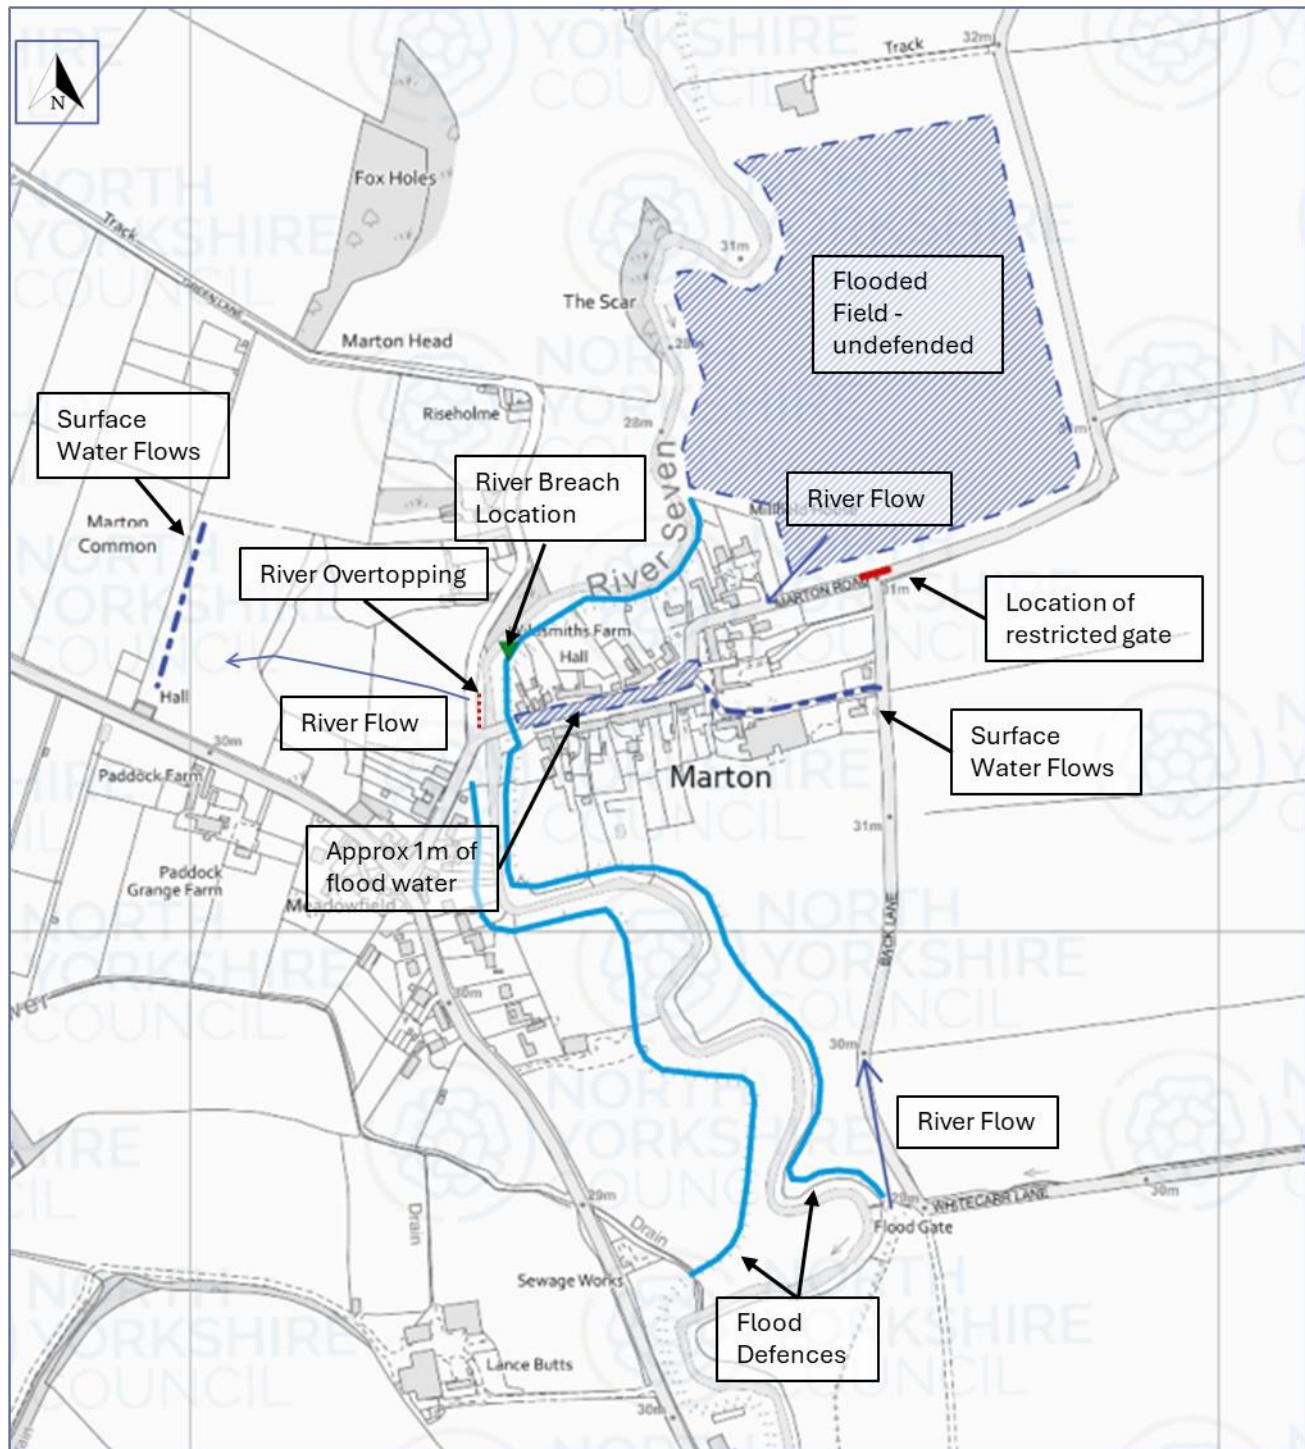
Figure 16 Map detailing observed events in Marton

Lead Local Flood Authority have 24 records of flooding in Marton, with 20 of these being internal flooding. Marton is partially defended by flood embankments, which stop at the northerly residential extent of the village. During Storm Darragh, the river level was high but was constrained by flood defences until early in the morning of the 8th December. To the north of Marton, where the flood defences are absent, water accumulates in the field as part of the natural flood plain. According to residents, the field normally floods and water exits a gate adjacent to Back Lane and travels down

From site walkovers, and discussions with the Environment Agency and residents, it is clear that the state of the flood banks is in variable condition, such as variable defence height, some defences being built on and vegetation growth within the banks. These factors could be flood risk factors, however, in this case the tree falling and causing a breach of the flood embankment was an important factor, as the defences themselves were never observed or recorded as overtopping. It was fortuitous that the breach did not occur earlier in the night, when the river peaked at 22:30.

The Environment Agency performed a temporary repair of the embankment on the 23rd December 2024 and planned to remove the second tree fallen in April/May. They also carried out tree and blockage work between Marton and Normanby in February 2025.
