ARBORICULTURAL ASSESSMENT REPORT

50 Dragon Parade, Harrogate, HG1 5DQ

PRI Ref: 261002

Survey Date: 24/05/2023

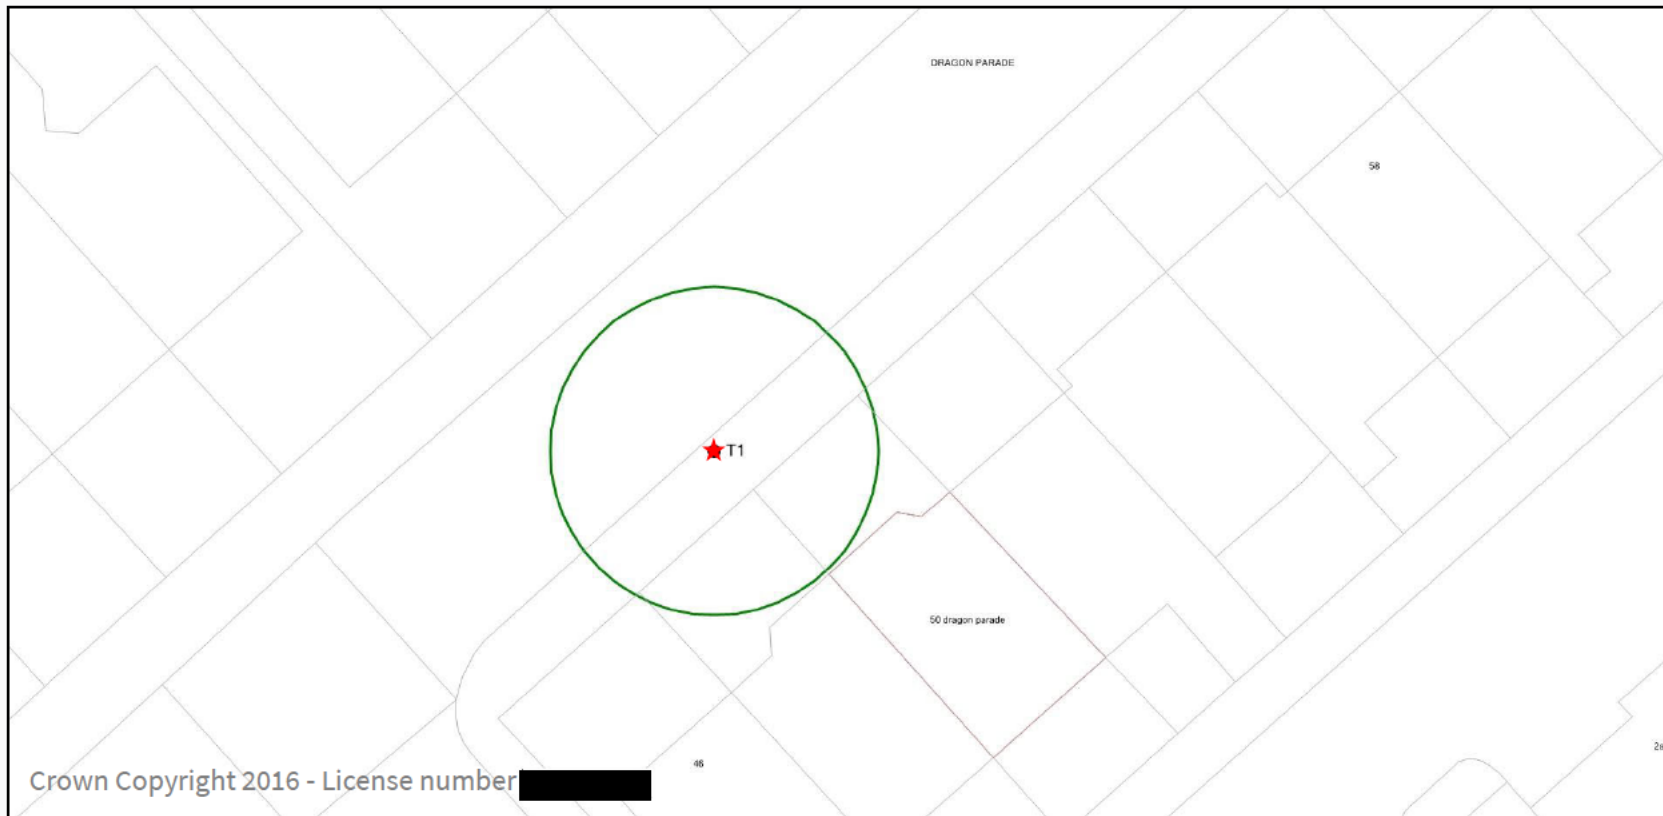
7.0 APPENDIX 2: SITE PLAN

Tree No	Common Name	Age Class	Condition	Height (m)	Crown Spread (m)	Stem diam. (mm)	Dist to bldg. (m)	Roots Implicated	Pruning history	Recommendation	Tree work constraints	Notes	Owner address	Owner
T1	Lime	Mature	Fair	18	14	560	1*	Y	Subject to past management.	Fell and treat stump with eco plugs (broadleaved).	Adjacent to highway - traffic management required.	Roots evident in test pit, section fell and treat stump, closest Lime to property.	Harrogate Council	Local Authority

Tree No:	Species	Works Required	CA	TPO	Ownership
T1	Lime	Fell and treat stump with eco plugs (broadleaved).	Yes	No	LA
