INSURANCE CLAIM: ENGINEERING APPRAISAL REPORT

50 Dragon Parade, HARROGATE, North Yorkshire, HG1 5DQ

Date: 11/05/2023

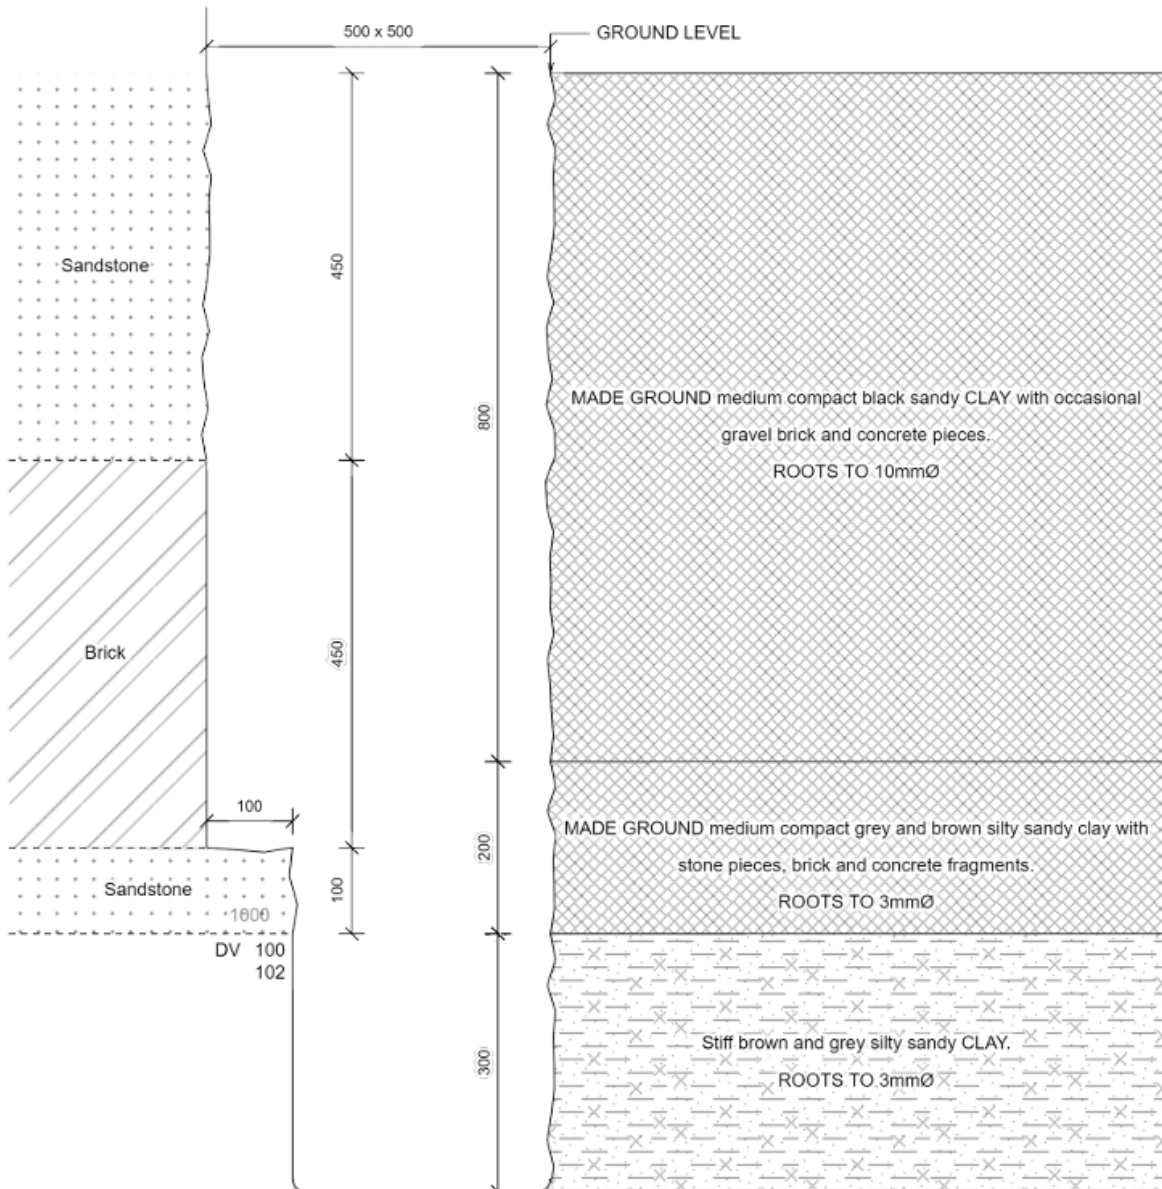
A trial pit was excavated at the front of the property and revealed a stone foundation bearing at a depth of 1000mm below external ground level on to a stiff silty sandy clay with roots to the underside of the foundation. The borehole terminated at 5m below ground level and roots were noted to 4.7m.

The soil testing found the clay to have a medium volume change potential and some signs of desiccation particularly at 4.7m depth where the sample moisture content was less than the plastic limit.

Based on the information detailed above, we are of the opinion that damage has occurred due to clay shrinkage subsidence. This has been caused by moisture extraction by roots altering the moisture content of the clay subsoil, resulting in volume changes, which in turn have affected the foundations. The Lime tree at the front of the property is the likely source of the roots both at the underside of the foundation and down to 4.7m depth.

An arboricultural report will be obtained to confirm the influence of the Local Authority Lime tree and to determine the vegetation works required to stabilise the property.

We have not yet decided on the final type of repair required, but have produced an outline of the most likely requirements. This involves undertaking superstructure repairs and redecoration. This decision has been taken based on our knowledge and experience of dealing with similar claims. In addition the results of the Site Investigation, laboratory testing and monitoring have been taken into account.
