# Arboricultural Consultancy for Aviva

## 1. Case Details

**Scope of Report:** To survey the property and determine significant vegetation contributing to subsidence damage, make recommendation for remedial action and assess initial mitigation and recovery prospects. The survey does not make an assessment for decay or hazard evaluation.

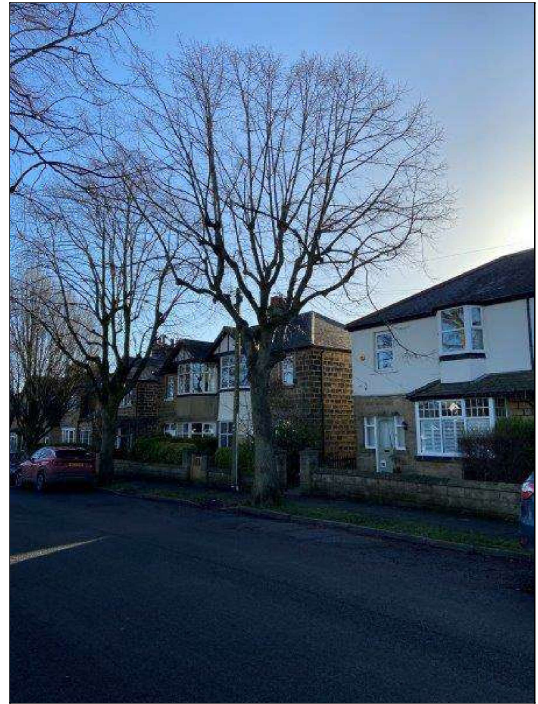
T3 - Lime

T3 (Lime) is also considered to retain a contributory influence, albeit in a limited / secondary capacity when compared to the above.

Tree No.	Species	Age Cat	Approx. Height (m)	Distance to Building (m) *	Ownership	Action	Requirement
T1	Lime	1	14	5.8	B - Local Authority	Remove	Remove close to ground level and manage stump to inhibit regrowth.
T3	Lime	1	14	11.3	B - Local Authority	Maintain as detailed	Crown reduce overall canopy by 30% (minimum) to achieve a crown volume reduction in line with BRE IP7/06. Maintain at reduced dimensions by re-pruning back to points of previous reduction on a 3 year (max) cycle.
<b>Age Cat:</b> 1 = Younger than property; 2 = Similar age to the property; 3 = Significantly older than property

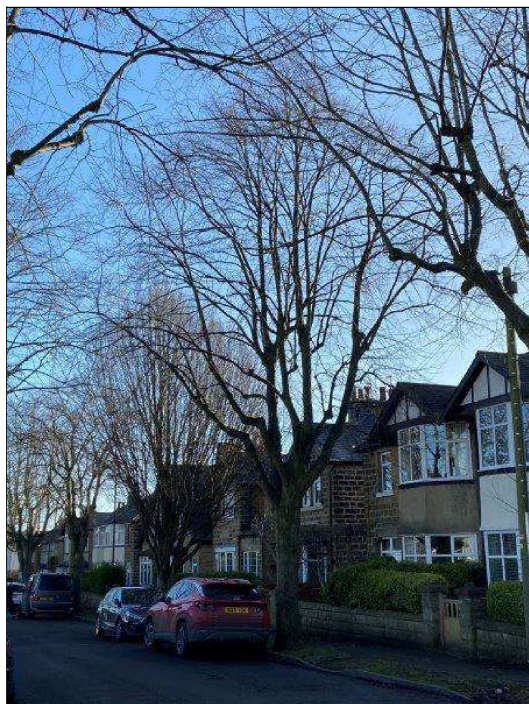
T1 - Lime

With due regards to species profile, size and proximity, T1 (Lime) is considered the dominant feature proximate to the focal area(s) of movement and accordingly, where vegetation is confirmed as being causal, we have identified it as the primary cause of the current subsidence damage.

Consequently, we have advocated the complete removal of T1, in conjunction with management of T3 (as detailed) as it will offer the most certain arboricultural solution likely to restore long-term stability.
