Flood Investigation Report

Harrogate – Greenfields Avenue

This document has been prepared specifically for the purpose of meeting the requirements of Section 19 of the Flood and Water Management Act 2010.

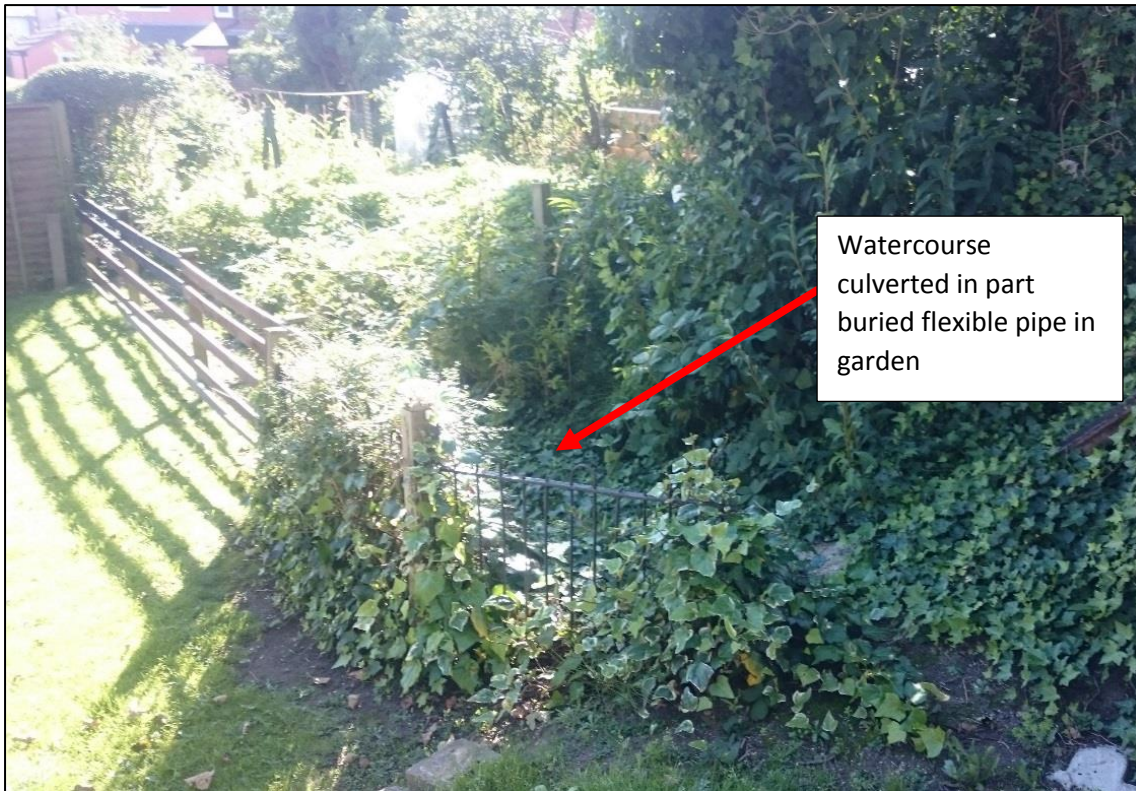
Figure 2.7 Flexible piped culvert

At this point the watercourse has been piped in with a part buried plastic flexible pipe of approximately 450mm diameter (Section C). This butts up to the existing culvert and it is believed that this is the point at which flood water has, in the past, surcharged out into the neighbouring gardens and house.

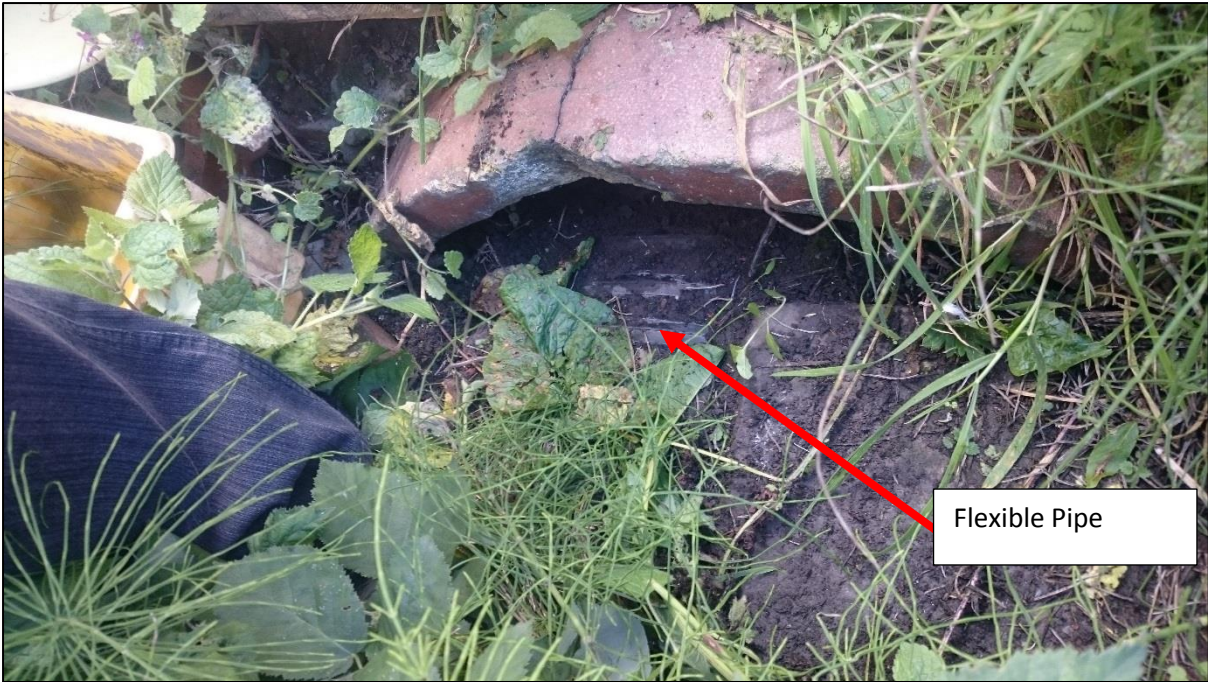
From here the culvert continues south towards Greenfields Avenue (Section D). Excavation has been undertaken by highways North Yorkshire within the curtilage of the property to locate the culvert before it passes beneath the road at Greenfields Avenue (Section E). Investigations have shown the culvert beneath the road to be heavily silted up and capacity is significantly compromised. However, this is because the downstream open ditch has not been cleared sufficiently for the upstream sections to drain and hence remain clear of silt.

Figure 2.8 Connection between flexible pipe and culvert at 35 Greenfields Avenue

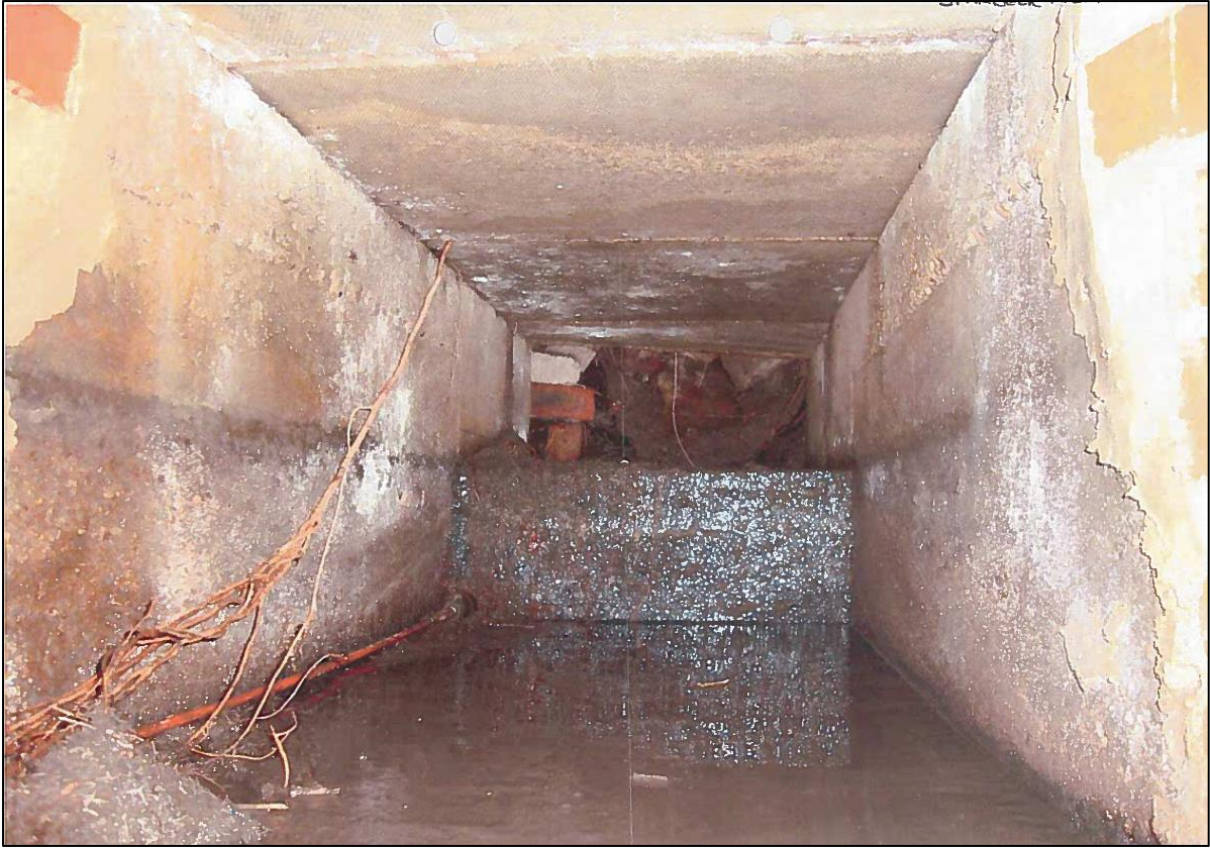
A manhole and length of concrete culvert was constructed on the line of the existing watercourse, as part of the development of Hookstone Grange Road in 1993. This runs from the boundary of the garden of No 30 Greenfields Avenue to the head of the Yorkshire Water public sewer system in Hookstone Grange Road (see Figure 2.9).

Figure 2.9 View upstream from Manhole at Hookstone Grange Way

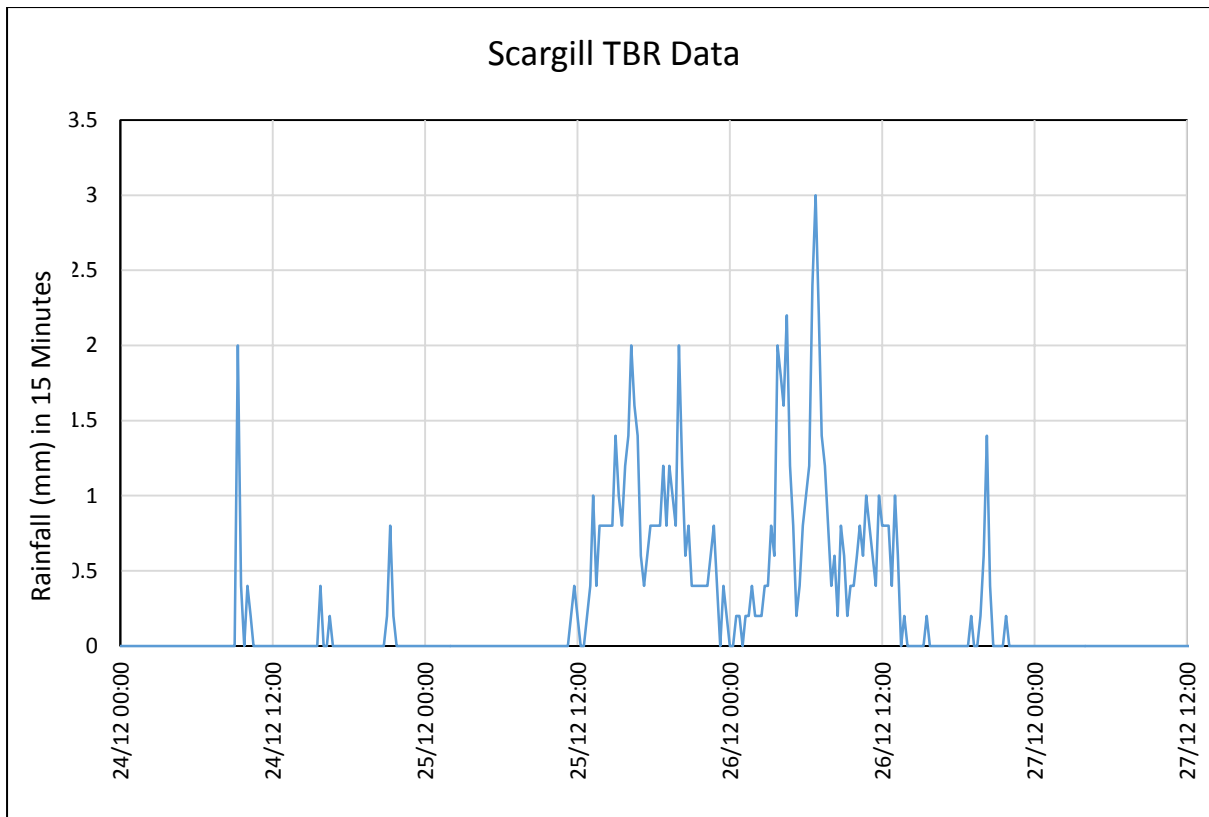
Figure 3.2 TBR data from Scargill (Source: EA)

Environment Agency tipping bucket rain gauge (TBR) rainfall data has been provided for Scargill. The rainfall data is illustrated in Figure 3.2. The data from the TBR shows two rainfall events, one on the 25th and the other on 26th of December 2015⁸. The rainfall event on the 25th started at 12:00 and finished at 23:30. The rainfall event on the 26th started at 00:45 and finished at 13:00 reaching a peak at 06:45.

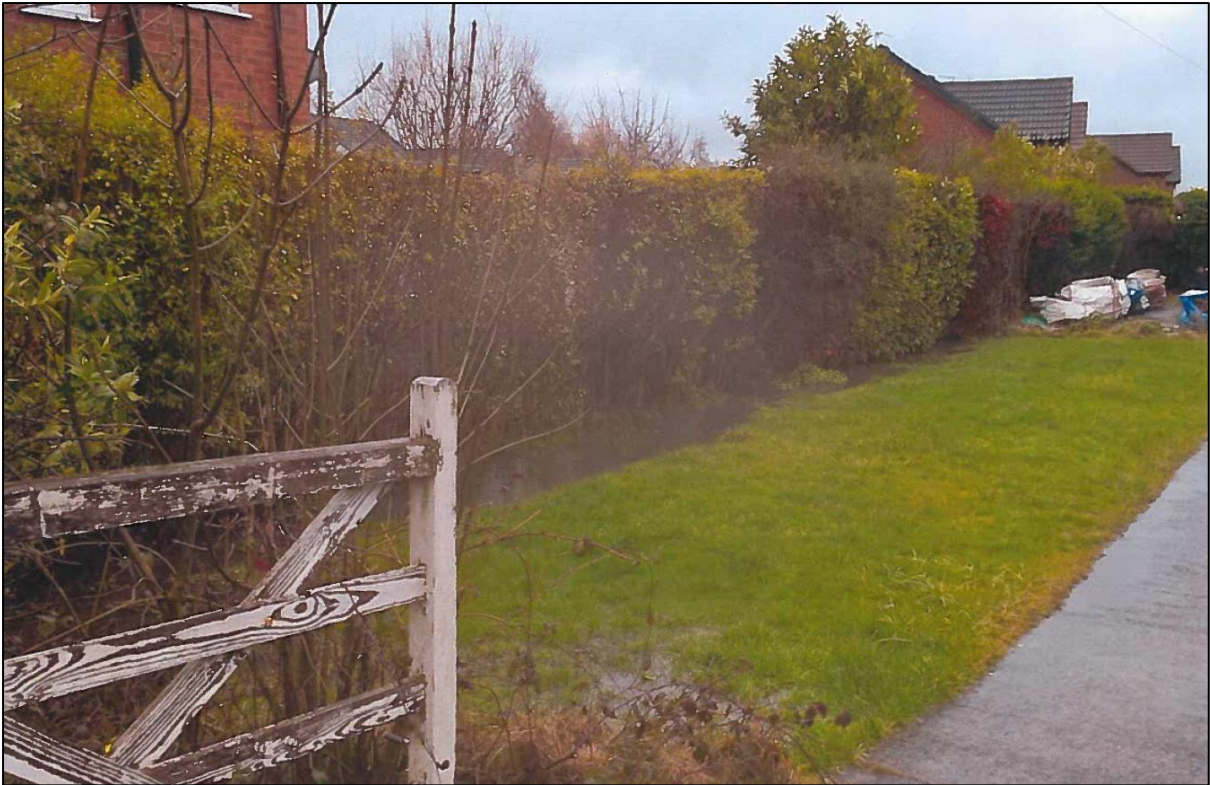
On Boxing Day 2015 flow escaped from the downstream end of the plastic flexible pipe in the garden properties on Greenfields Avenue and caused extensive flooding to the garden and the house.

On the opposite side of the road water ponded along the hedge bottom on the boundary of 30 Greenfields Avenue. From here, flood water overflowed to both the south and east, to cause flooding to properties on Hookstone Grange Road and Prospect Road.

Figure 3.4 Photograph of flooding at Greenfields Avenue
