Flood Investigation Report Sessay

This document has been prepared specifically for the purpose of meeting the requirements of Section 19 of the Flood and Water Management Act 2010.

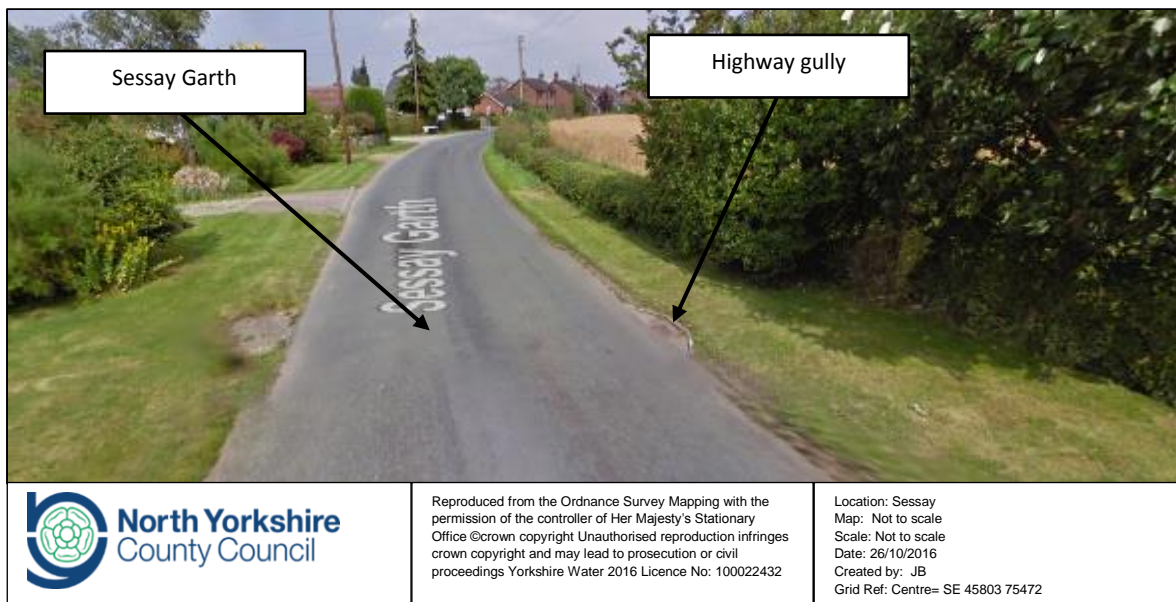
Figure 2.5 Photograph showing Sessay Garth highway drainage (Source: Google Maps)

Sessay Garth is the highway passing through the centre of the village of Sessay. Sessay Garth is drained via conventional road gullies⁵, as shown in Figure 2.5. Sessay Garth is a single carriage way without kerbs. There are no available highway drainage plans for Sessay.

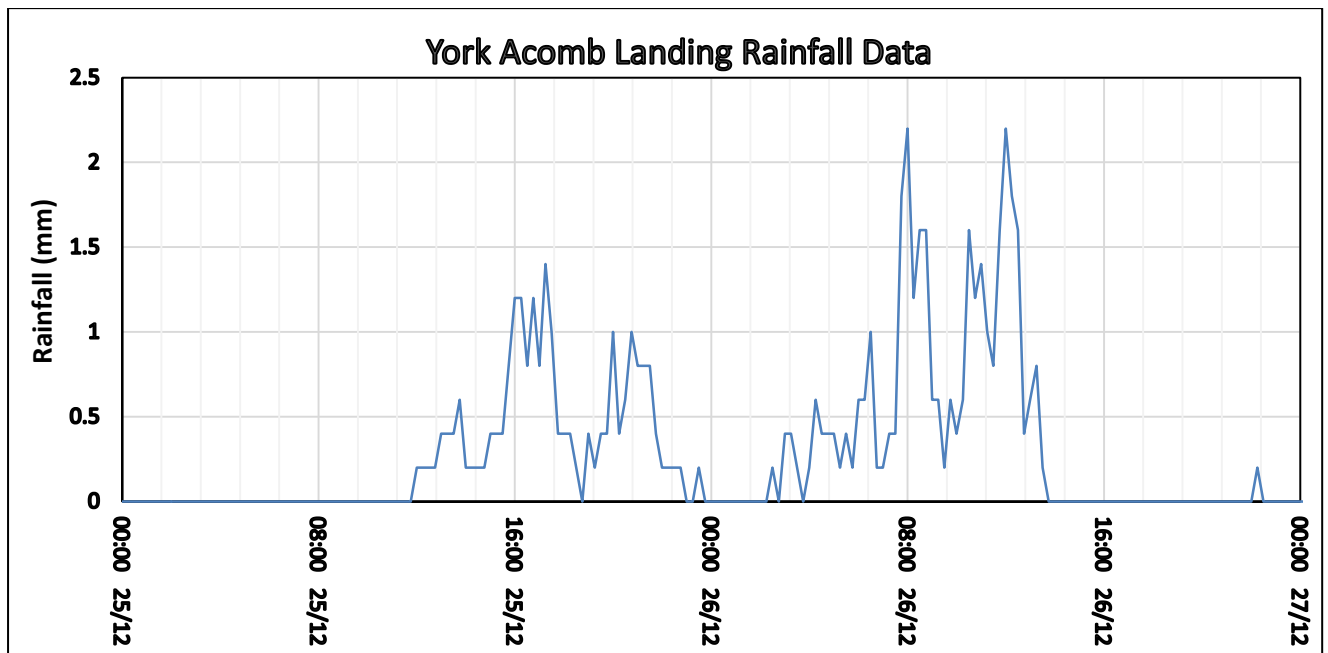
Figure 3.2 TBR Data for York Acomb Landing on the 25th and 26th of December.

Environment Agency tipping bucket raingauge (TBR) rainfall data has been provided for York Acomb Landing 26km away from Sessay. The rainfall data is illustrated in Figure 3.2. The data from the TBR shows two rainfall events on the 25th and 26th of December 2015. The rainfall event on the 25th started at 12:00 and finished at 23:00. The rainfall event on the 26th started at 02:30 and finished at 14:00 reaching a peak at 08:00. The total rainfall depths on Christmas and Boxing Day were 22.6mm and 34.2mm respectively¹¹.

Comparison of the data from York Acomb Landing with rainfall radar data from YWSL shows a good match. Within approximately the same time periods as the YWSL data, the York Acomb data indicated that 34mm of rainfall fell on Boxing Day and 17mm on Christmas Day.

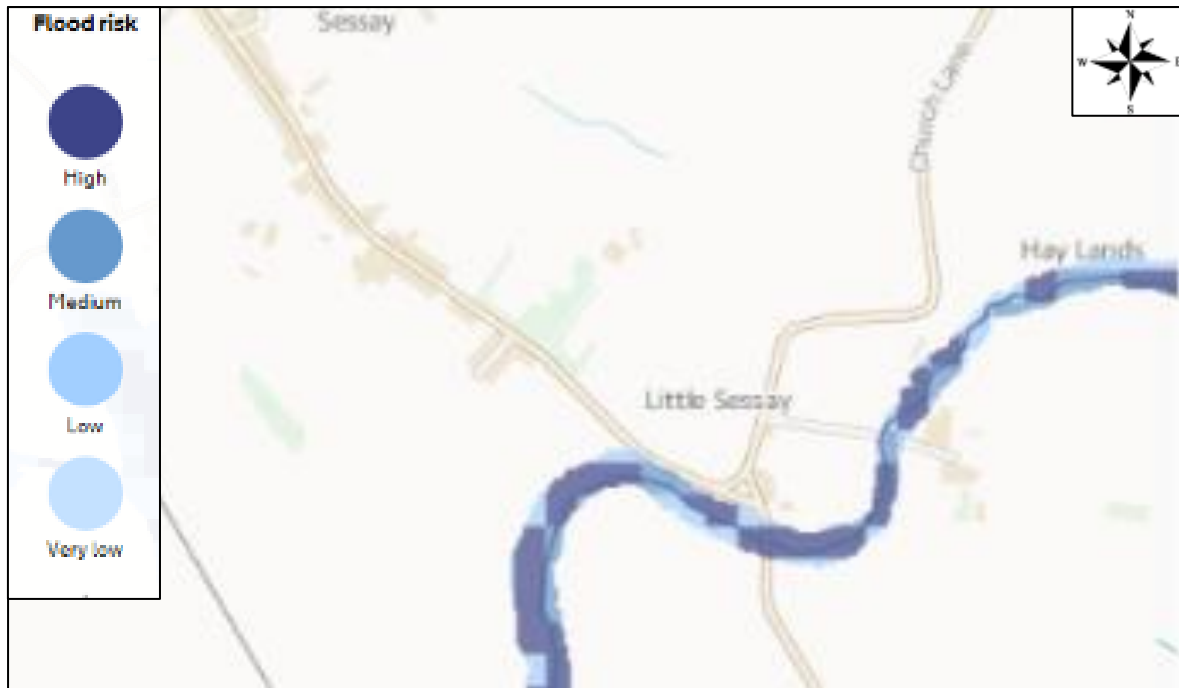
Figure 3.6 EA Map of risk of flooding from rivers and the sea

None of the flood events in Sessay on Boxing Day 2015 were generated by the river Swale. The EA's map of flood risk rivers and the sea (see Figure 3.6) shows that there are areas around Birdforth Beck that are at risk of flooding. There were no reports recorded of property or highway flooding at this location in December 2015.
