Flood Investigation Report

Whixley

This document has been prepared specifically for the purpose of meeting the requirements of Section 19 of the Flood and Water Management Act 2010.

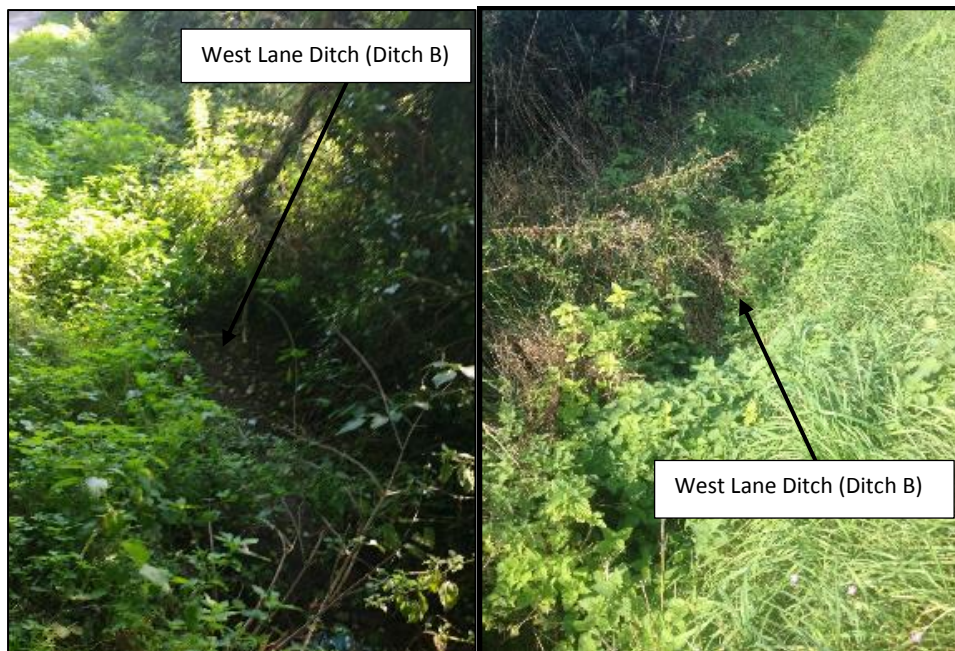
Figure 2.5 Photographs of West Lane Ditch

Ditch B, shown in the photograph in Figure 2.5, runs alongside West Lane from the Starra Field Lane junction to a short section of masonry culvert known as the “*hole in the wall*”, opposite Whixley Hall, photographed in Figure 2.6. Ditch B was overgrown and had a considerable amount of debris in the channel.

The ditch does not carry all of the West Lane surface water because the grass edge verge from the Starra Field Lane junction to the “the hole in the wall” does not allow free flow of rainwater from the carriageway surface into this ditch.

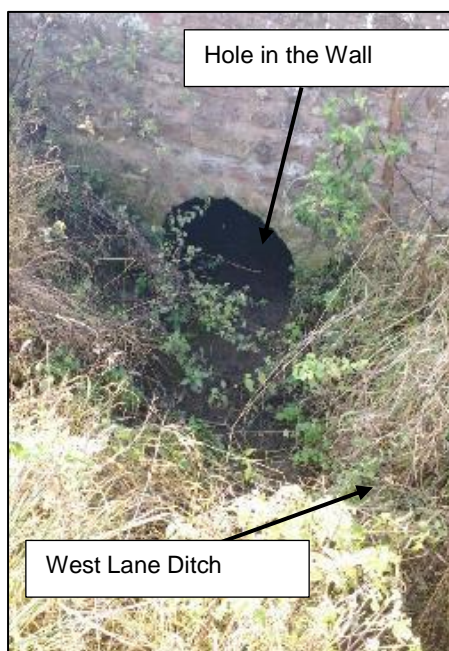
Figure 2.6 Photograph of the Hole in the Wall

After the “Hole in the Wall” Ditch C flows across Whixley Park and discharges into the Whixley Cut. The Whixley Cut is then culverted under Stone Gate and proceeds to flow to the east of Whixley in an open ditch and discharges into the Score Ray Beck, 2km to the east.

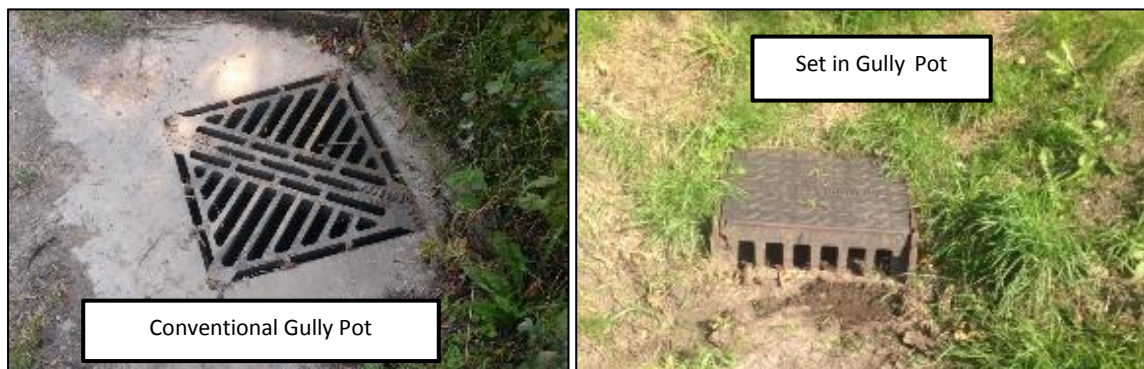
Figure 2.7 Church Street highway drainage gullies

The highway drainage on Church Street is via a mixture of 'set in' gullies and conventional gully grates, as shown in Figure 2.7, which feed into a 600mm brick culvert that runs along Church Street.

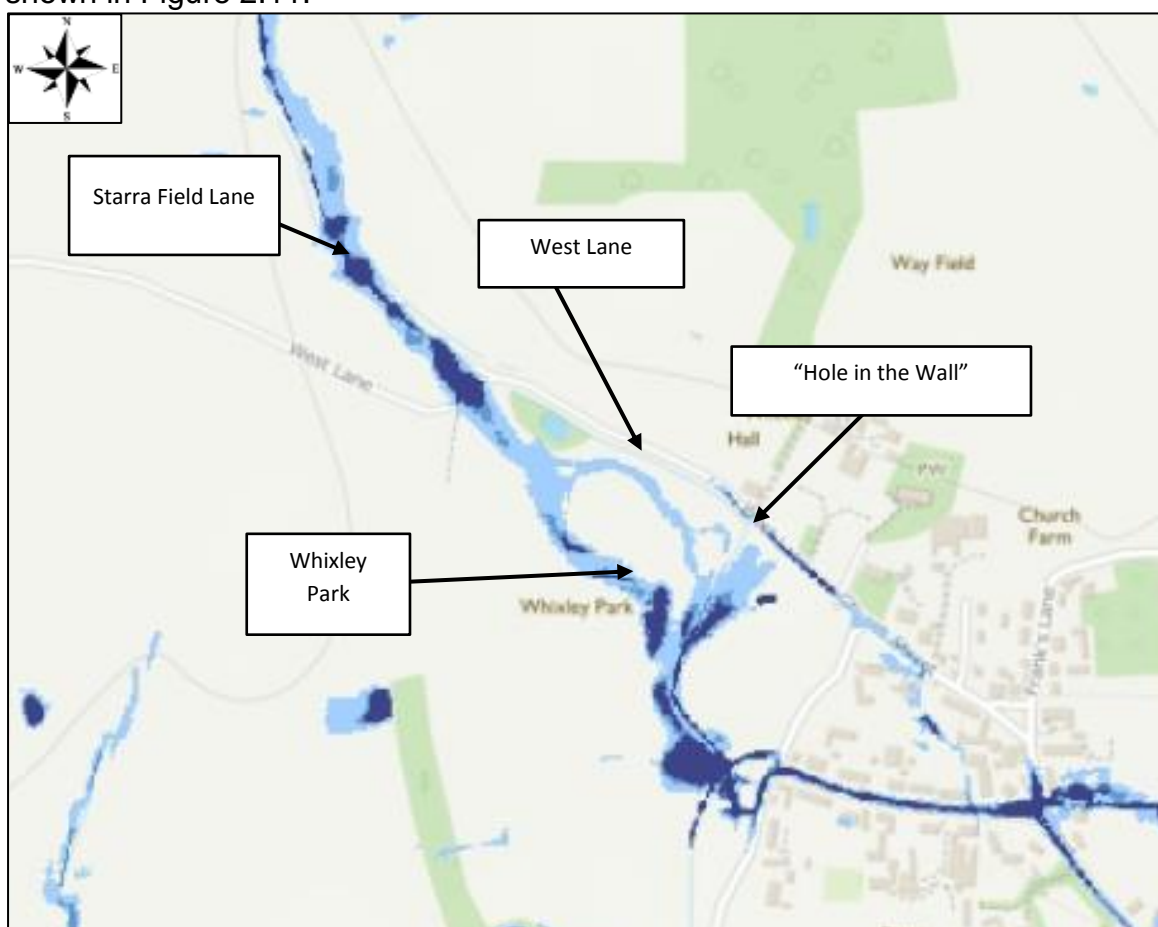
Figure 2.11 Whixley flow path map. (Source: EA)

A review of the EA Flood Maps for Surface Water show there is a significant surface water flow path flowing northwest to southeast originating from Starra Field Lane, as shown in Figure 2.11.

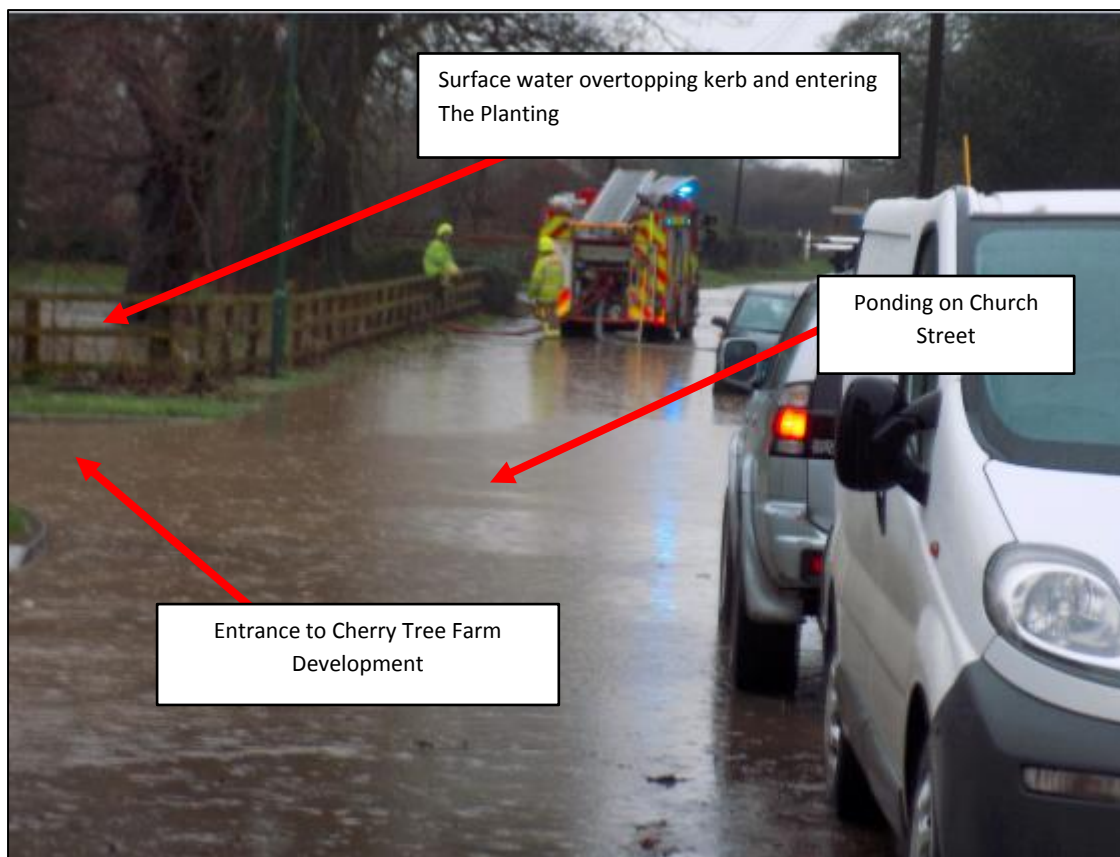
Figure 3.4 Photograph showing ponding on Church Street

Excess surface water on Church Street overwhelmed the drainage infrastructure and began to pond at a low point at the entrance to Cherry Tree Farm Development, as shown in Figure 3.4.

Surface water was reported to be surcharging from the existing culvert and highway drainage systems. It is also reported that excess surface water was flowing down the private lane opposite Cherry Tree's Church Street entrance. It was reported that this lane conveyed a significant amount of surface water and debris.¹⁰
