North Yorkshire
County Council

Flood Investigation Report

February 2020

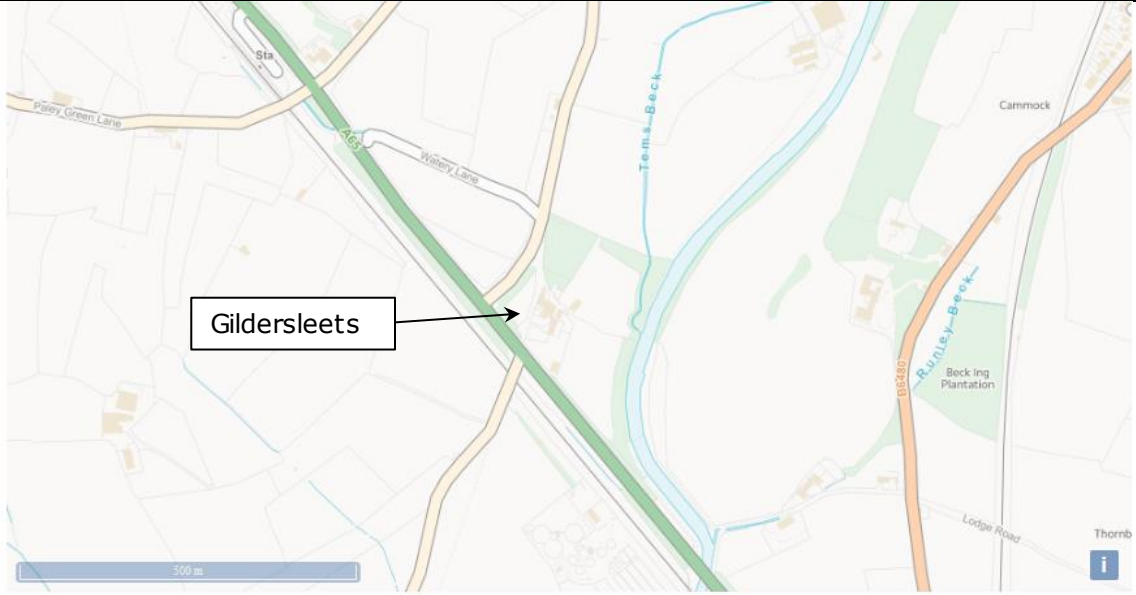
<p>Reservoir Flooding</p>

<p>Extent of flooding from reservoirs</p> <ul style="list-style-type: none"> ● Maximum extent of flooding <p>Gildersleets is not shown to be at risk of flooding from reservoirs.</p>
<p>Flood Alert and Warning Areas</p>	<p>Gildersleets is included in the Upper River Ribble Flood Alert Area</p>
<p>Current Flood Defences</p>	<p>There are no formal flood defences to protect the Gildersleets from the River Ribble. A flood defence barrier was installed in a partnership project between NYCC Highways and NYCC Flood Risk Management Team to prevent surface water flows from the A65 flooding the properties. This work was funded by central government flood recovery framework grant in 2015.</p>

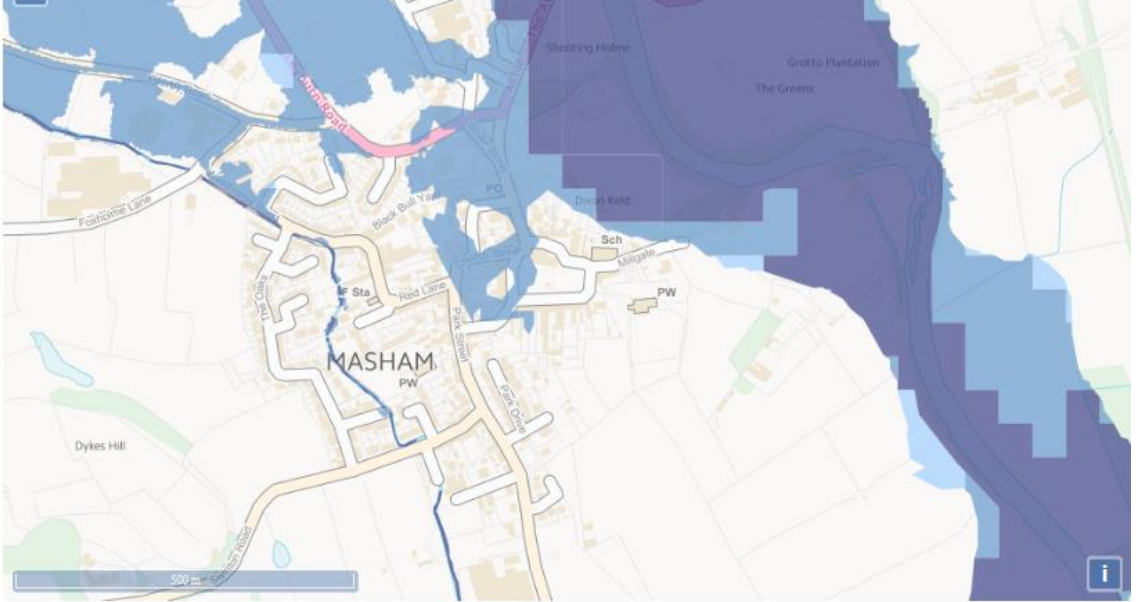
<p>Extent of flooding from rivers or the sea</p> <ul style="list-style-type: none"> ● High ● Medium ● Low ● Very low <p>As per the description of Masham, the majority of the town is located outside of the high risk floodplain of the River Ure. An area of medium risk (a flooding frequency of between 1 in 30 years and 1 in 100 years) is shown to affect Silver Street and Church street. Along Swinney</p>

<p>Beck, the main areas of risk are indicated to be upstream of Westholme Road with isolated areas within the gardens of properties.</p>
<p>Fluvial Flood Risk (River Flooding)</p>

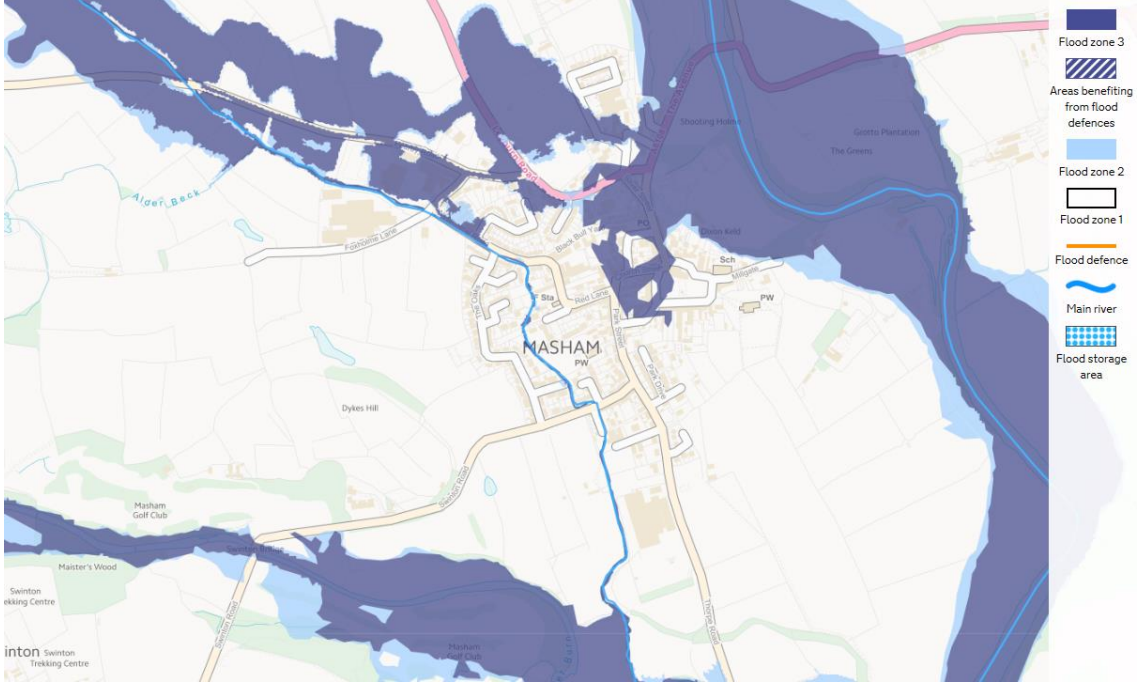
<p>The flood map for planning is primarily based on the modelling used to inform the rivers and sea (in addition to anecdotal evidence of flooding). The flood zone extents therefore mirror the map above. Both main rivers are easily identifiable in light blue and the map confirms that there are no formal defences in Masham.</p>
<p>Pluvial Flood Risk (Surface Water)</p>

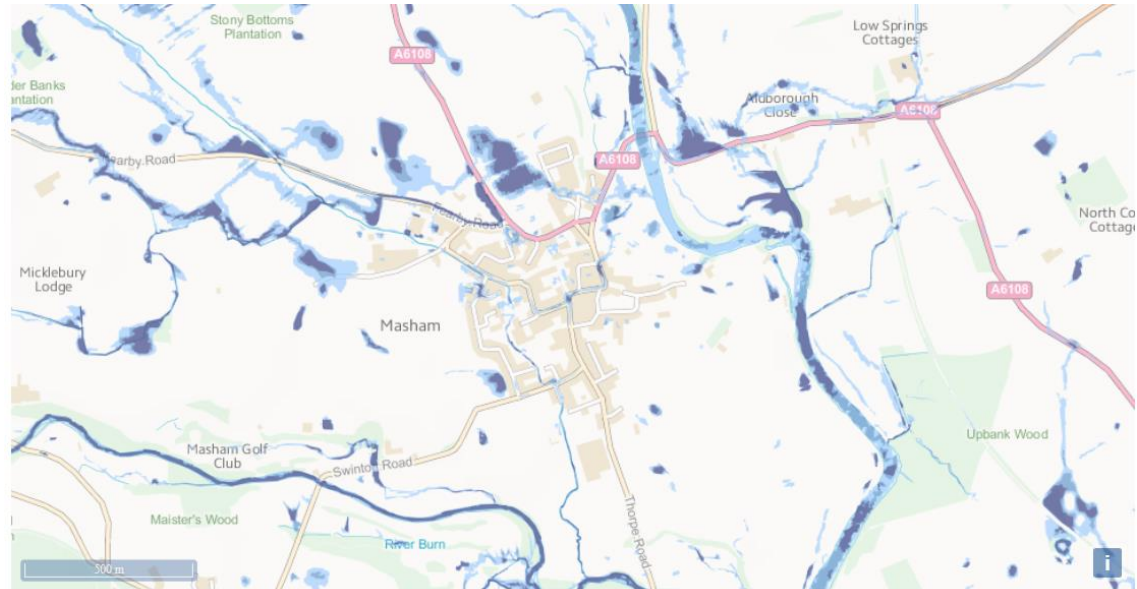
<p>Extent of flooding from surface water ● High ● Medium ● Low Very low</p> <p>It is noted the areas shown at most risk within Masham are predominantly contained within the highways and are representative of the flow paths observed in recent event. The map does not however show any links between Swinney Beck and the flow paths (this is likely due to the modelling methodology and we must acknowledge the limitations of modelling). Of particular interest to this study is the high (frequency of more than every 1 in 30 years), medium (frequency between 1 in 30 years and 1 in 100 years) and low (between 1 in 100 and 1 in 1,000</p>

years) risk shown on Westholme Road adjacent to Swinney Beck, Red Lane, Park Square, Church Street and Silver Street.
<p>Reservoir Flooding</p>

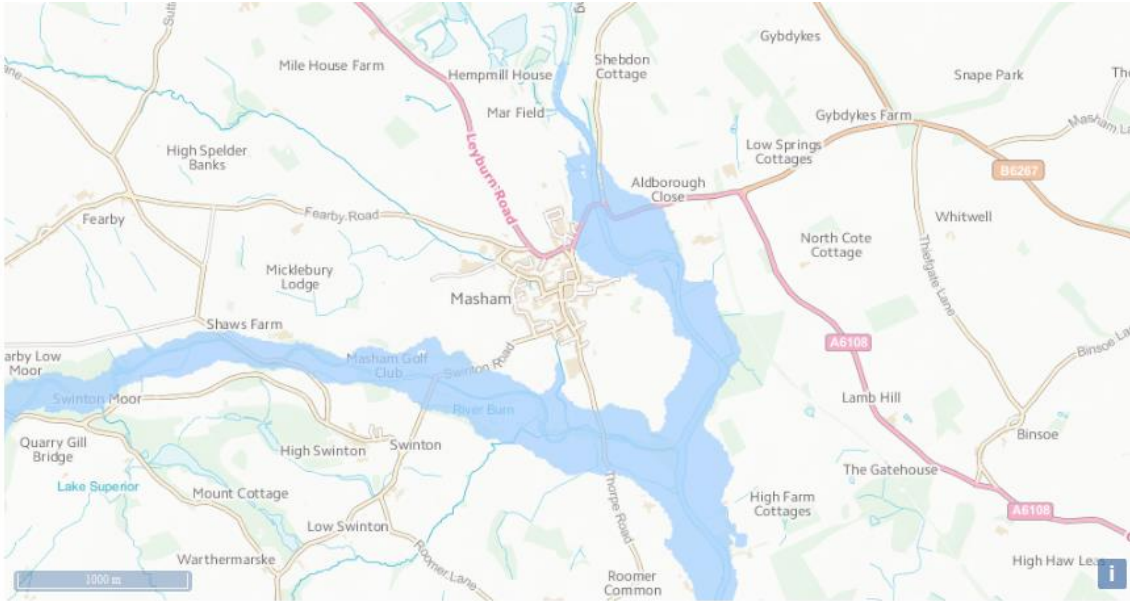
<p>Extent of flooding from reservoirs</p> <ul style="list-style-type: none"> Maximum extent of flooding <p>The risk of flooding from reservoirs is shown to follow a similar extent to the risk of fluvial flooding. Overall, the centre of Masham is not shown to be at risk of flooding from reservoirs.</p>
<p>Flood Alert and Warning Areas</p>	<p>Masham is included in the Lower River Ure Flood Alert Area</p>
<p>Current Flood Defences</p>	<p>Masham is not shown to benefit from any flood defences.</p>

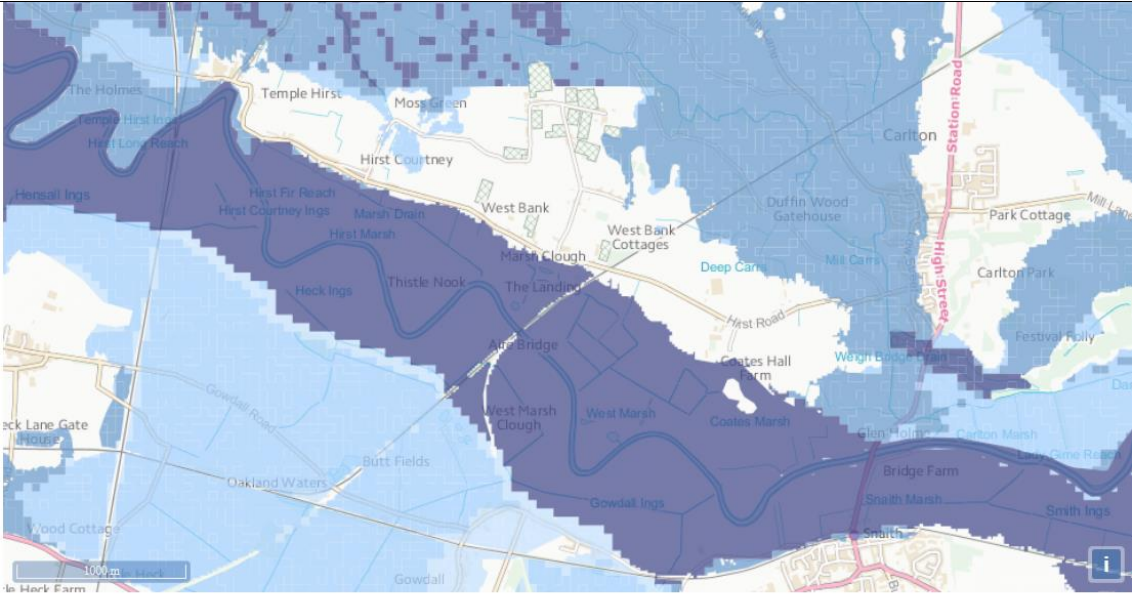
<p>Extent of flooding from rivers or the sea</p> <ul style="list-style-type: none"> ● High ● Medium ● Low ● Very low <p>The predominant area of risk associated with the River Aire is to the southern side of Hirst Road. The properties on the south side of Hirst Road are at high (a flooding frequency of more often than 1 in 30 years) and medium (a flooding frequency of between 1 in 30 and 1 in 100 years) risk of flooding. It is clear to see when on site that Hirst road is considerably higher than the surrounding area and as such acts as a barrier to the water for the properties to the north side of the road. The land immediately north of the road is shown to be at less than very low risk (frequency of less than 1 in 1,100 years).</p>
<p>Flood Map for Planning</p>

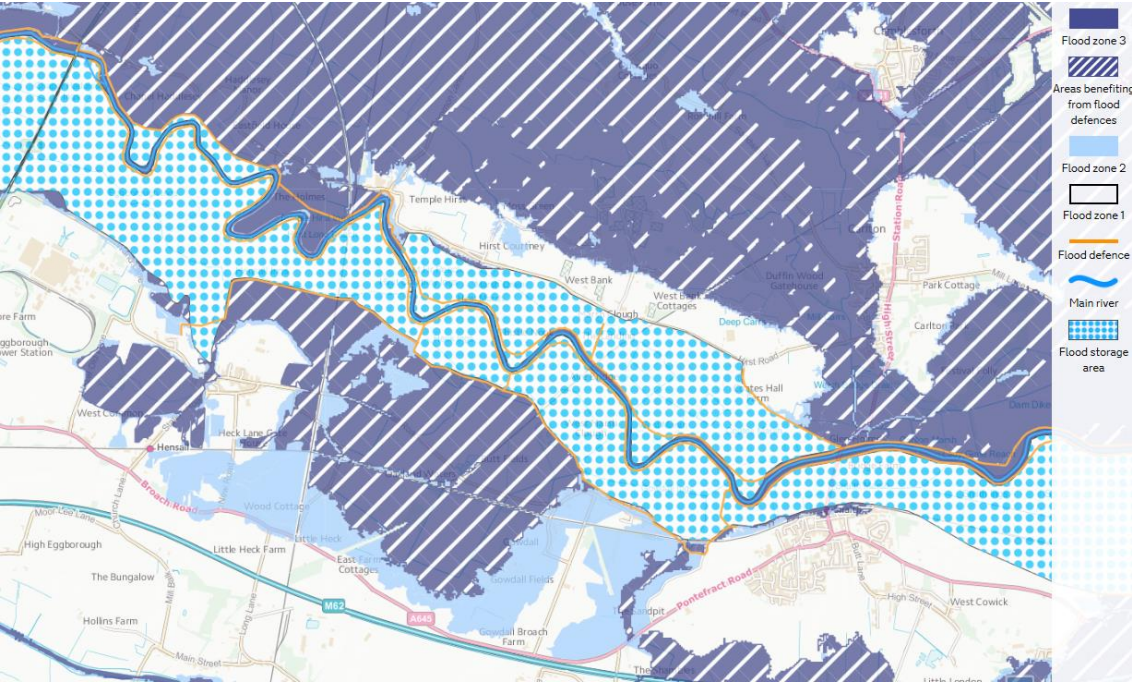
<p>The flood map for planning illustrates the location of the formal flood defences (orange lines) in relation to the areas at risk and flood storage areas. The washlands between the River Aire and Hirst Road are clear to see as flood storage areas. The northern extent of the storage area is</p>

<p>defined by Hurst Road with no formal defences present. Flood storage areas are defined by the EA as those areas that act as a balancing reservoir, storage basin or balancing pond. Their purpose is to attenuate an incoming flood peak to a flow level that can be accepted by the downstream channel. It may also delay the timing of a flood peak so that its volume is discharged over a longer time interval. Flood storage areas do not completely remove the chance of flooding and can be overtopped or fail in extreme weather conditions.</p> <p>The A19 is shown in the far west of the map and can be seen crossing the flood storage area.</p>
<p>Pluvial Flood Risk (Surface Water)</p>

<p>Current Flood Defences</p>	<p>As discussed above, the flood map for planning shows an extensive network of flood defences, both adjacent to the River Aire channel and within the fluvial floodplain to define and manage the water levels within the washlands. There are no formal defence between the current defences and the properties on the south side of Hirst Road.</p>

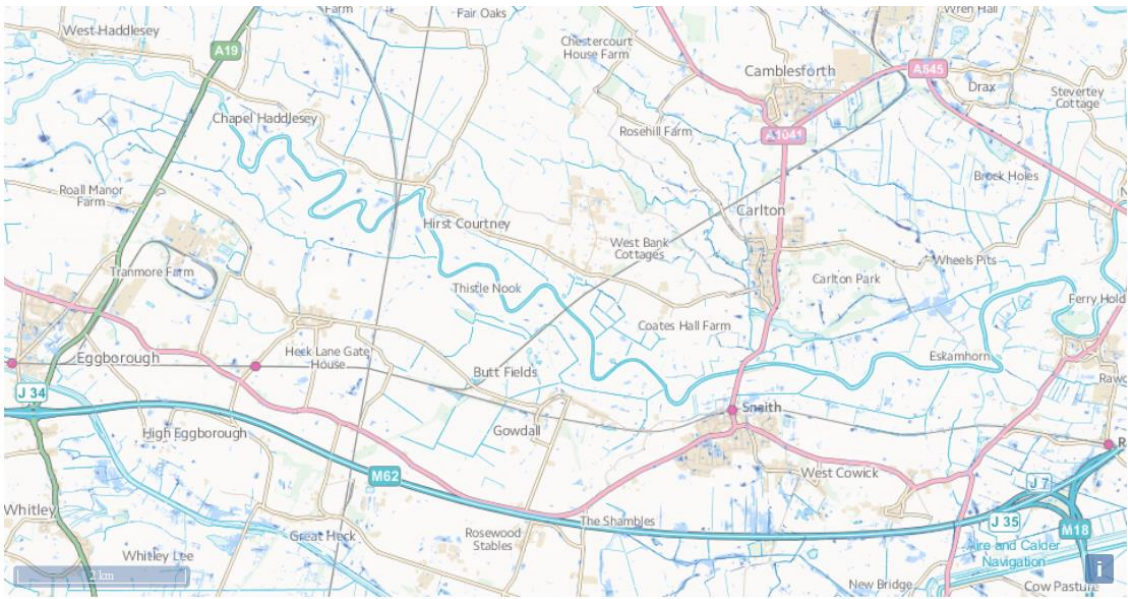
<p>Extent of flooding from surface water</p> <ul style="list-style-type: none"> ● High ● Medium ● Low ○ Very low <p>Given the topography and the generally well-draining soils, the surface water flood extents are limited. The predominant risk of flooding in the area is fluvial/tidal.</p>

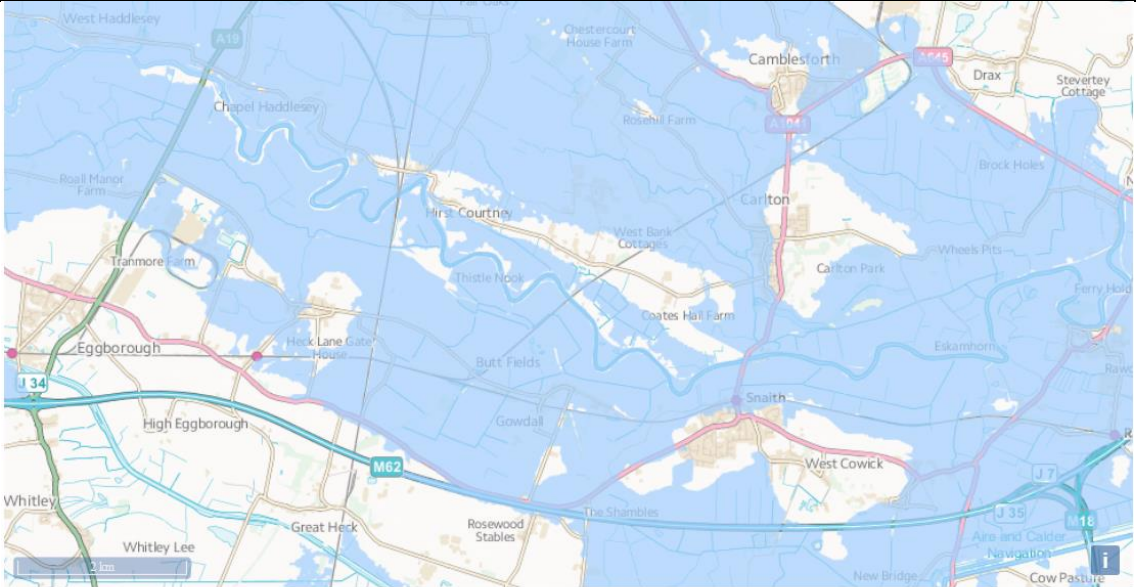
<p>Extent of flooding from reservoirs</p> <ul style="list-style-type: none"> ● Maximum extent of flooding <p>Given the number of reservoirs located within the extensive upstream catchments, there is a residual risk of reservoir flooding in the area should one of the reservoirs fail. The flood extents are akin to the fluvial but not as severe around Hirst Courtney and West Bank.</p>
<p>Flood Alert and Warning Areas</p>	<p>There are a number of flood alert and flood warning areas that cover the lower air reaches.</p> <p>Areas upstream of the East Coast Mainline are located within the River Aire from Brotherton to Chapel Haddlesey flood alert area. Whilst on the downstream side of the railway line Hirst Courtney, West Bank and Carlton are downstream to Airmyn is cover by the Tidal River Aire Catchment flood Alert Area.</p> <p>Chapel Haddlesey has a flood warning area that covers West Haddlesey and Chapel Haddlesey including Millfield Road and downstream to Lock Farm.</p> <p>The Flood Warning Area for Hirst Courtney extends from Temple Hirst through to the eastern side of Hirst Courtney. It includes Main Street and Hirst Road.</p> <p>A third flood warning areas is located at Hirst Marsh and West Marsh. The flood warning area covers the southern part of Higher Road including West Bank to Coats Hall Farm</p> <p>The western extent of Carlton is covered by the River Aire at Carlton flood warning area and includes Carlton from Low Street to Horley Park including Lynwith Lane, Almond Tree Avenue, The pastures, Camm Land and Church Fields.</p>

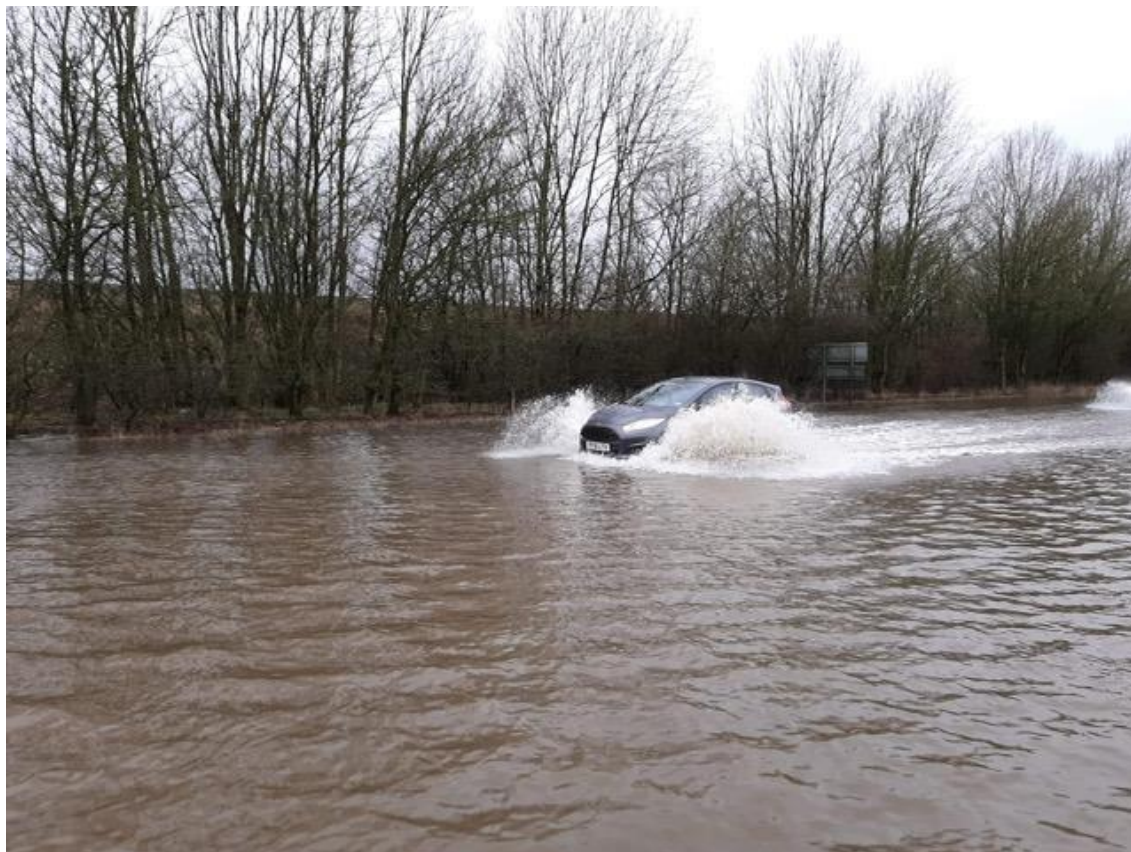
Five properties were recorded to have flooded in Gildersleets, with significant depths of flooding occurring on the A65 as shown in Figure 5. The A65 was not closed during the event. It was noted that the passage of vehicles exacerbated flows towards the properties.

Figure 10: A65 at Gildersleets

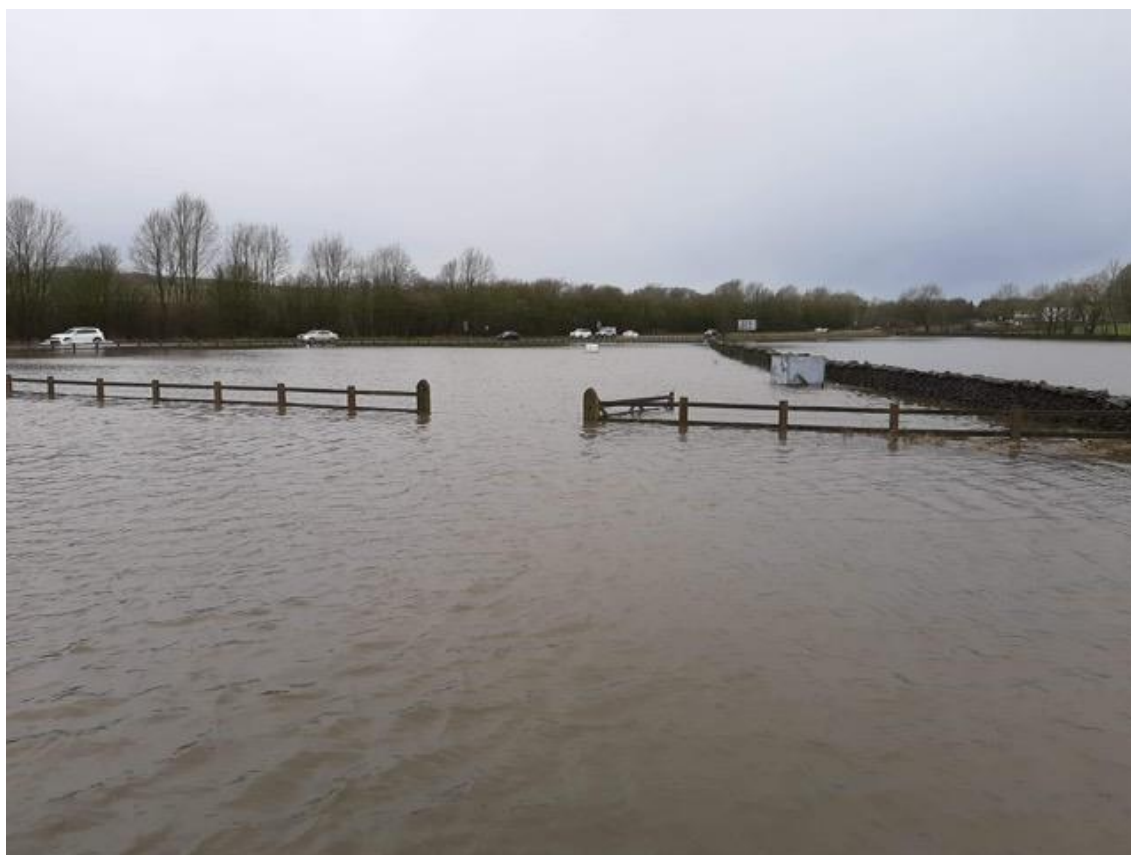
Figure 11: Looking north west from Gildersleets towards the A65.

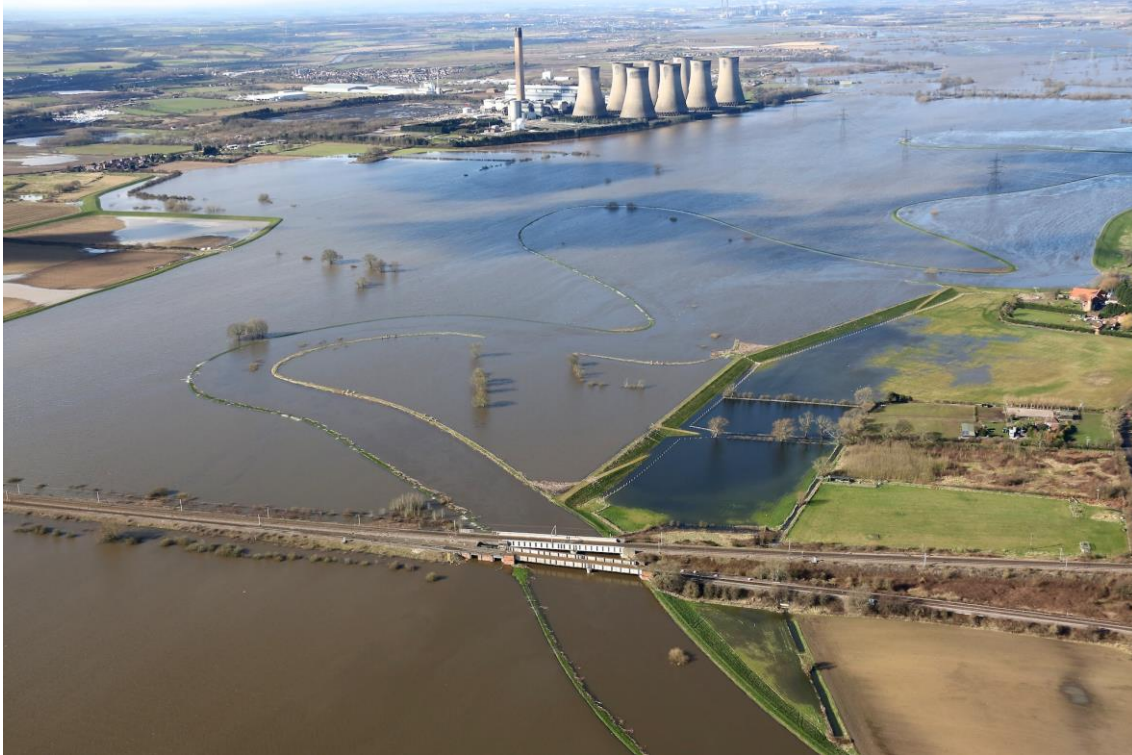
Aerial Imagery shows the vast extent of the flooding in the area.

Figure 12: River Aire Floodplain looking west

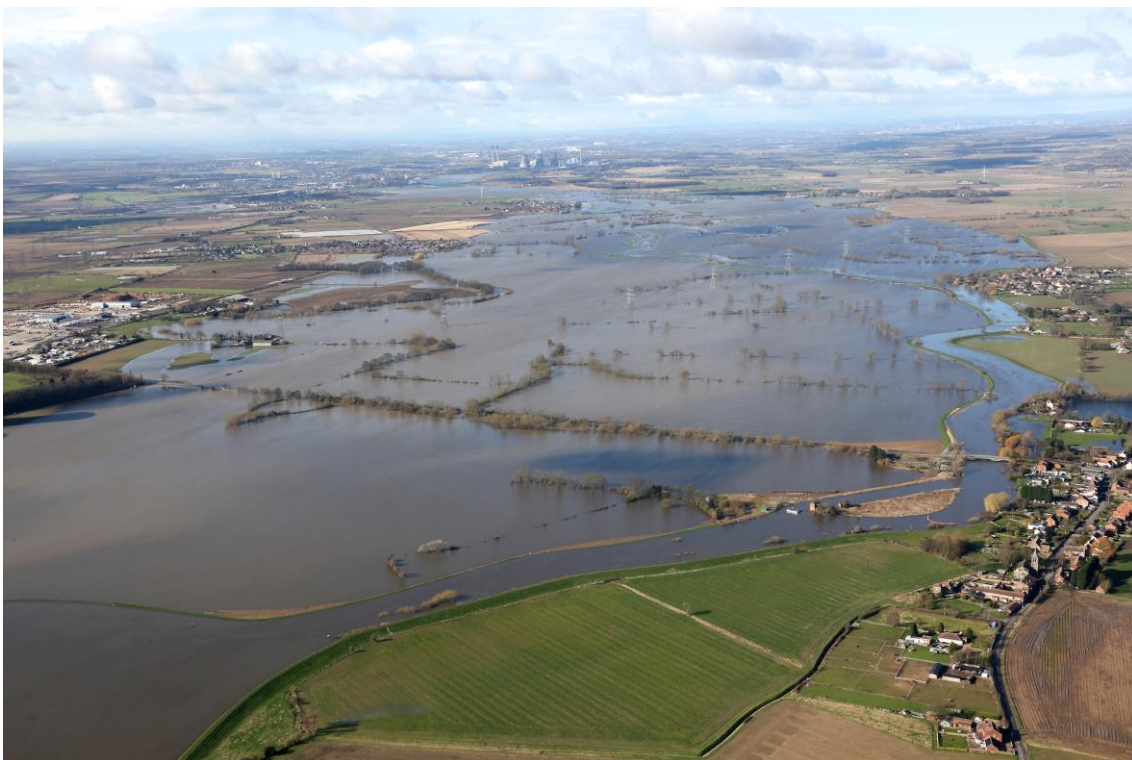
18 properties were recorded to have internal flooding in Selby District, concentrated around Hirst Courtney, Carlton and Acaster. The A19 was closed at Chapel Haddlesey on the 19th February and tests carried out to ascertain the damage to the road as it was suspected the water had eroded the carriageway underneath, when the River Aire overtopped and started filling the washland.

Figure 13: Submerged A19 at Chapel Hadlessey

- Minor sign and verge repairs on Cawood Road, Cawood.
- Sandbags were removed from carriageway, and verge and carriageway repairs were undertaken on Hirst Road, West Bank, Carlton
- Most significantly, damage was caused to the A19 at Chapel Haddlesey, meaning that embankment and road reconstruction is required.
- Remedial Works at Dalton Bridge
- Feasibility Study for flood relief works at Morton Flats

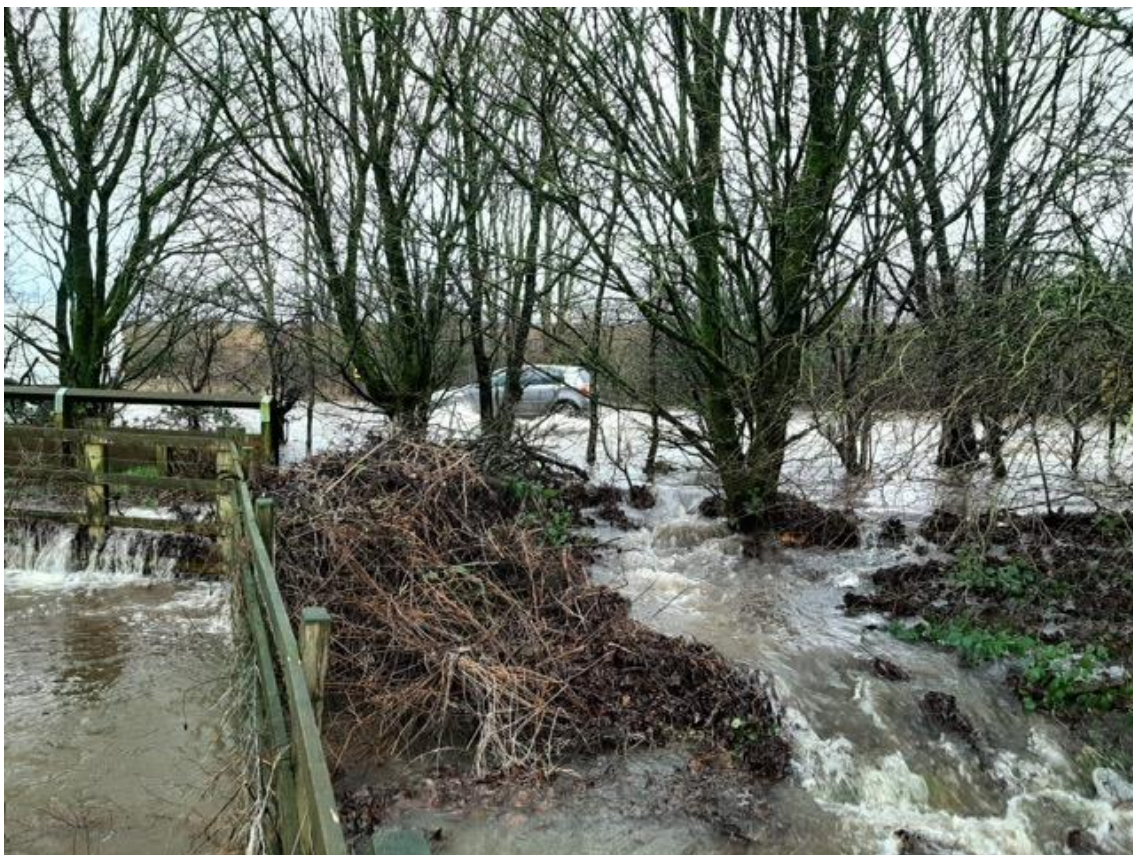
It is apparent from the submitted photographs that significant amounts of water is by-passing structure (Figure 15) erected next to the A65 which is resulting in continued flooding of the properties.

Figure 15: Gildersleets - floodwater by-passing bund

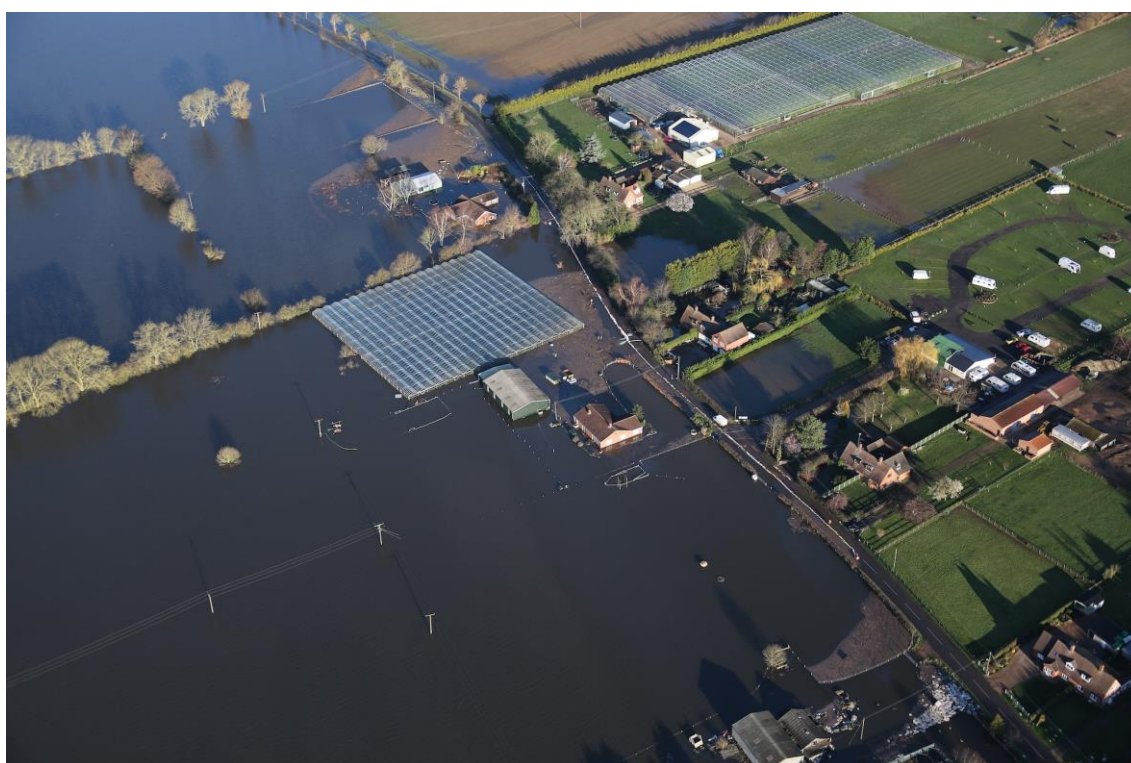
In terms of exacerbating the flooding, again it is impossible to say without further modelling how much impact, if any the makeshift defence had on water levels. Given the enormous expanse of floodplain, a bund of this sort is unlikely to raise water levels at all, if only by a few millimetres, certainly not enough to cause further damage than had already been caused. Whilst the Section 19 cannot make comment on the immediate emergency response, the uncertainty about where or not it increased flood risk to the south of the river and the introduction of residual risk associated with breach is considered unacceptable and a bund of this sort should not be attempted in future unless endorsed by the EA as part of its emergency response.

Figure 17: West Bank - Makeshift Defence Extent

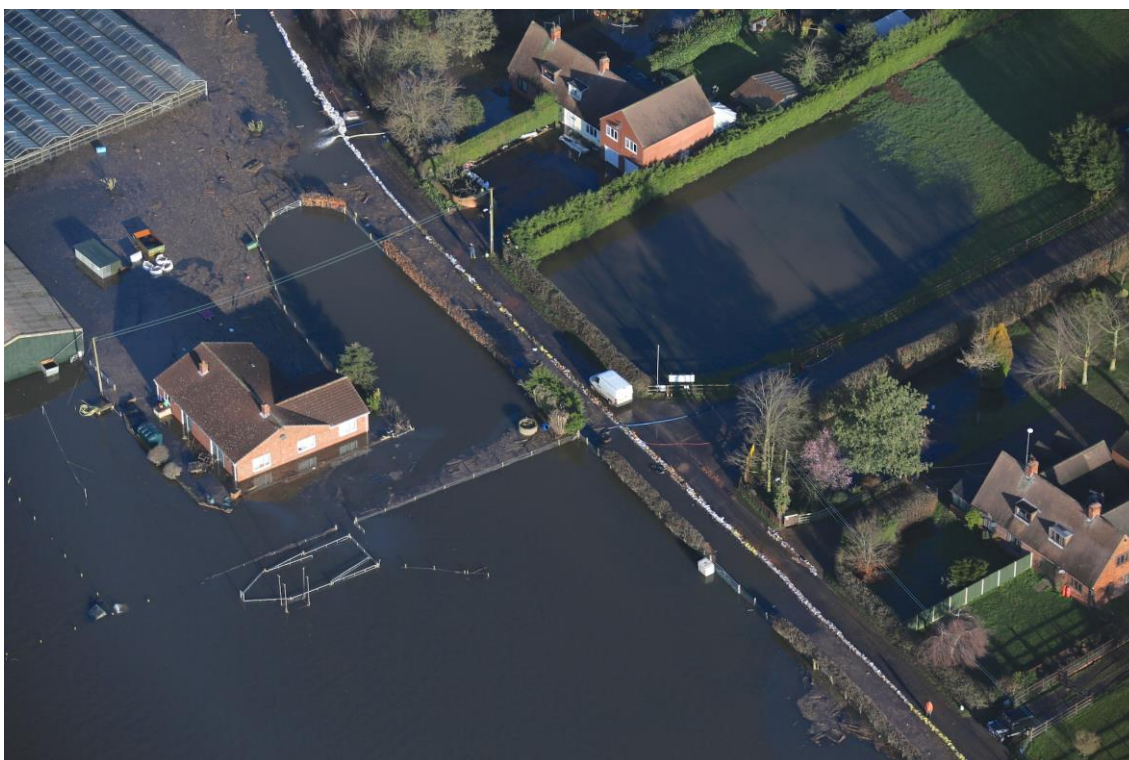
Figure 18: West Bank - Makeshift Defence

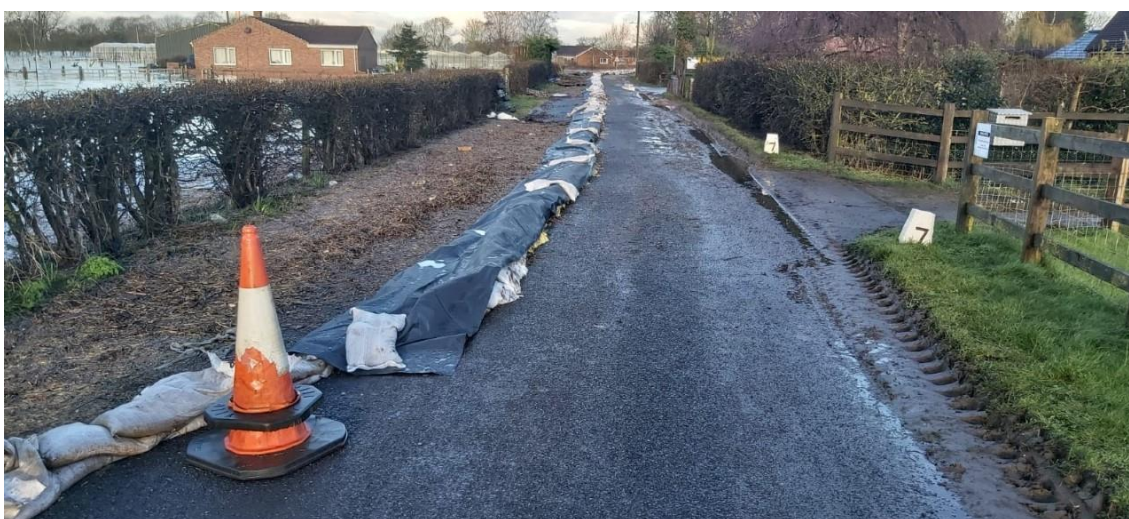
Figure 19: West Bank Visqueen and Rubble Defence
