North Yorkshire  
County Council

# Flood Investigation Report

## Tadcaster

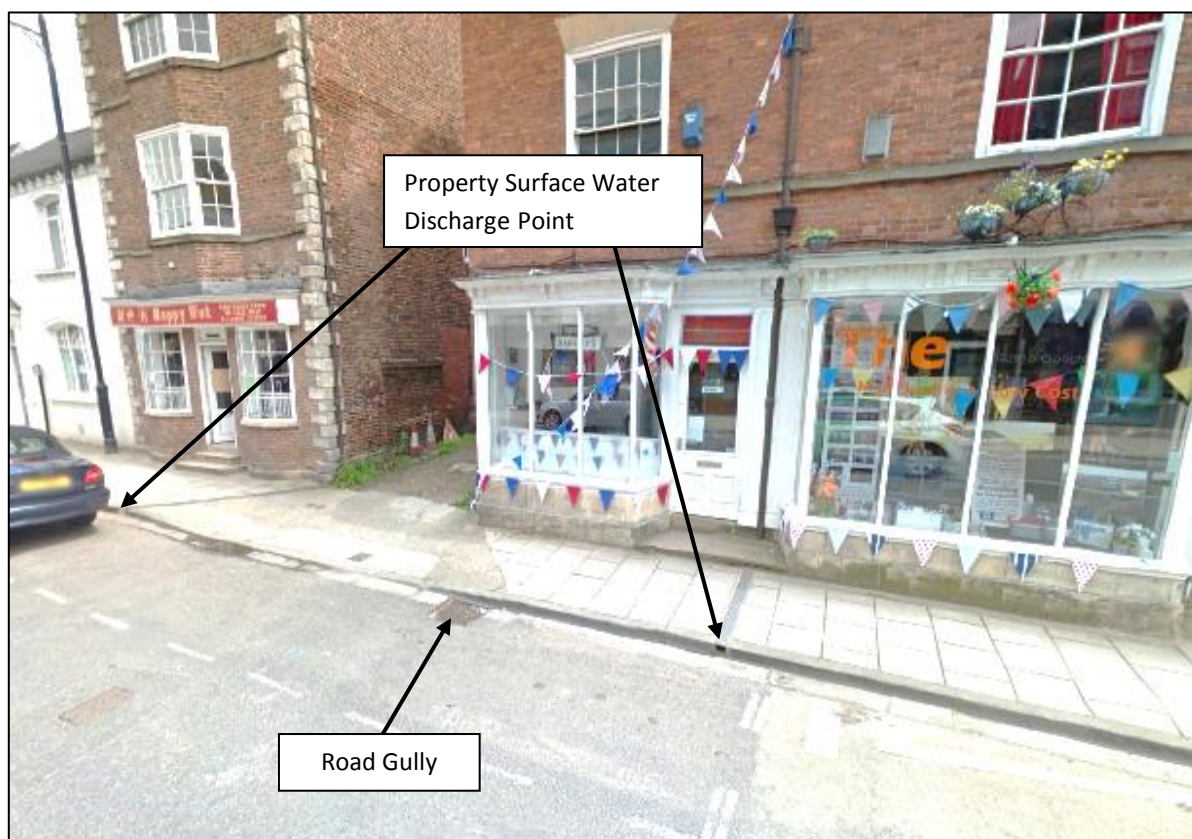
In addition to collecting rainwater from the road, rain water downpipes from individual properties discharge in channels across the footpath and onto the highway on Bridge Street. Hence the highway gullies here are transferring both roof and road water into the surface water sewer as shown in Figure 1.5, this increases the volume of water discharged to the sewer.

**Figure 1.5 Bridge Street surface water components (Source: Google Maps)**

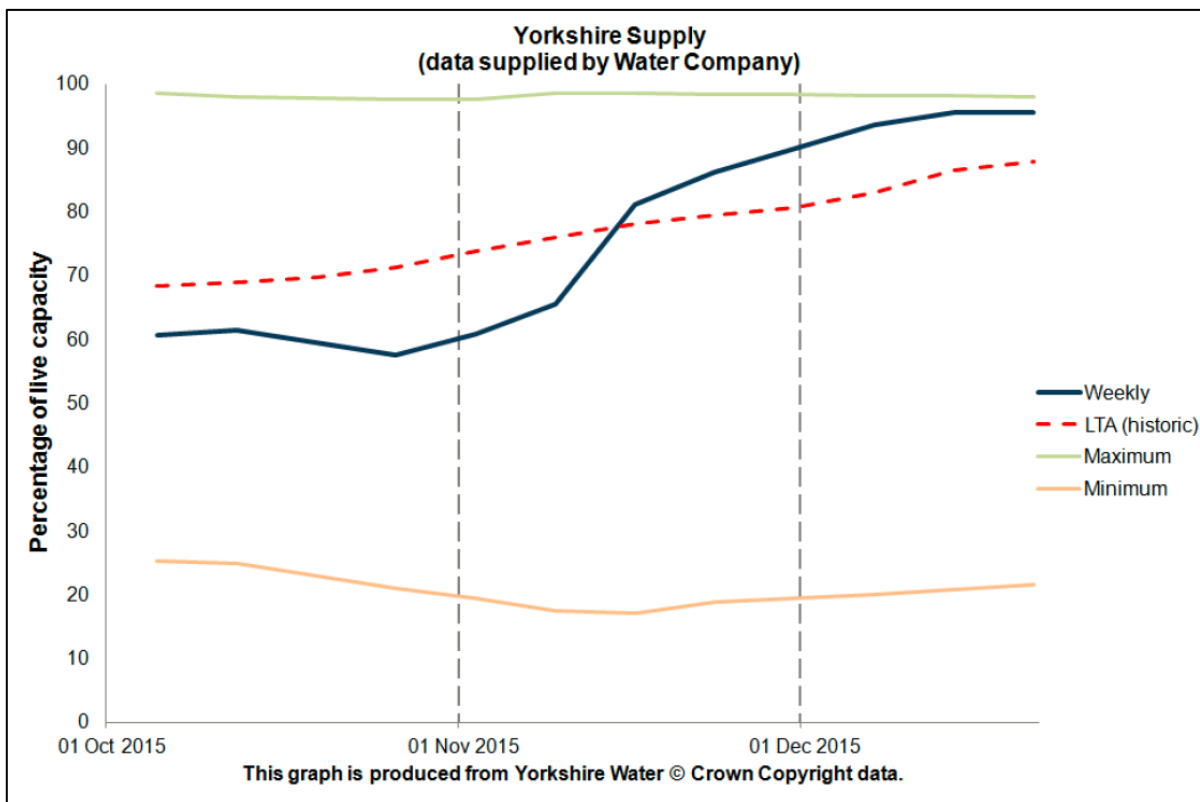
YWSL supply stocks were below the long term average (LTA) leading into November, but the increased rainfall in November and December saw overall levels rise above the LTA and they were virtually full prior to the flood event (see figure 2.0 below) and remained so well in to March<sup>10</sup>.

**Figure 2.0 Antecedent reservoir stocks demonstrated by Yorkshire Supply (Source: YWSL)**

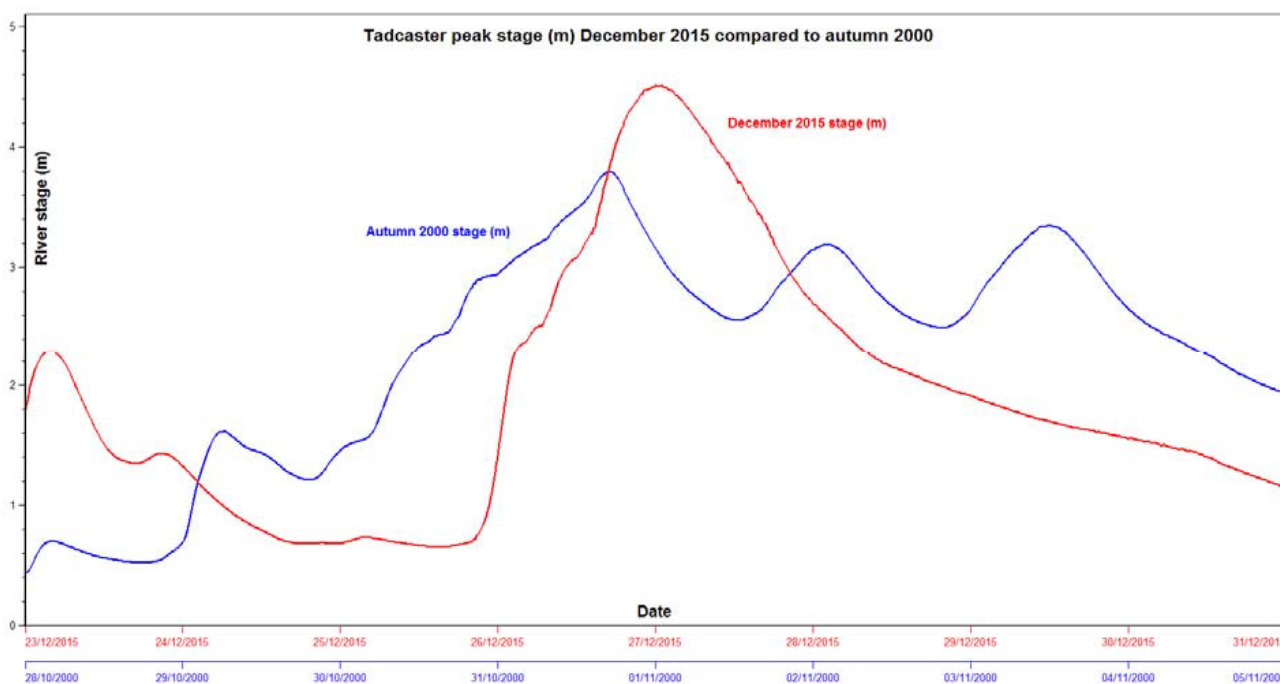
The severity of the December 2015 levels compared to the previous major event in autumn 2000 is demonstrated at the Tadcaster (Wharfe) flow gauge as shown in Figure 2.5. Water levels 0.7m higher than in autumn 2000 were recorded and the A659 Tadcaster Bridge was severely damaged. In addition the River Wharfe rose much faster at Tadcaster than in 2000<sup>9</sup>.

**Figure 2.5 Peak stage comparison for Tadcaster (Source: EA)**

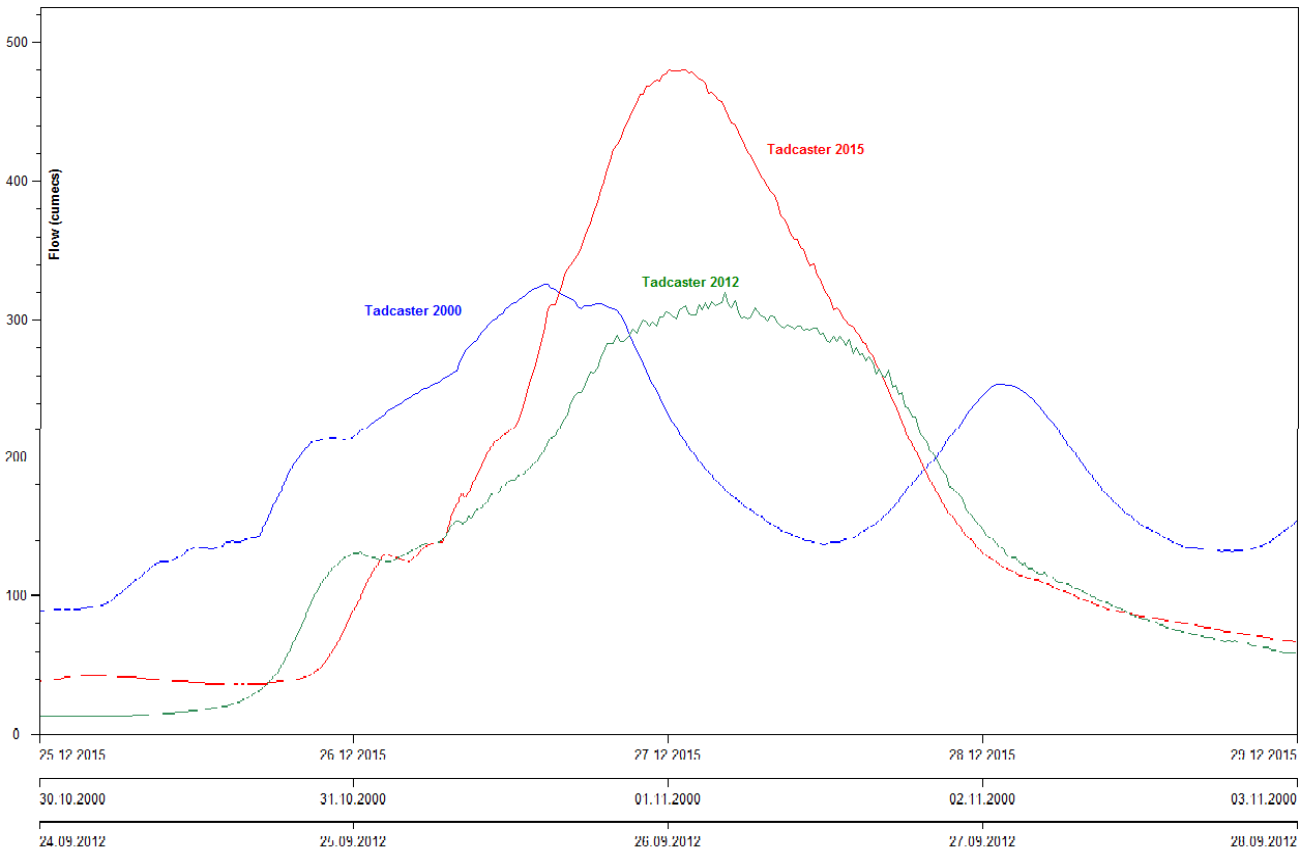
In December 2015 flow at Tadcaster increased more quickly than, and exceeded, past events. Figure 2.7 below shows a comparison of the flood events of 2000, 2012 and 2015 in Tadcaster. In 2015 the river rose faster, and to a higher level, than in previous flood events. This was due to a combination of intense rainfall, high flows arriving from upstream and the catchment being saturated.

**Figure 2.7 Wharfe at Tadcaster comparison of peak events**

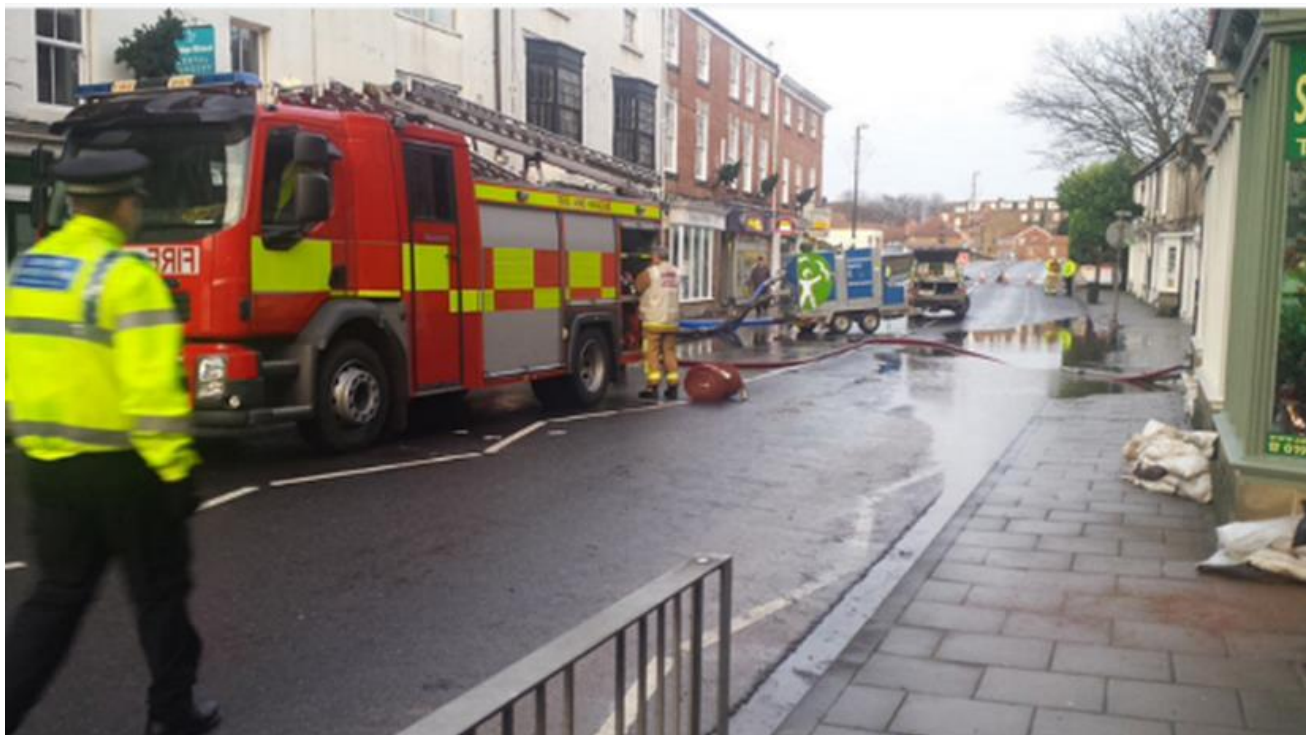
**Figure 2.8 Surface water ponding on Bridge St, 26/12/15 Source: Richard Rafferty**

Initial surface water flooding on Bridge St was caused by the inability of the drainage and sewer network to cope with the volume of rain which fell on the town. Rising river levels reduced the ability of the network to discharge through the outfall by the bridge. Investigations into the network's capacity and performance are ongoing.

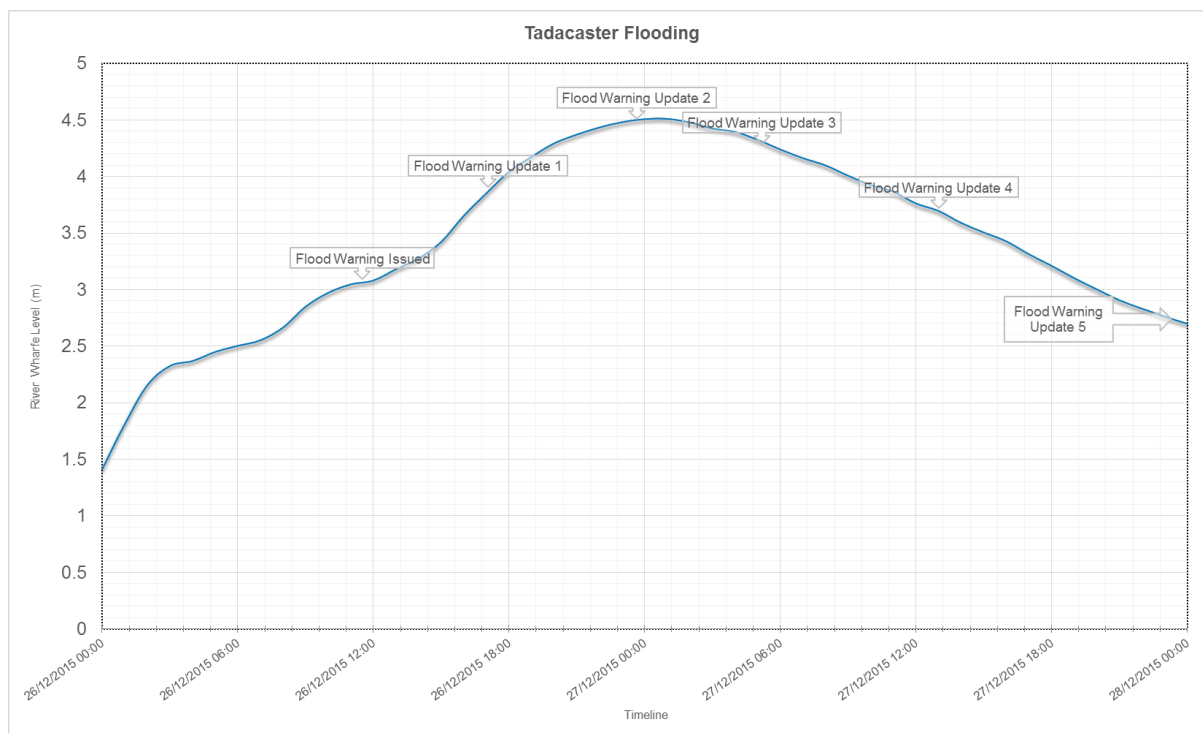
**Figure 2.10 Tadcaster flood warning against water level (source: EA)**

Figure 2.10 above shows when Flood Warnings and Updates were given out in relation to river levels. A Flood Alert for Tadcaster was issued at 12:27 on Christmas Day. Members of the public signed up to the flood warning service would not normally receive or rely on Flood Alerts, but the alert was picked up by professional partners and the Tadcaster Flood Action Group. The first Flood Warning was issued at 11:27 the following day, 26<sup>th</sup> December. Flood Warnings are issued to members of the public who are signed up to the service for a particular area, when property is expected to flood and people need to take action.

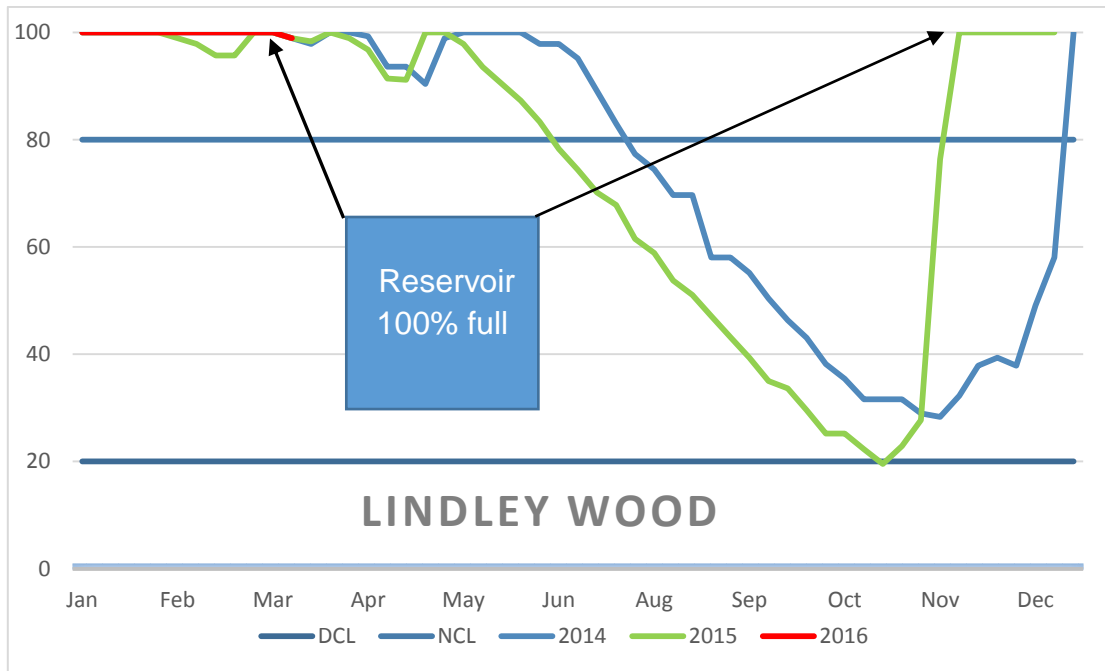
YWSL show how all the Washburn Reservoirs were full by mid November 2015, and were still full through to March 2016, as can be seen in Figure 2.13 below.

**Figure 2.13 Historic reservoir levels at Lindley Wood (source: YWSL)**

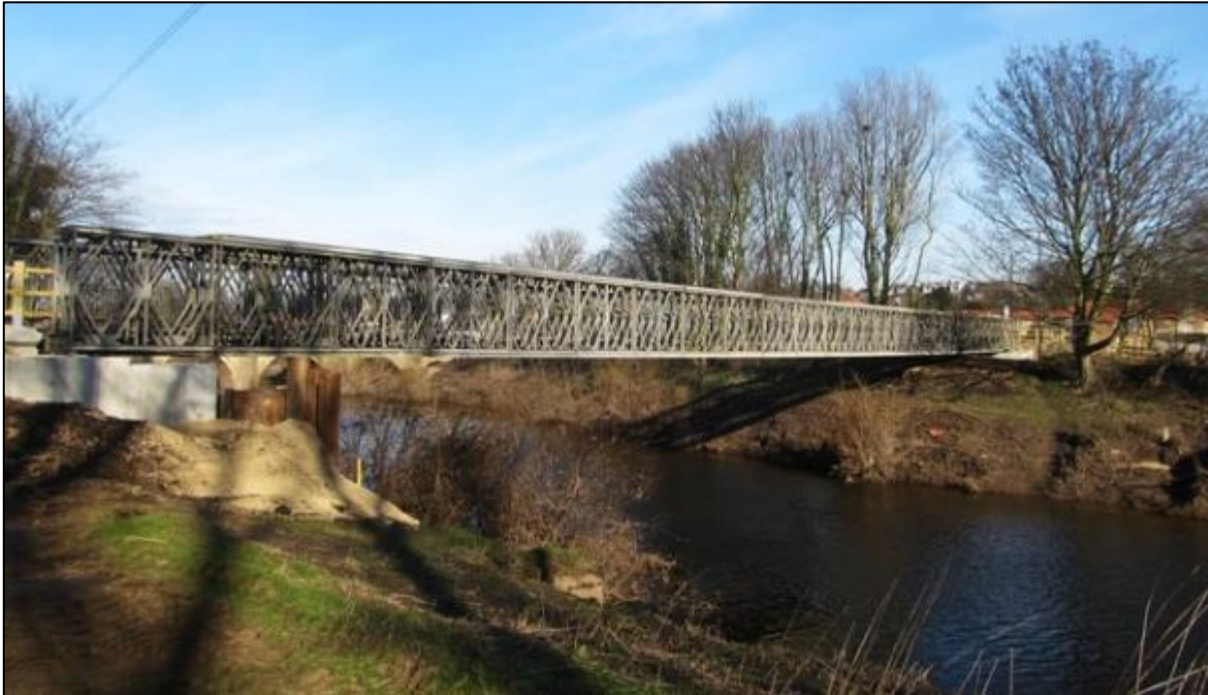
*Figure 3.0 Temporary Footbridge*

- Secured an additional £1.4M to fund improvements to the bridge, alongside the £3M provided by Government for the basic repairs.
- Works have been undertaken to underpin the bridge structure. The bridge has been reconstructed and widened to improve the space for vehicles and increase safety for pedestrians. The bridge reopened in February 2017.
