From: Ayres, Ben J (Dewsbury) GBR <Ben.Ayres@hanson.biz>
Sent: 12 May 2015 15:37
To: Planning Control
Cc: Julia Casterton; Ian Irwin; Amy Taylor
Subject: RE: Blubberhouses Quarry - Application ref NY/2011/0465/73 -Landscape & Visual Impact Assessment (LVIA)- revised photo montages
Attachments: Photomontage Views.pdf

From: Ayres, Ben J (Dewsbury) GBR <Ben.Ayres@hanson.biz>
Sent: 12 May 2015 14:58
To: Planning Control
Cc: Amy Taylor; Ian Irwin; Julia Casterton
Subject: Blubberhouses Quarry - Application ref NY/2011/0465/73 - Email 1 of 3
Attachments: Blubberhouses Initial Management Plan March 2015.pdf; FW: Blubberhouses - Application ref NY/2011/0465/73

***BLUBBERHOUSES
QUARRY: INITIAL
MANAGEMENT PLAN***

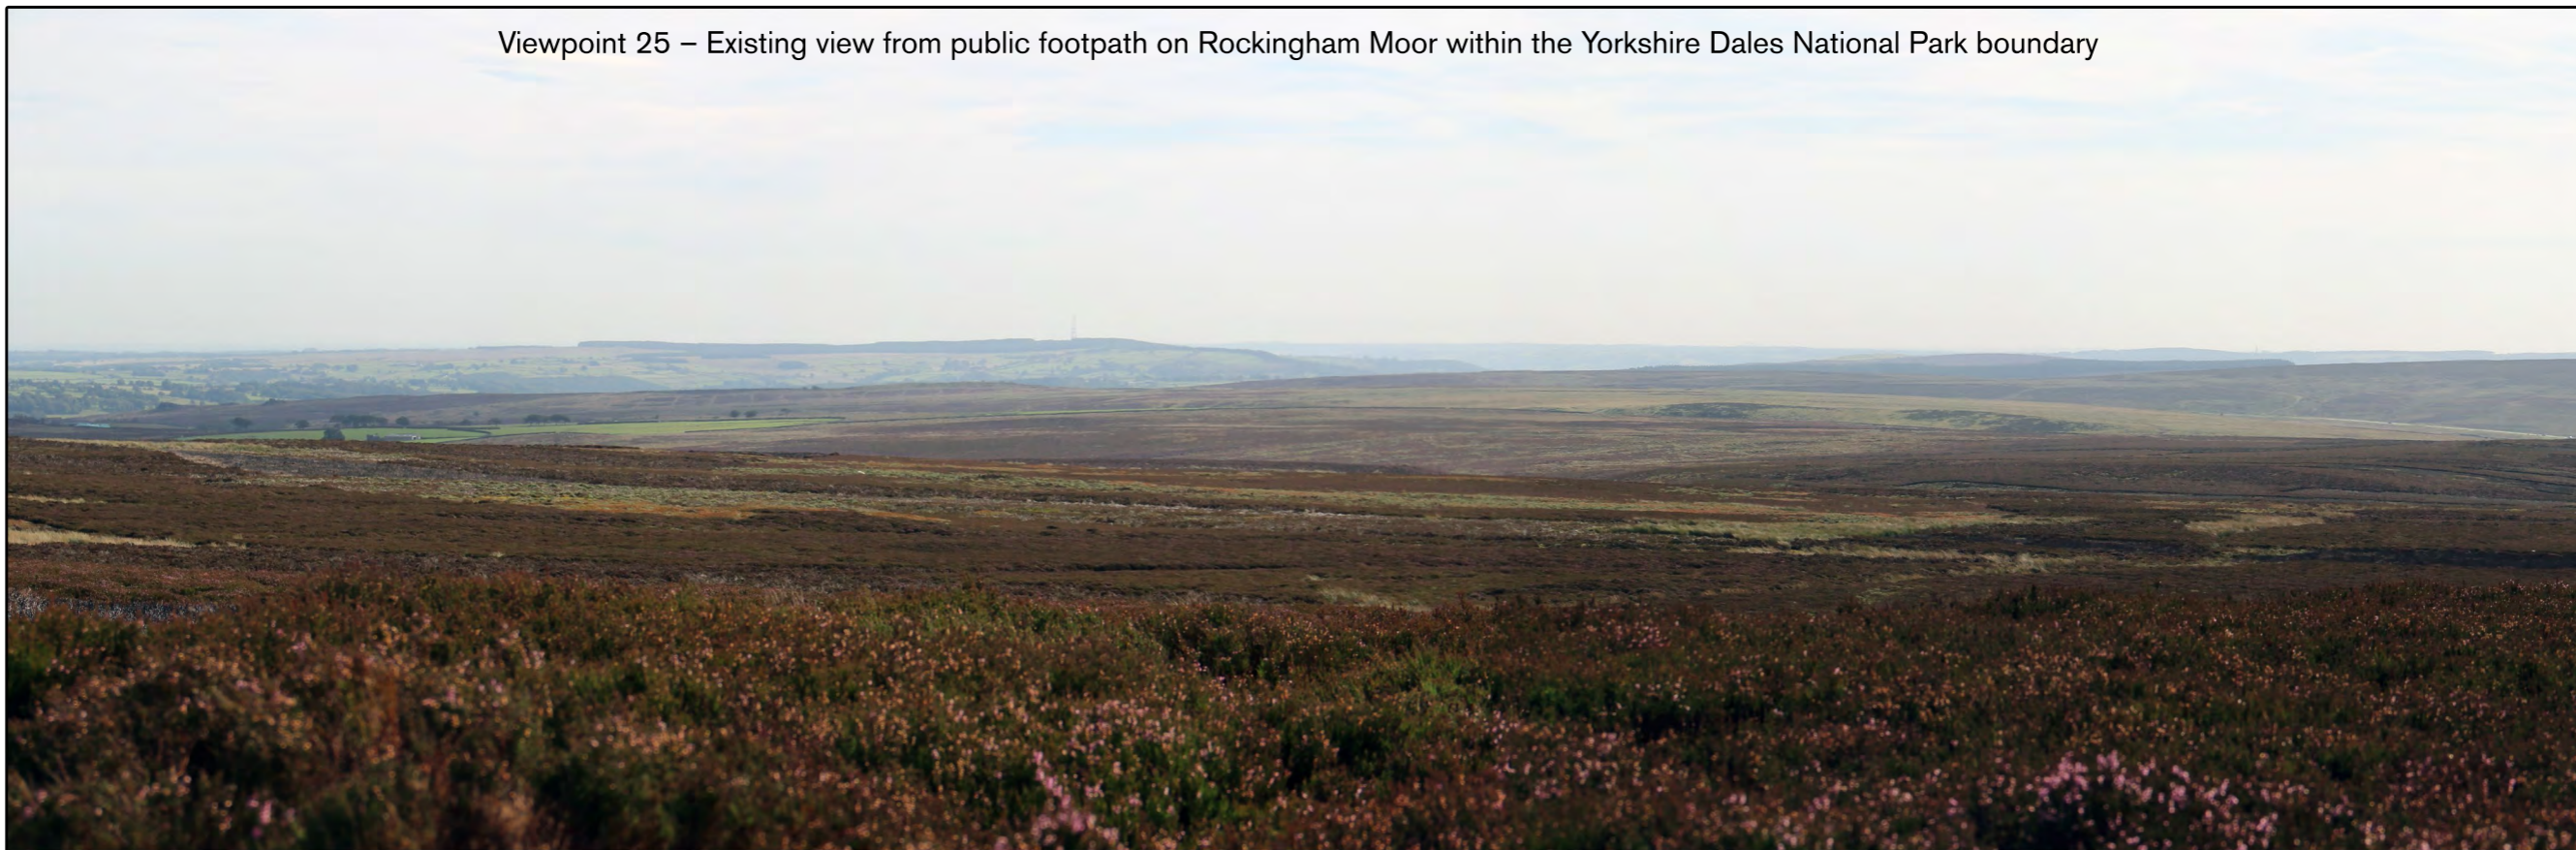
Site		BLUBBERHOUSES	
Title		Photo Sheet 6.	Fig No. Fig 4.11
Scale	Paper Size	Drawn by	Revision
Date	OCT 2014	AG	B126/34
		Check by	BA

Viewpoint 25 – Existing view from public footpath on Rockingham Moor within the Yorkshire Dales National Park boundary

An additional photo viewpoint from the Yorkshire Dales National Park on Rocking Moor (Number 25) has now also been taken.

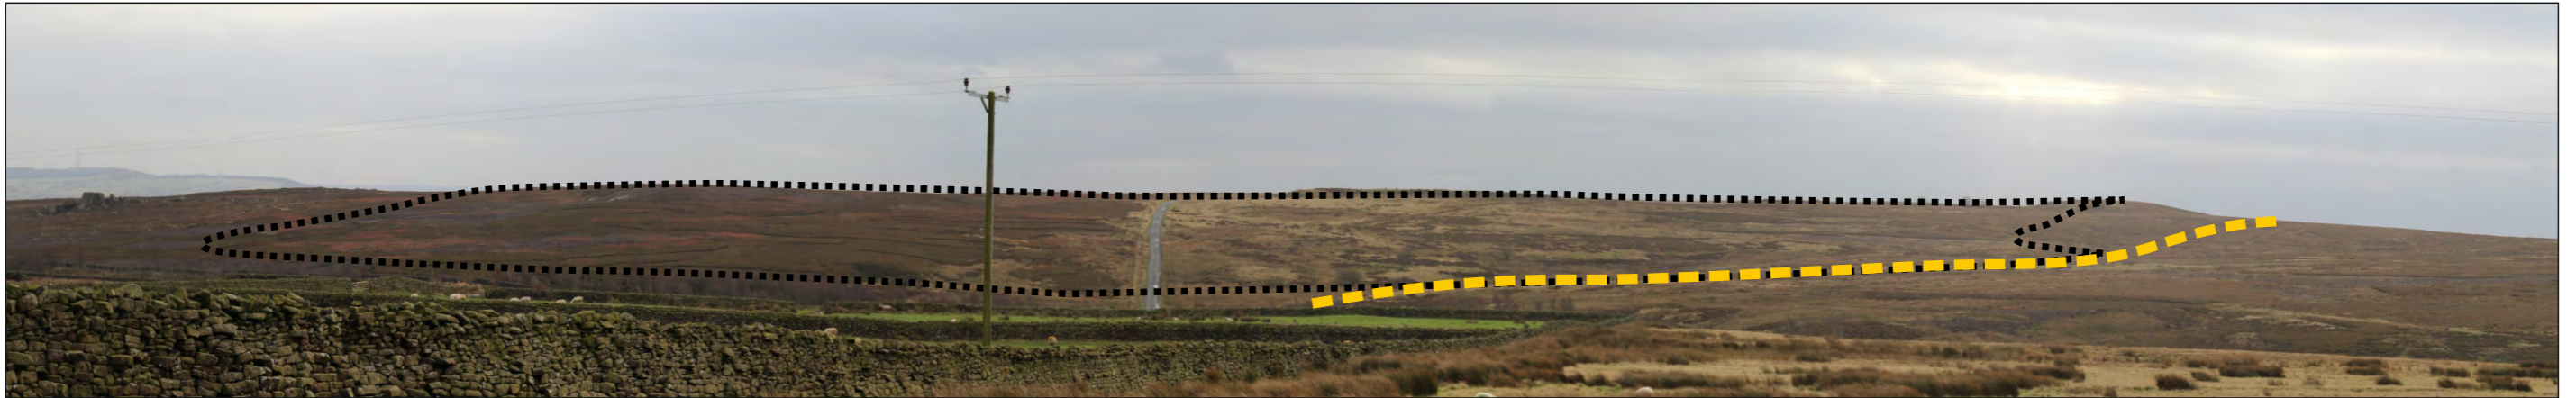
Viewpoint 11: Existing view looking south from Dales Way Link footpath near Burnt House and Brandrith Barn.

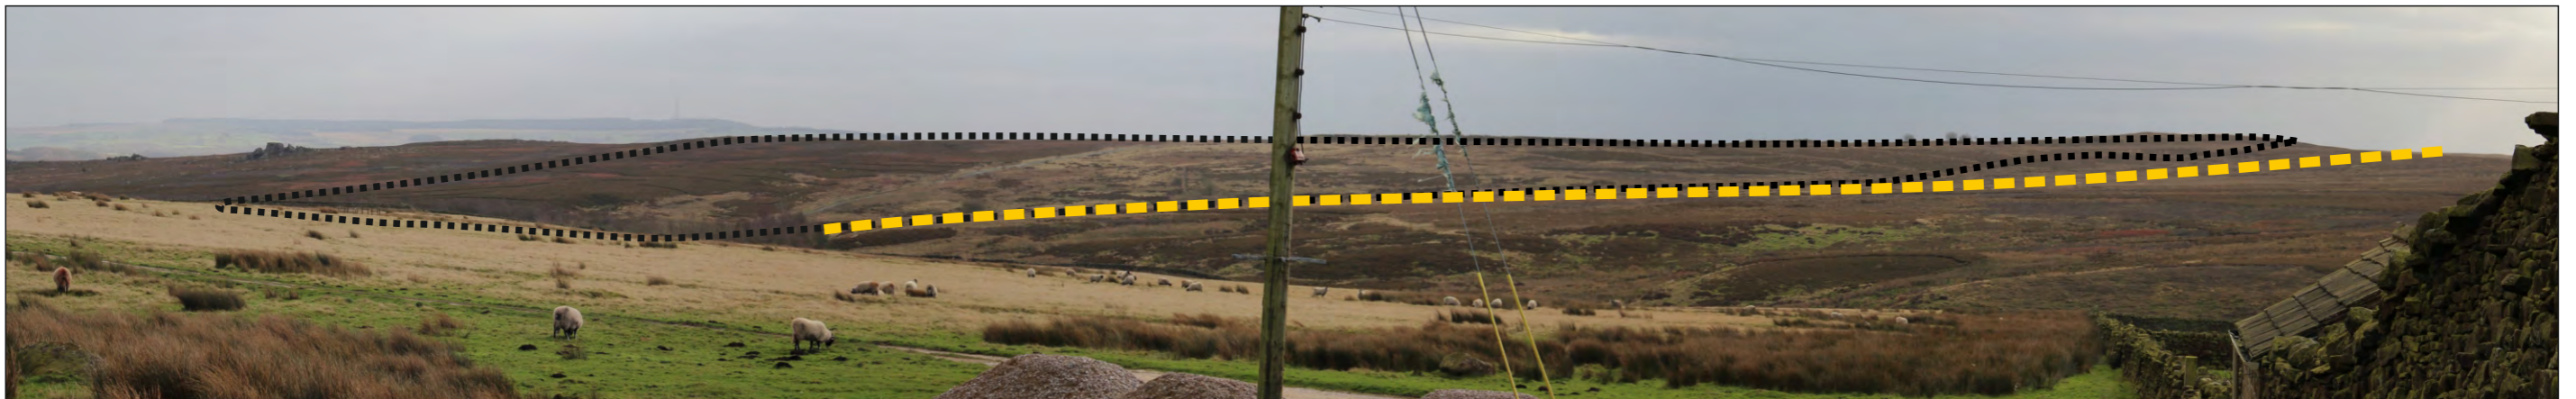
Viewpoint 12: Existing view looking southeast from Dales Way Link footpath adjacent to Spittle Ings farmhouse.

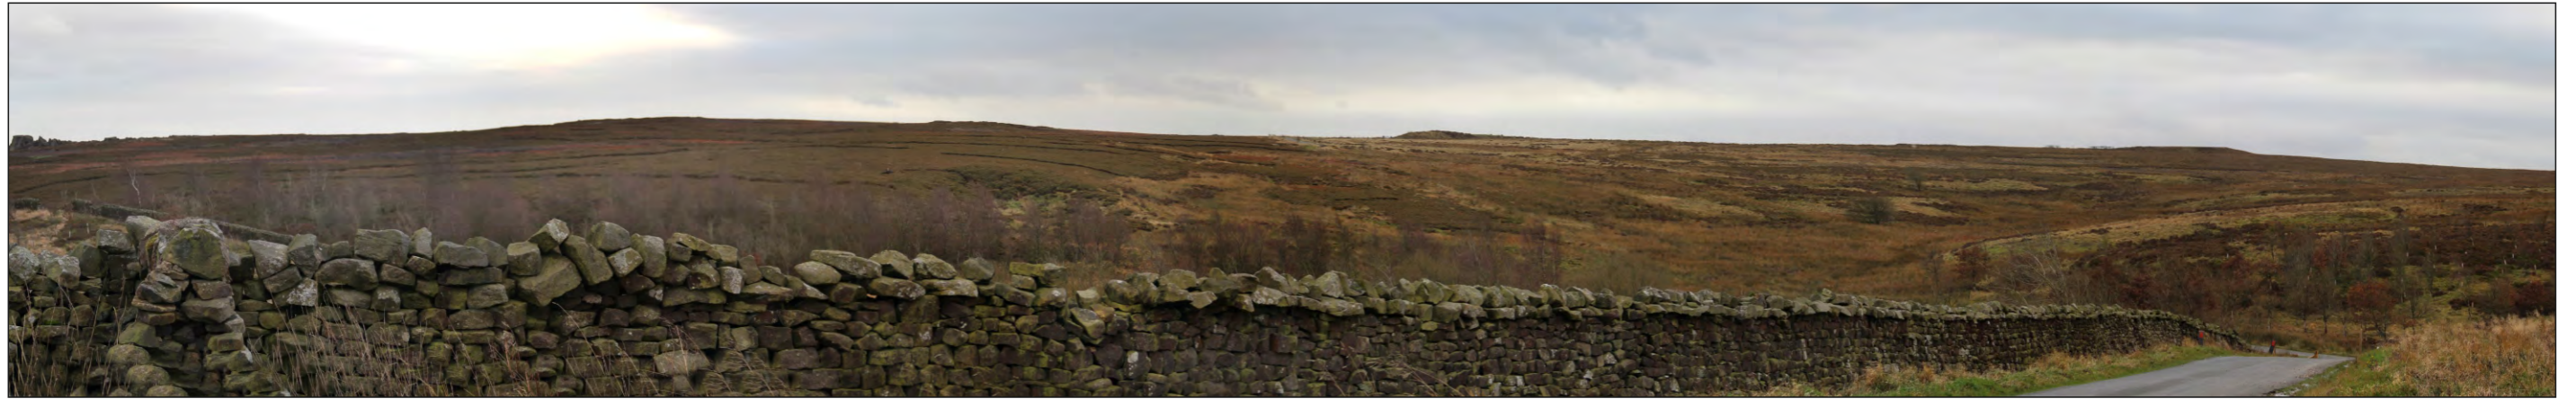
Viewpoint 13: Existing view looking south from Kex Gill road.

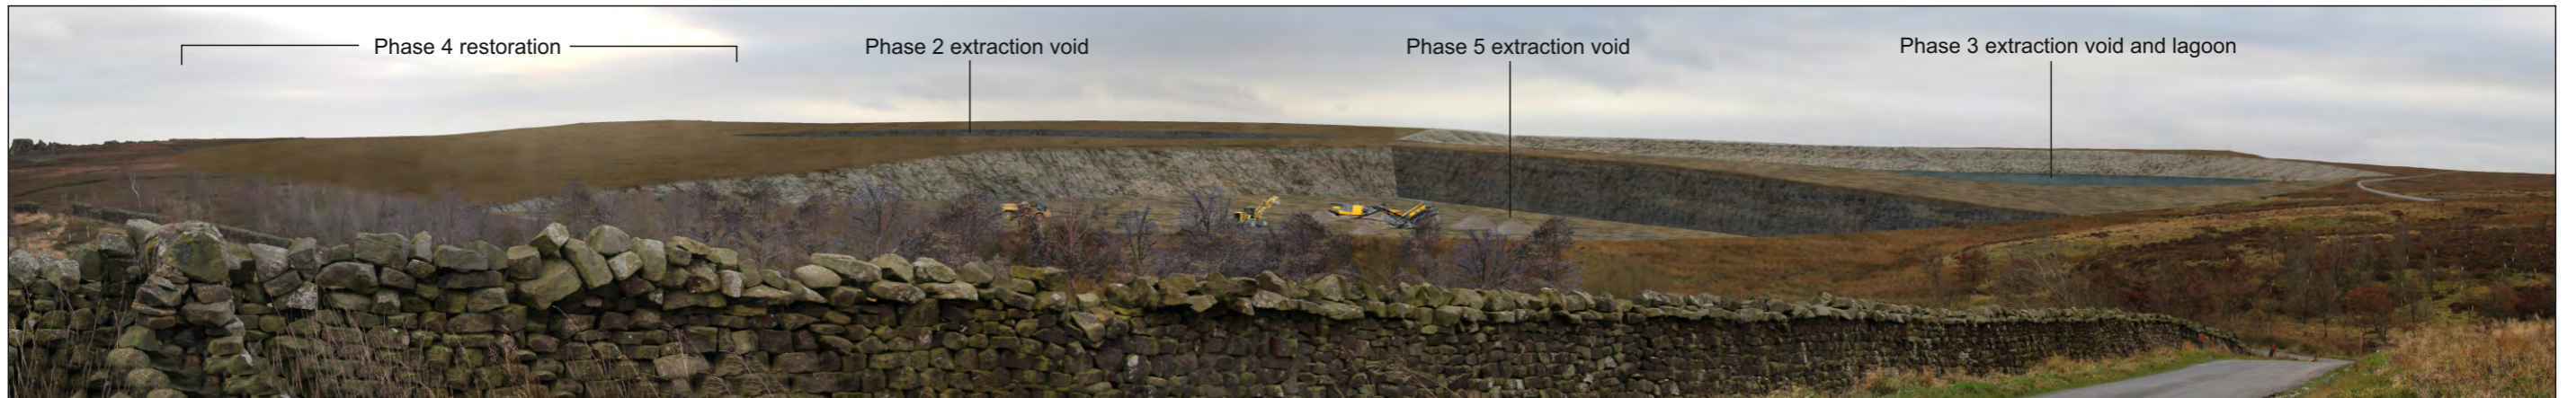
Viewpoint 13: Proposed view during Phase 5 extraction.

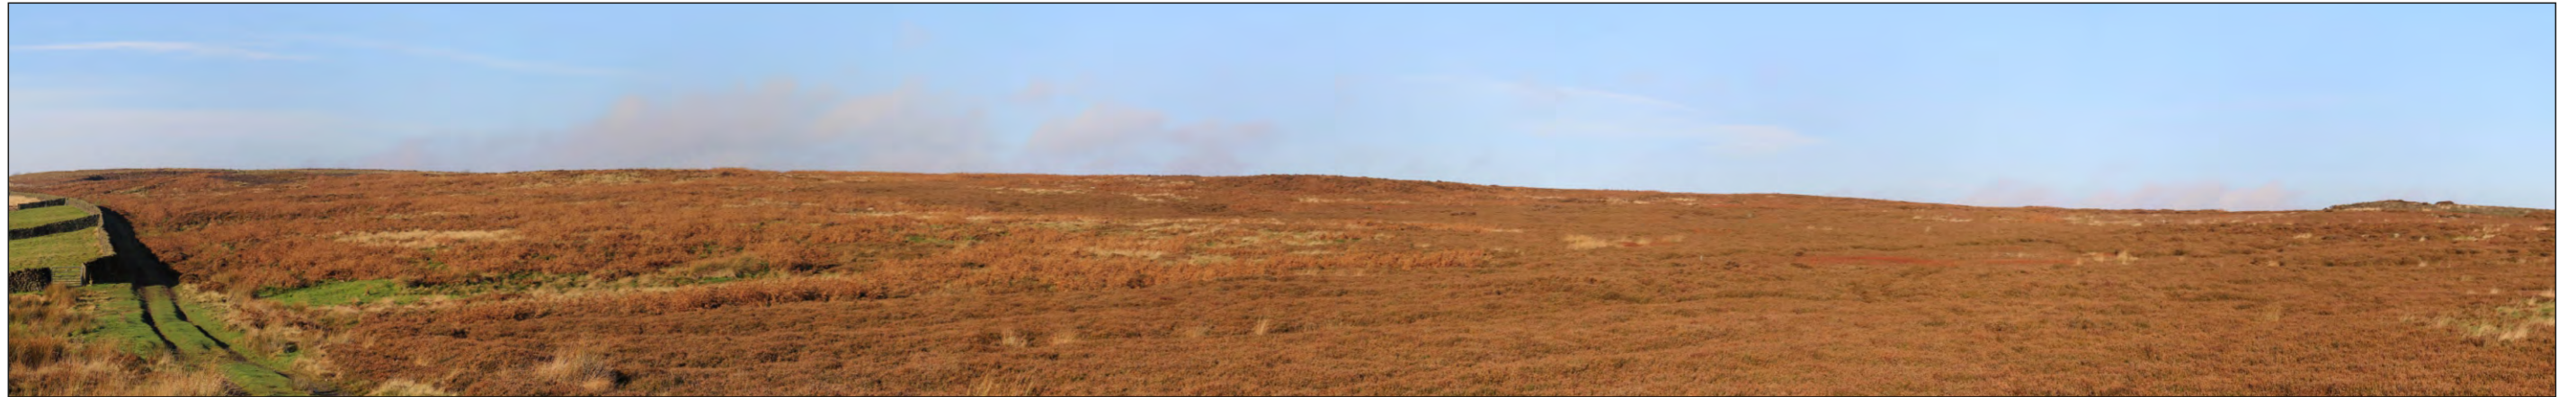
Viewpoint 19: Existing view from bridleway looking northwest.

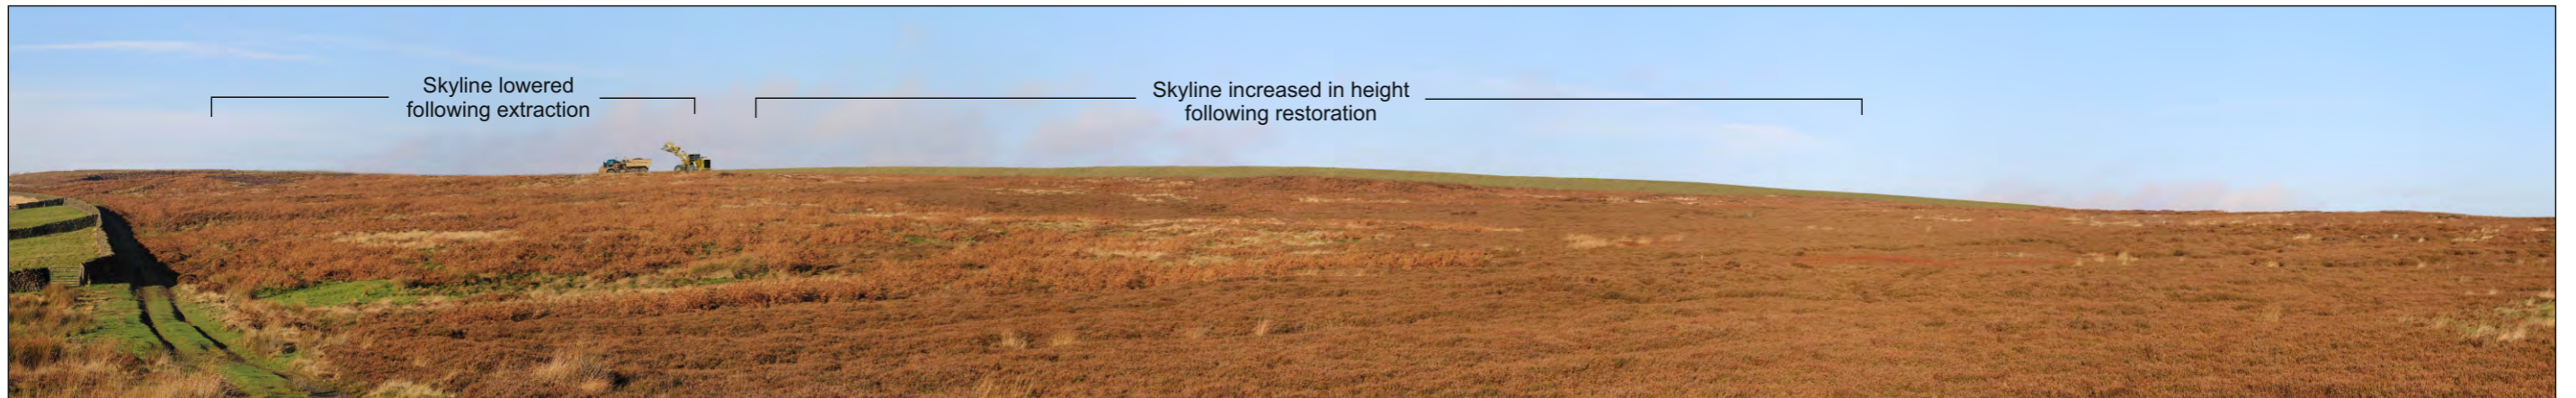
Viewpoint 19: Proposed view during Phase 5 extraction.
