# Flood Investigation Report

Knaresborough 6<sup>th</sup> May 2024

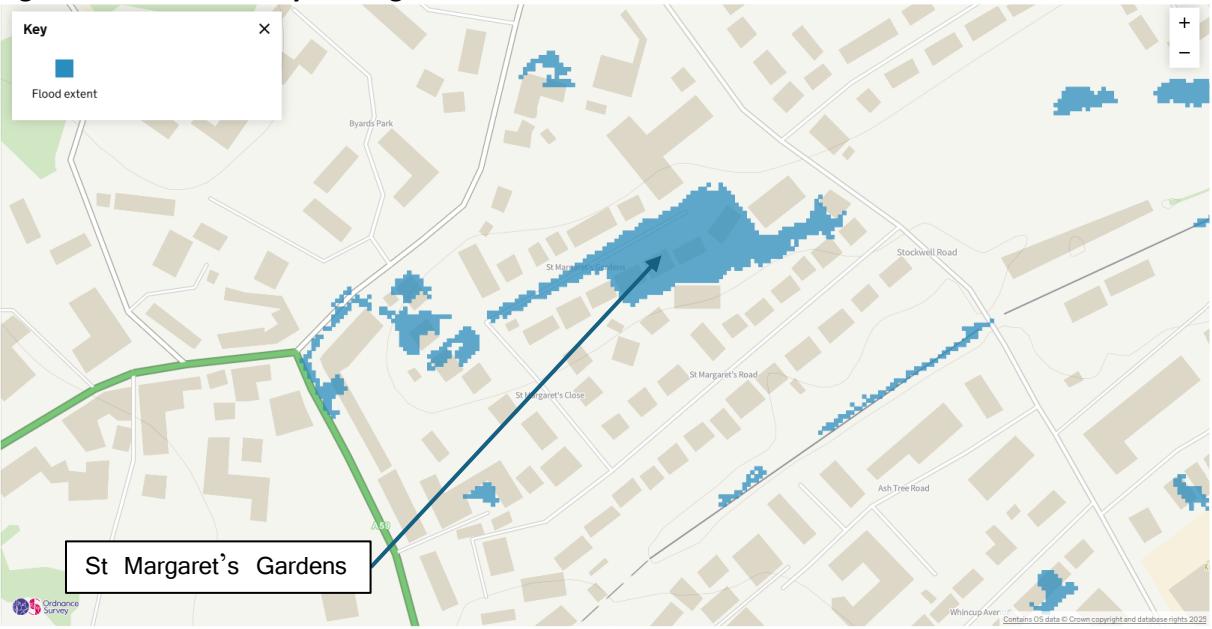
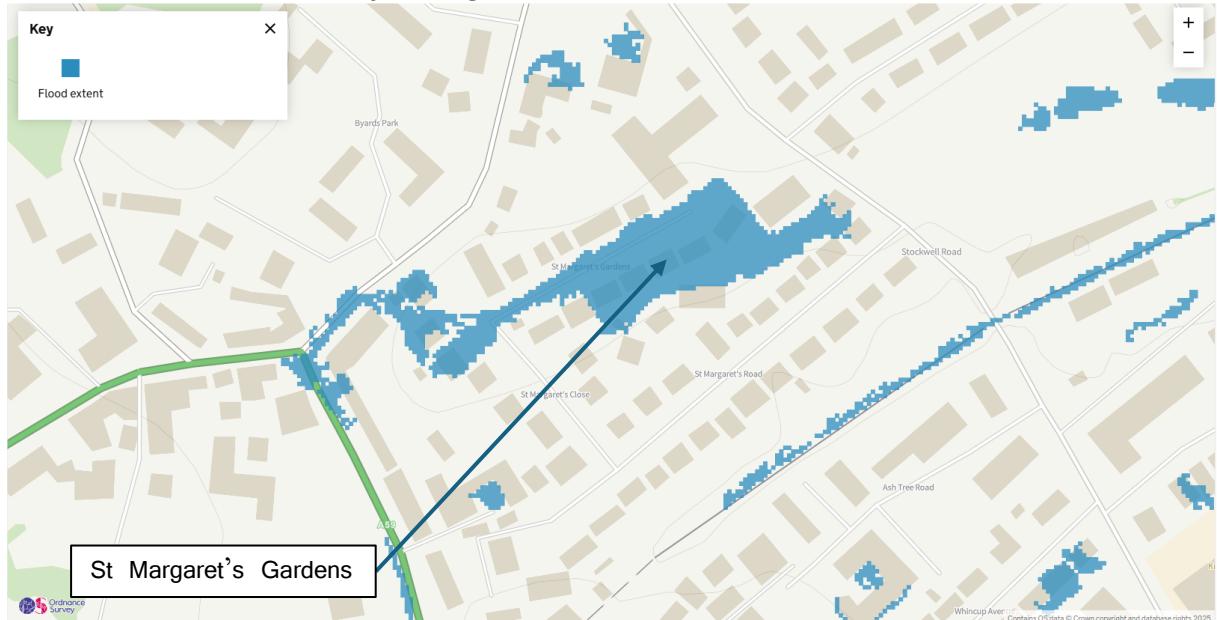
It is noted the map above shows the surface water flood risk for St Margaret's Gardens. The data presents a large area of properties that are within the High and Medium risk area from surface water flooding. The mapping in this location shows a higher number of properties at risk of flooding than reported flooding during event. It could be considered that the above flood extent and risk is conservative.

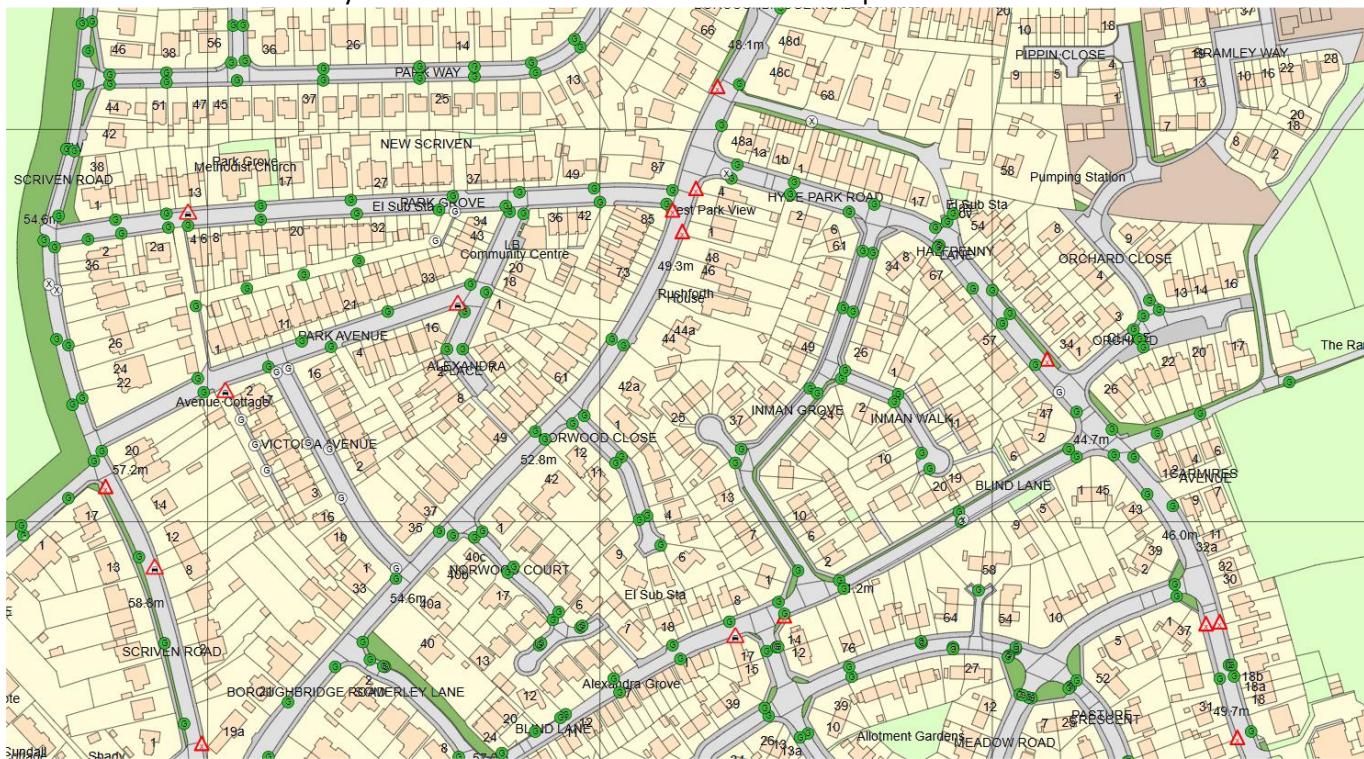
Figure 6: Kaarbontech Data for Park Avenue, Halfpenny Lane and Orchard Close

Figure 6 below shows the current layout of highway gullies within the vicinity of Halfpenny Lane and Orchard Close and the wider catchment beyond this area based on the overland flows presented in Table 2.

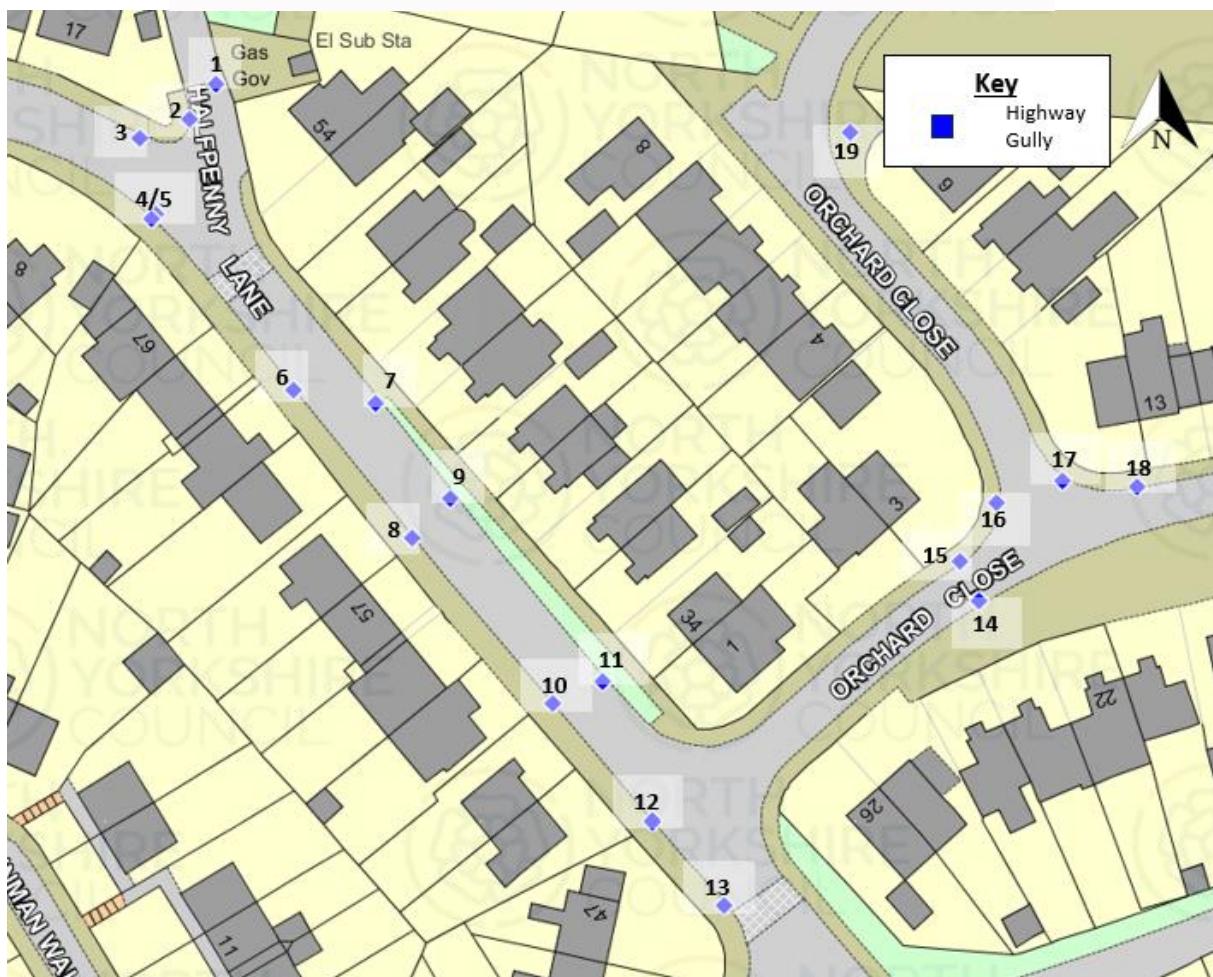
Figure 7: Halfpenny Lane and Orchard Close Highway Gully Schedule

For demonstration purposes the gullies within Figure 7 have been numbered to give reference for a table that will be provided below. This will showcase data that was collected from Highways to highlight the maintenance and routine cleaning of these gullies.

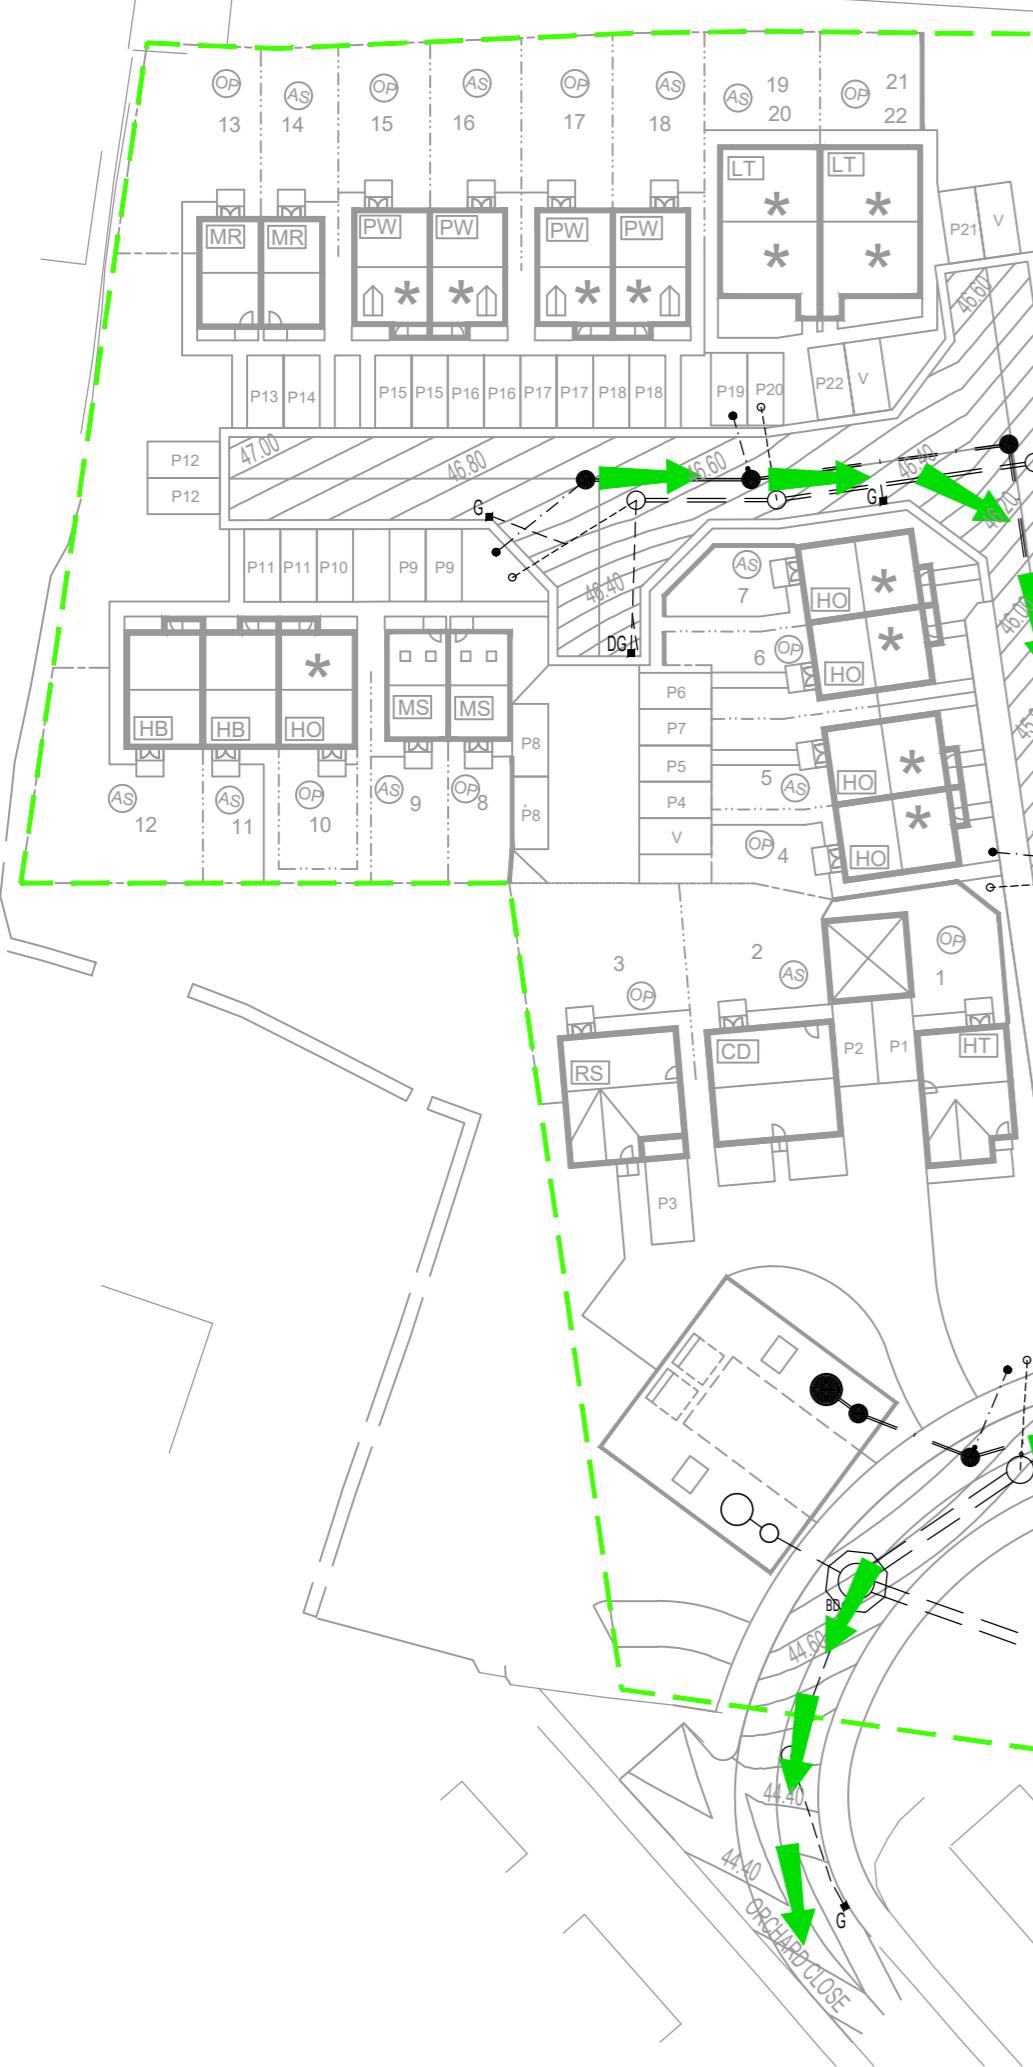
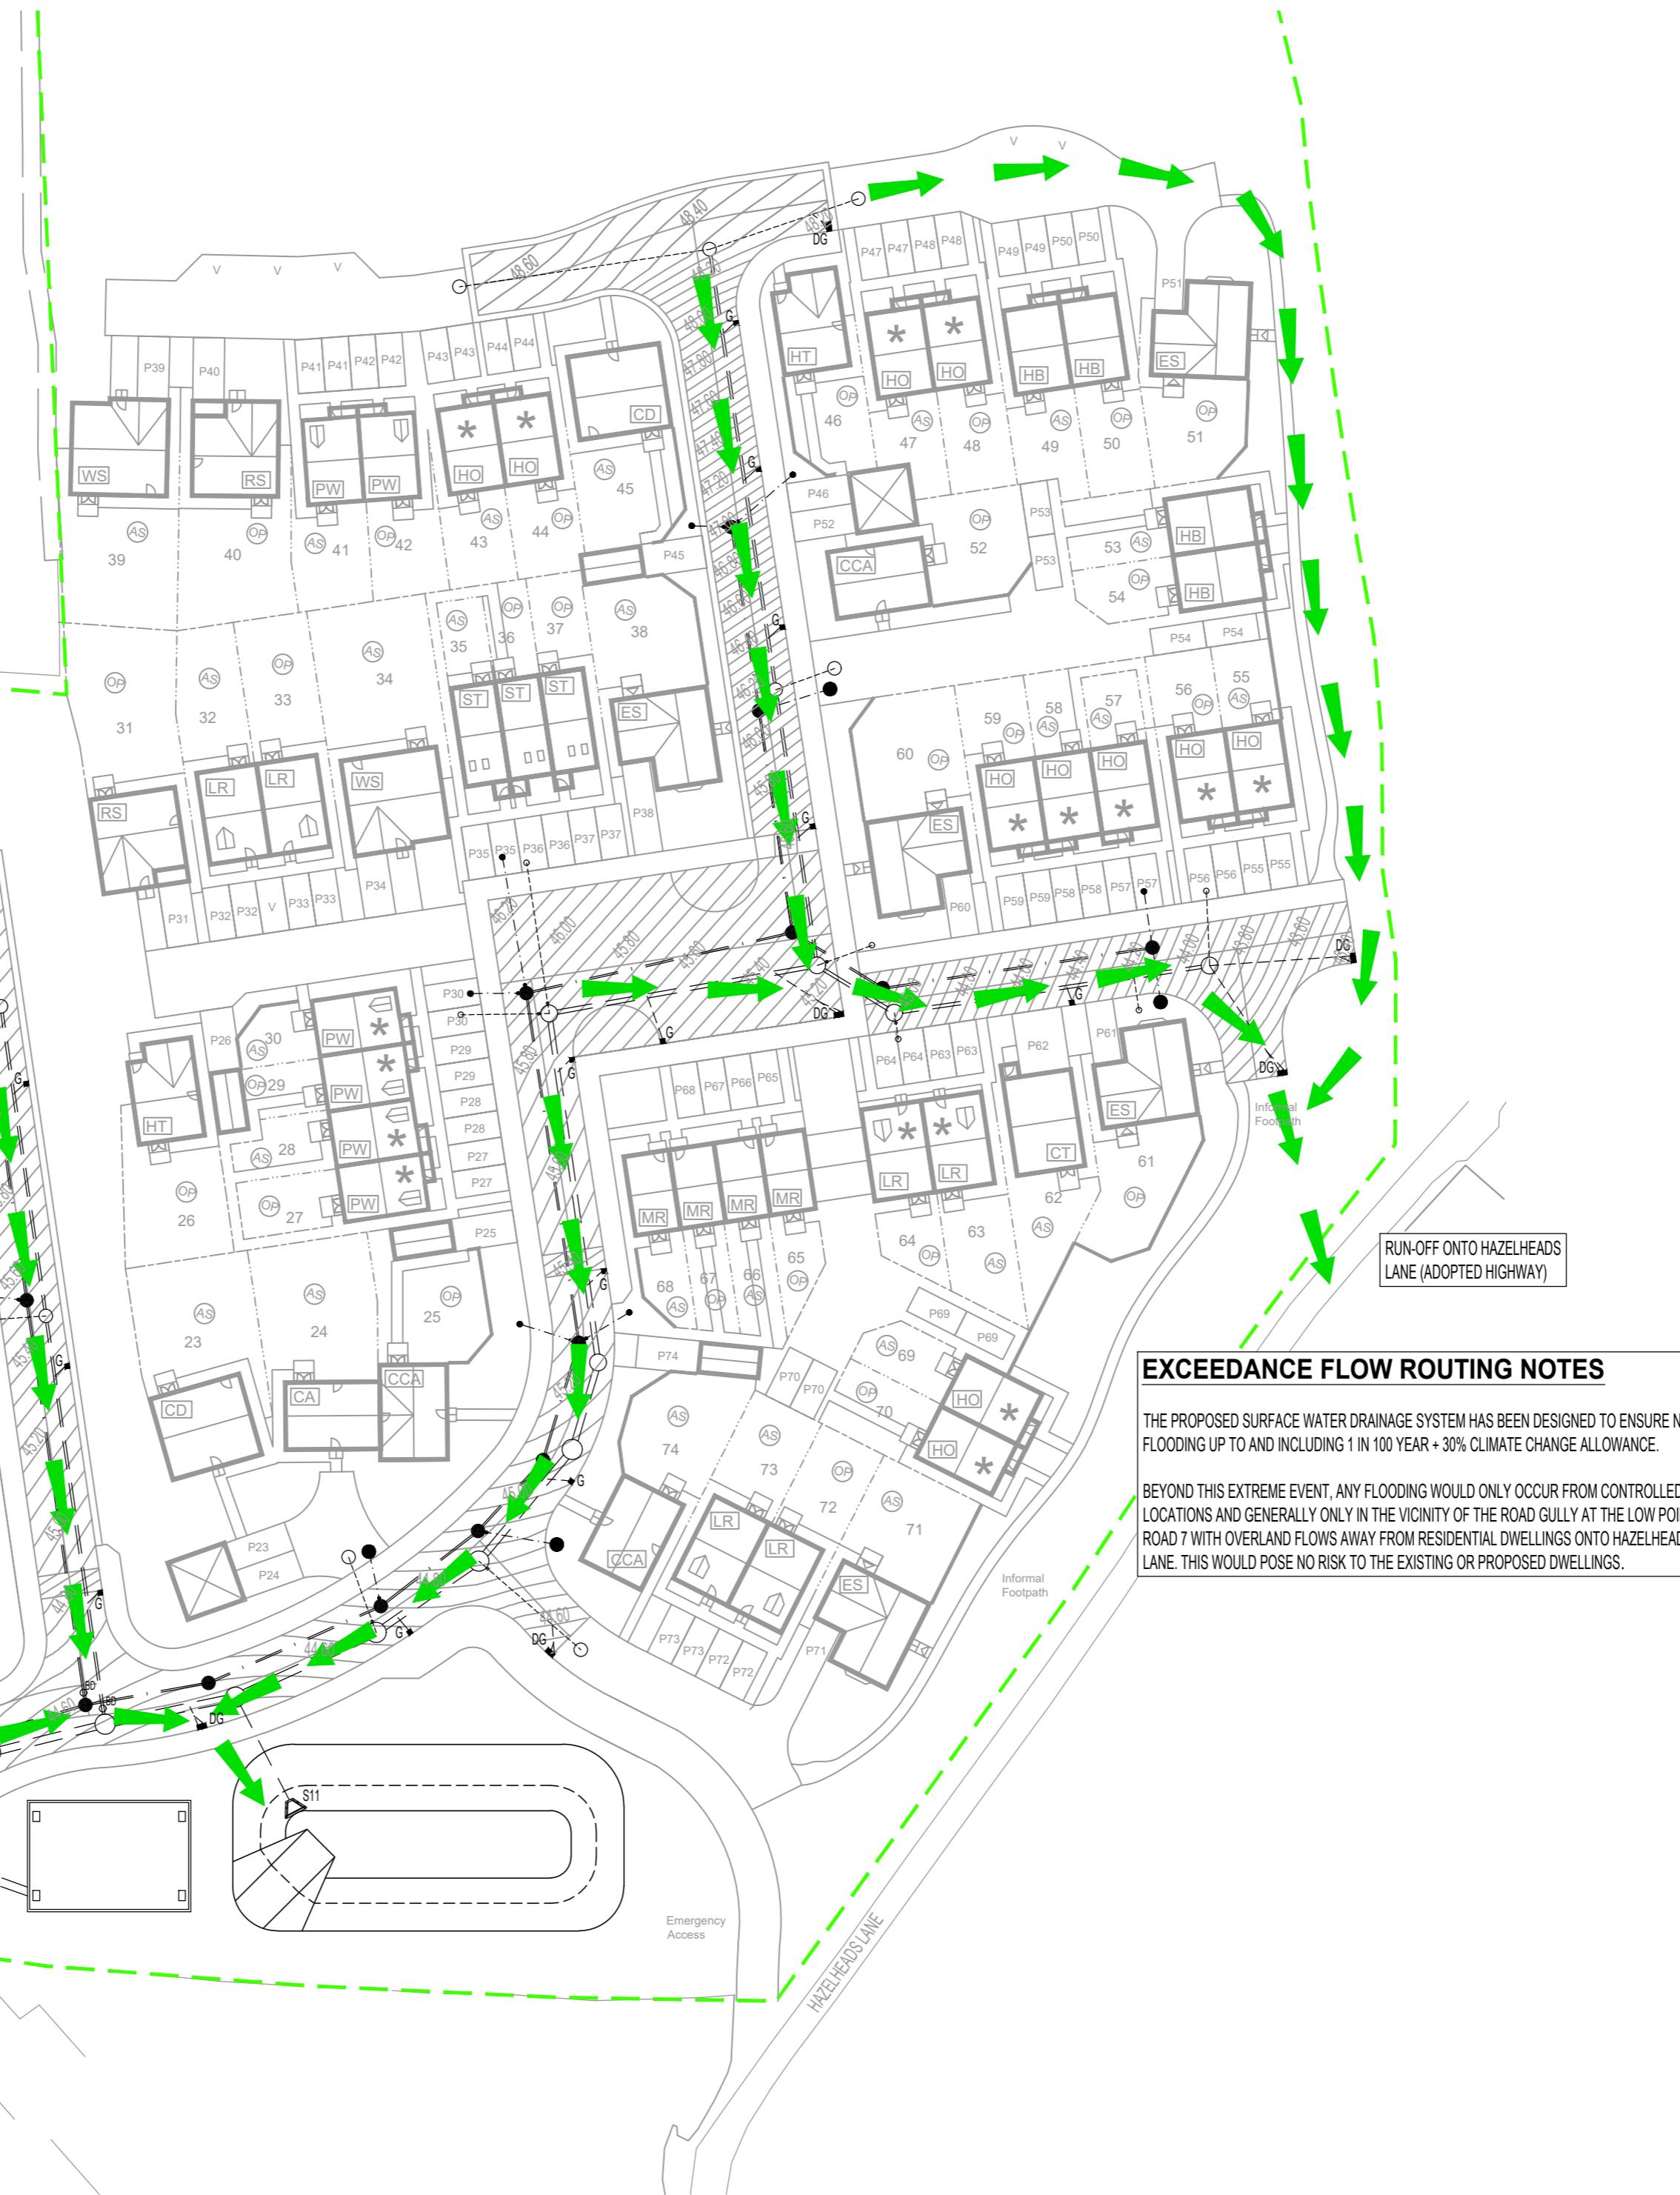
FLOW ROUTE MAPPING

THE PROPOSED SURFACE WATER DRAINAGE SYSTEM HAS BEEN DESIGNED TO ENSURE NO FLOODING UP TO AND INCLUDING 1 IN 100 YEAR + 30% CLIMATE CHANGE ALLOWANCE.

BEYOND THIS EXTREME EVENT, ANY FLOODING WOULD ONLY OCCUR FROM CONTROLLED LOCATIONS AND GENERALLY ONLY IN THE VICINITY OF THE ROAD GULLY AT THE LOW POINT OF ROAD 7 WITH OVERLAND FLOWS AWAY FROM RESIDENTIAL DWELLINGS ONTO HAZELHEADS LANE. THIS WOULD POSE NO RISK TO THE EXISTING OR PROPOSED DWELLINGS.
