NORTH YORKSHIRE COUNCIL

Notice of an application to deregister a building wrongly registered as town or village green

Application Reference Number: CA13 038

A Village Green, Langthorne (VG 217)

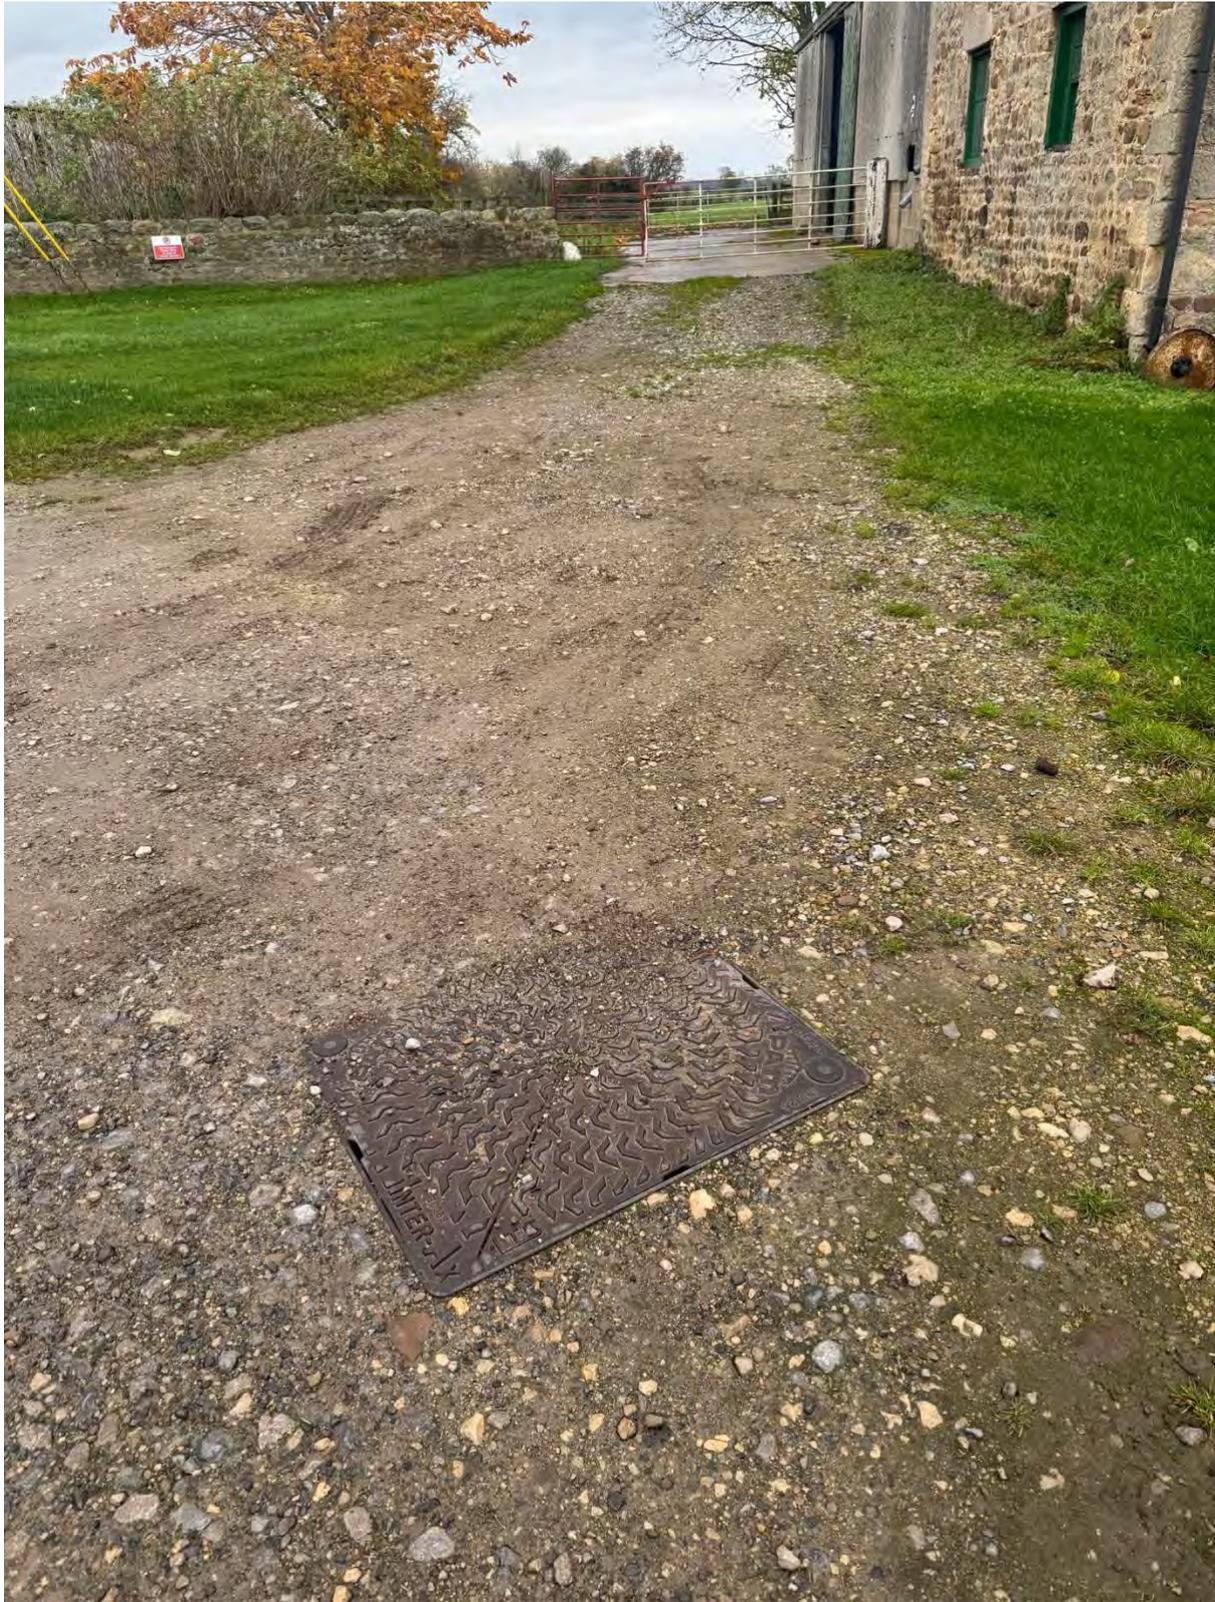
Photo 7 – service apparatus manhole shown within the access. It shows a ductile iron double inspection cover made by **Antar-Tax Ltd**, most likely installed **between about 1985 and 1995**, serving a **drainage or water access** beneath the drive. Taken 2025.

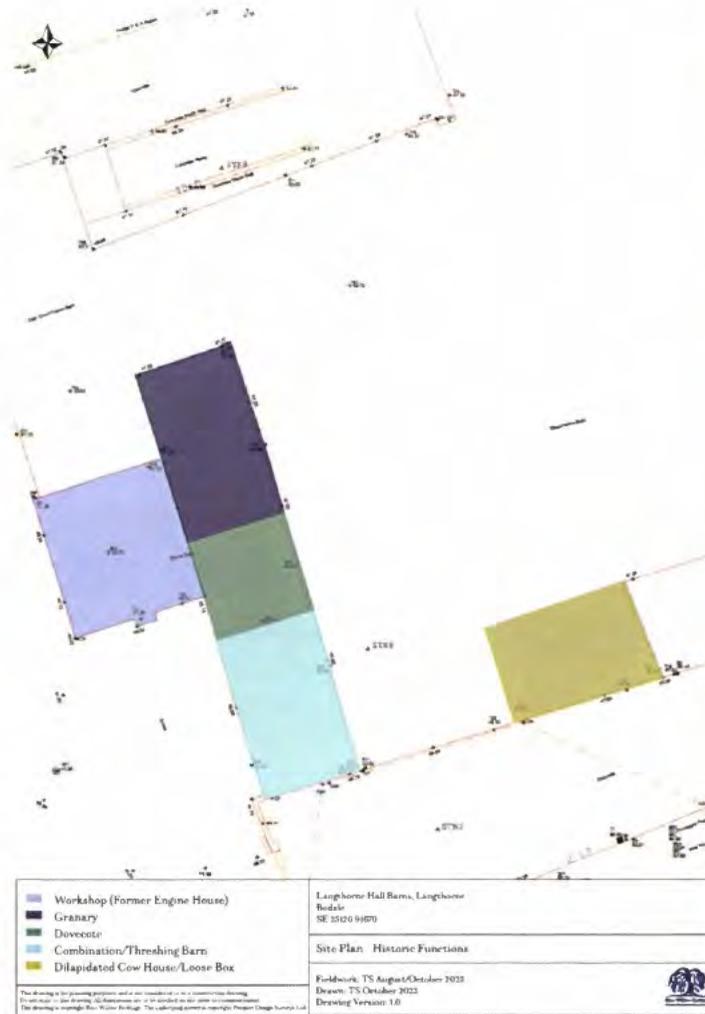
Figure 3 Site Plan - Historic Functions

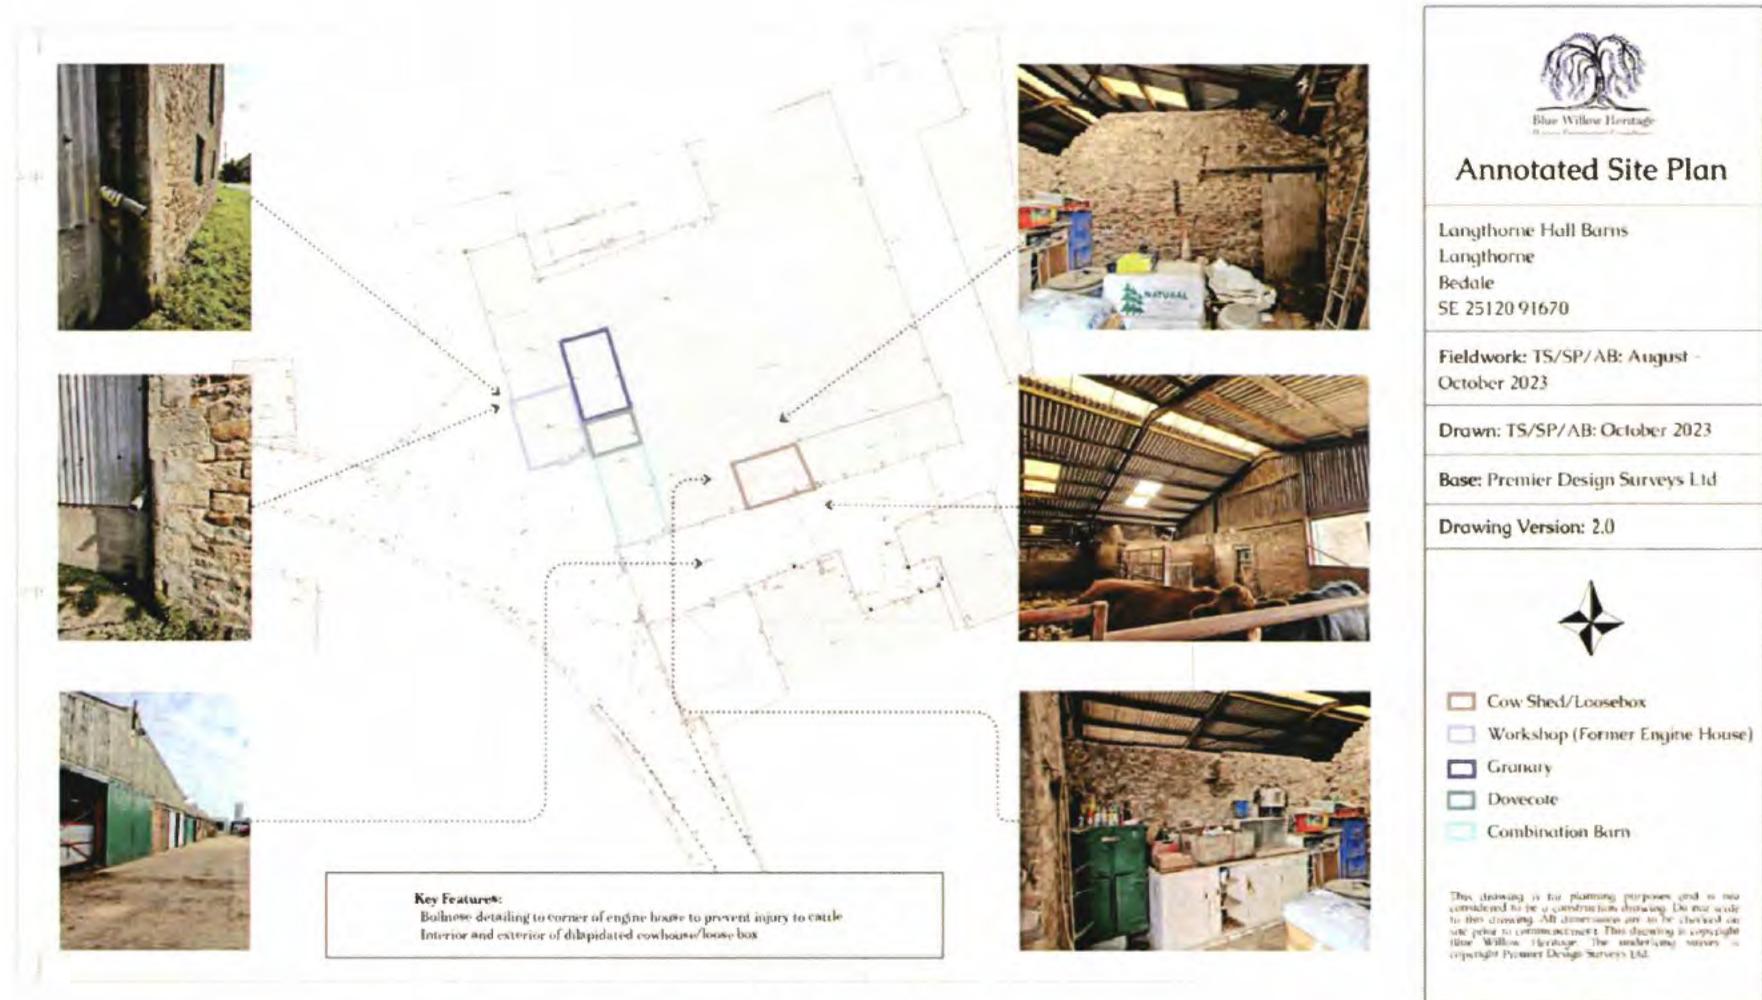
Figure 6 Annotated site plan

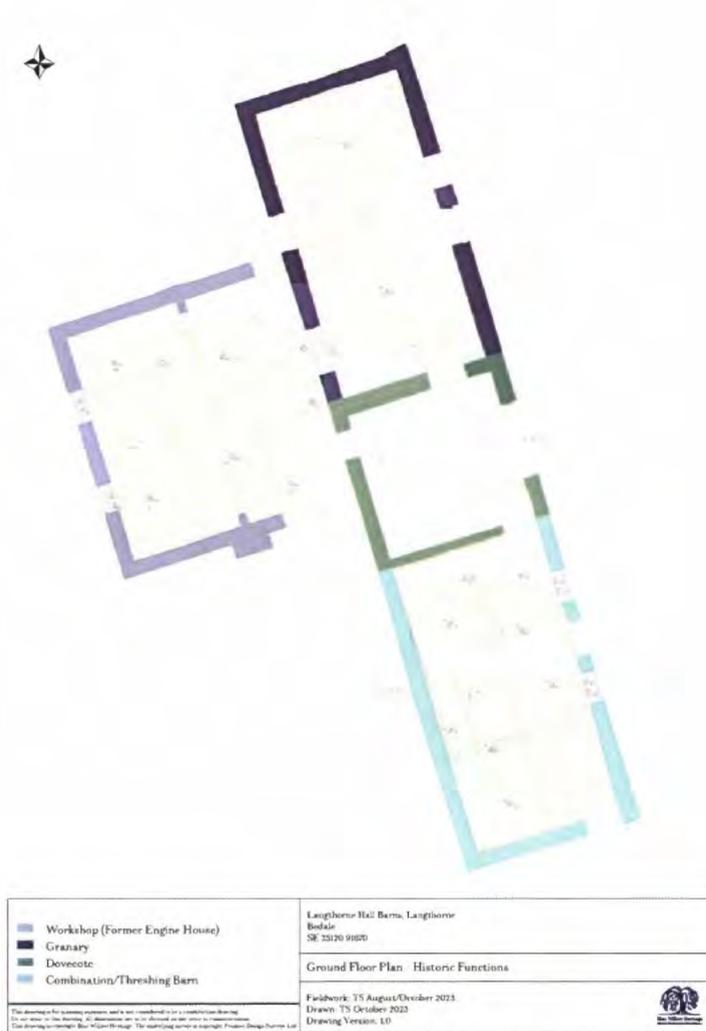
Figure 7 Ground-floor historic functions

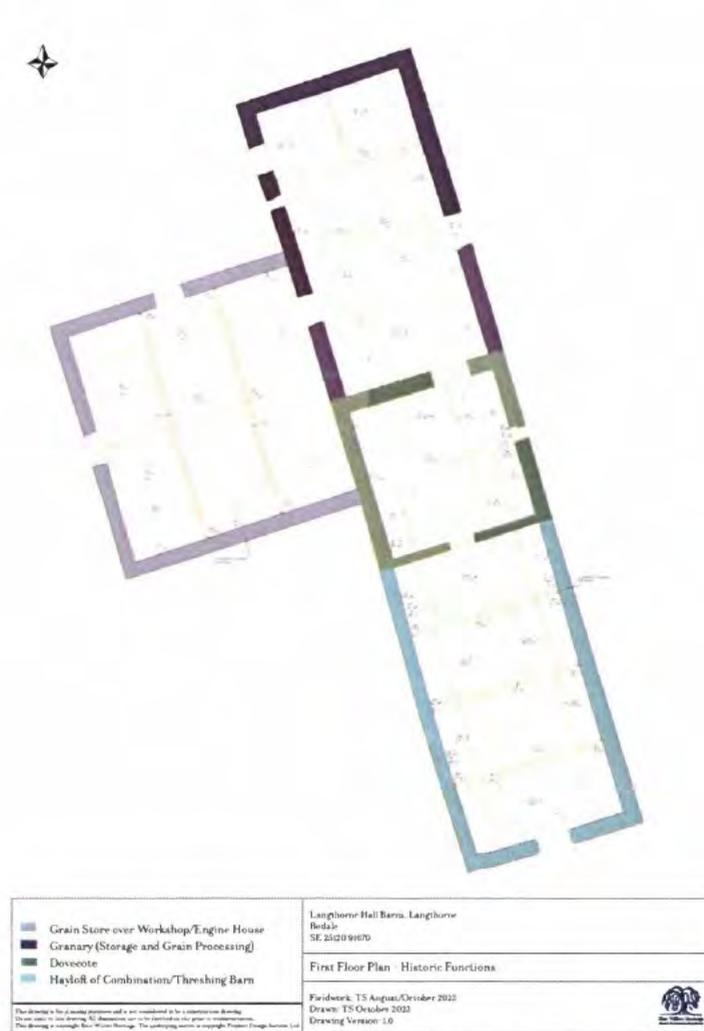
Figure 8 First-floor historic functions

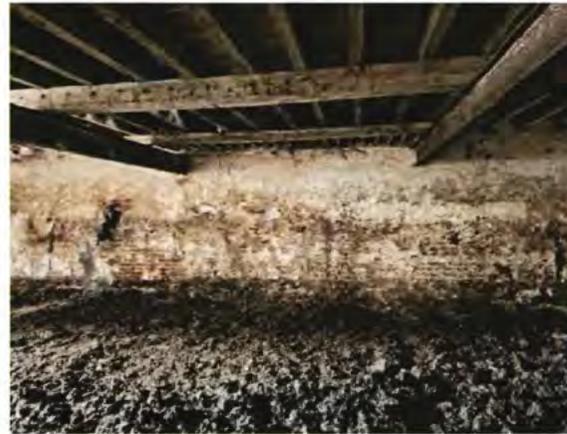
Figure 13 Interior of barn, facing west wall

Internally, the barn comprises two large rooms – one at ground-floor level and one at first-floor level. The ground floor of the barn has undergone substantial alterations, presumably to support its later use as animal housing. Whilst close internal inspection of the ground-floor space was not possible due to deep layers of soil and animal waste, precluding any visual inspection of the floor, features noted within included two inserted feeding chutes mounted to the ceiling, metal troughs, and internal views of the blocked doorway opening. Brick additions to the interior were also noted to have been rounded on the corners near the livestock entrance to the south-facing elevation – a technique often referred to as ‘blunting’ to prevent injury to livestock on entry and exit from farm buildings. Interestingly, two additional timber beams were mounted beneath the original timber ceiling which was later supported by two further RSJ beams in a perpendicular arrangement. This could correspond to increased load-bearing requirements for the feed and any machinery above.

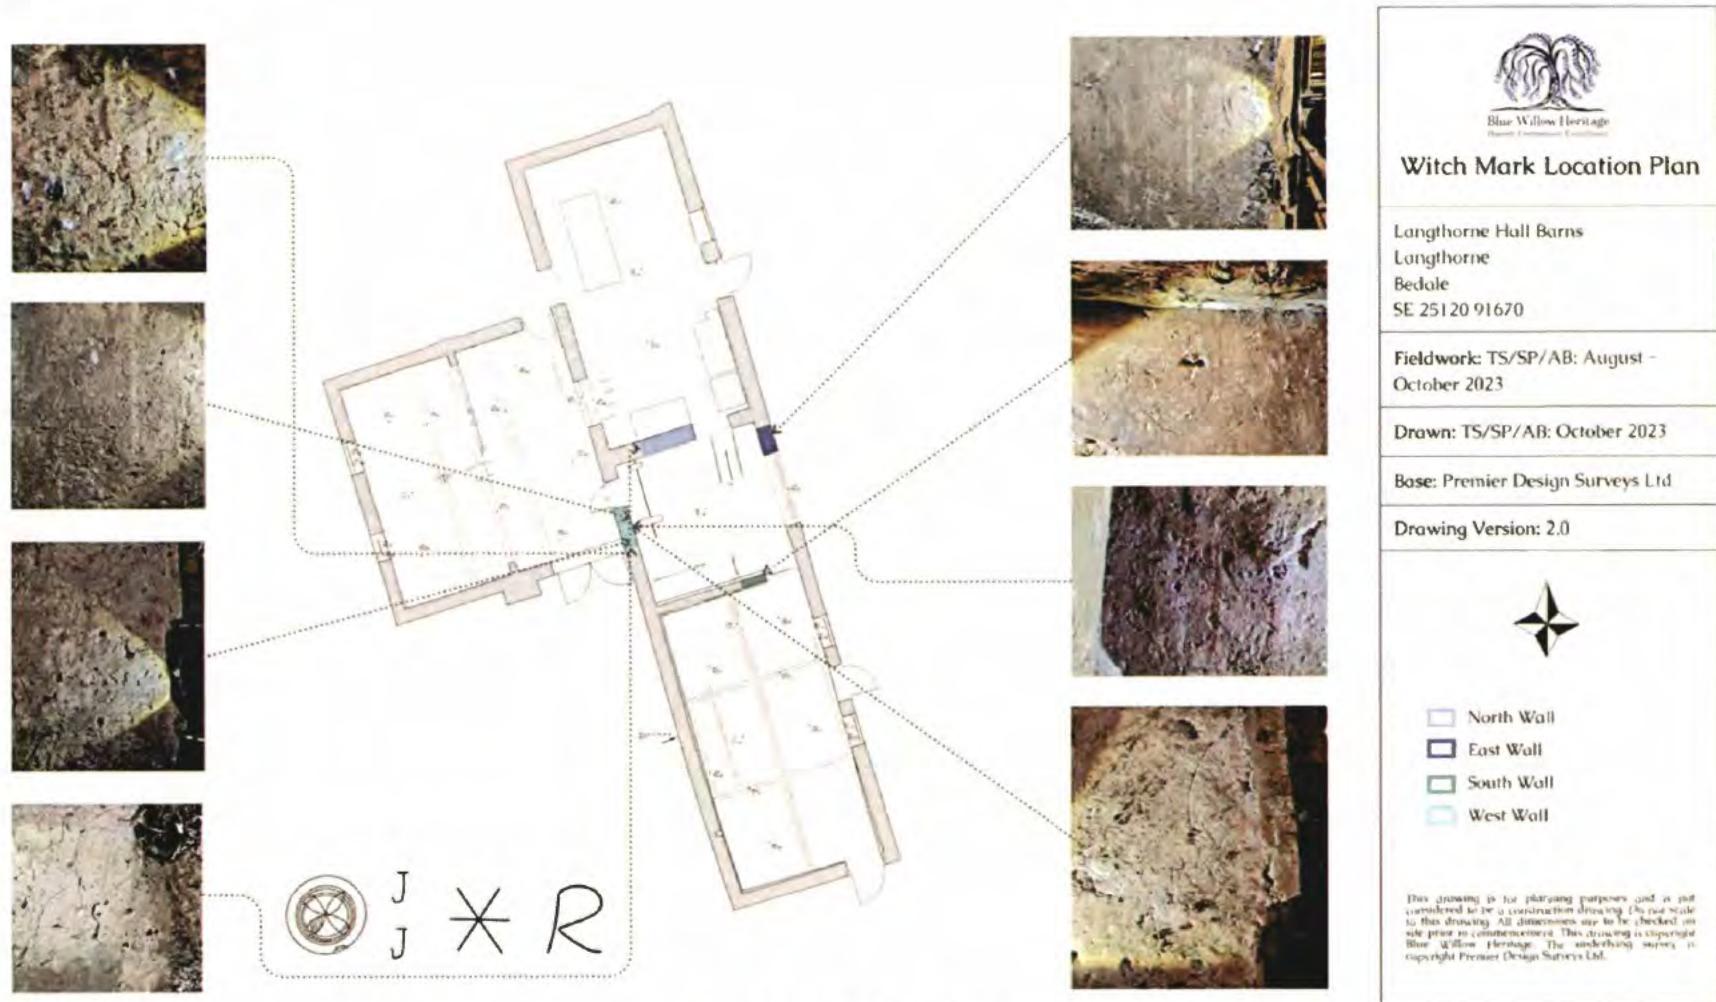
Figure 27 Witch Mark Location Plan

Finally, and perhaps most significantly, the room features extensive apotropaic marks inscribed into the plasterwork on all four walls of the room at ground-floor level. A more detailed description of the history of witch marks contextualising their meaning and possible explanations for their presence in this specific building is outlined in Section 2.10.3. The most prevalent of these within the dovecote comprise overlapping hexafoils contained within concentric circles, several of which feature hatched detailing to the petals and outer bands. Other markings, including a mason's mark and other symbols, such as several examples of the letters 'J' and 'R', are also present. The most impressive examples survive on the north wall to the left of the doorway and on the west wall to the left of the doorway. Sections of hexafoils are cut along the western wall, providing further evidence that the doorway to the right is a later insertion. The apotropaic marks vary in terms of condition and legibility but on the whole, comprise an exemplar surviving feature of this type.

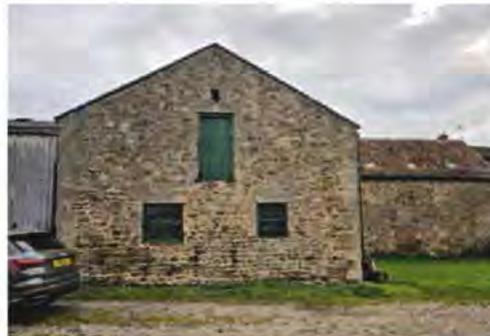
Figure 28 West-facing elevation of former engine house

which appear to be historic, if not original, comprising an eight-pane sash window to the right and a six-paned window to the left. Both windows sit beneath stone sills, although the one above the latter is partially damaged. The left window also features brick detailing. Interestingly, the quoining at the north-western extent of the building features blunted stonework to roughly the height of a cow, again to prevent injury to cattle when being herded in either direction. At first-floor level is a centrally placed hayloft door which also sits beneath a stone lintel and, as with the other surviving door openings, has a vertical planked timber door painted in the characteristic green shade found throughout.

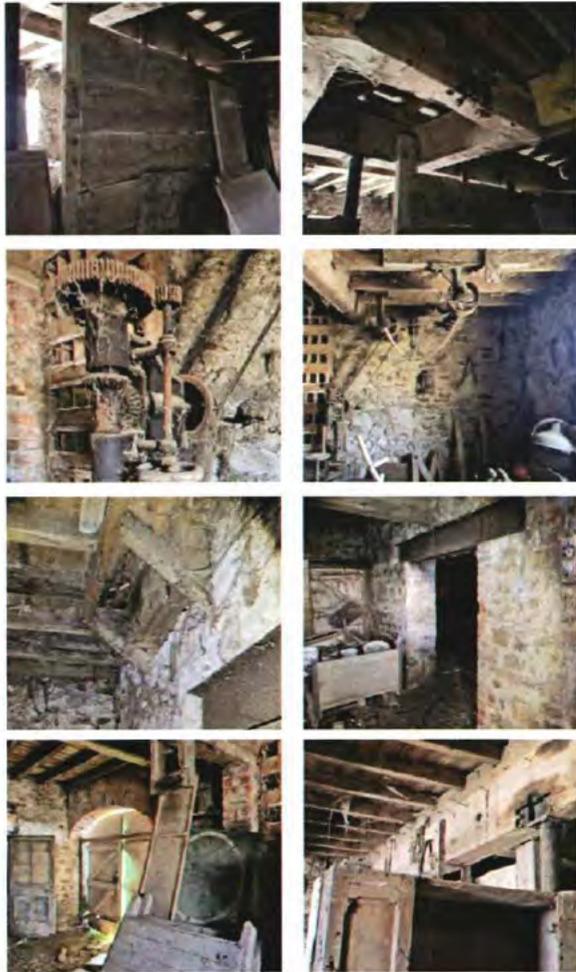
Figure 41 Key features within former engine house (GF)

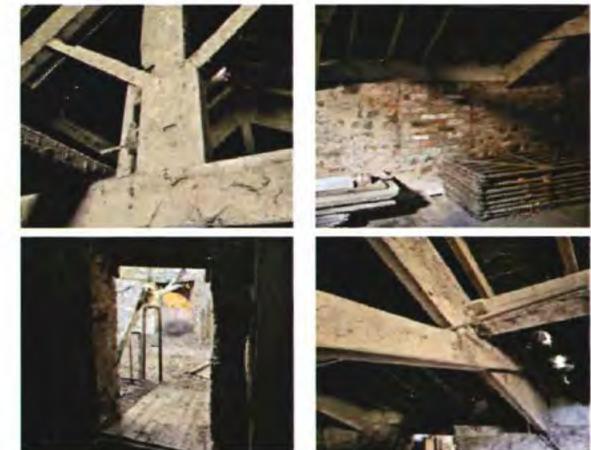
Figure 45 Key features within former engine house (1F)

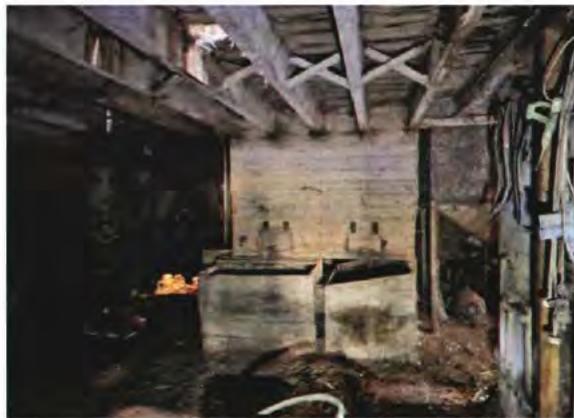
Figure 48 East wall of granary, note hoppers, grain bins, and ceiling cross noggin features

space also contains a series of more modern hoppers, chutes, and pipe networks allowing various products to be distributed throughout the farmyard complex, including through the historic timber chutes which would have originally fed into the timber grain bins below. The roof structure comprises a series of simple A-frame trusses with three large tie beams that cut across the space. The southernmost of these tie beams was noted to feature carpenter's marks and are presumed to be original to the construction of the barn, although further inspection of the remaining beams was precluded due to safety concerns. The timbers appear to be in good condition, although given that a large part of the roof coverings are missing and the building has been open to the elements for some time, some of the purlins have visibly perished and a detailed timber survey is recommended to assess the condition of the surviving timbers.

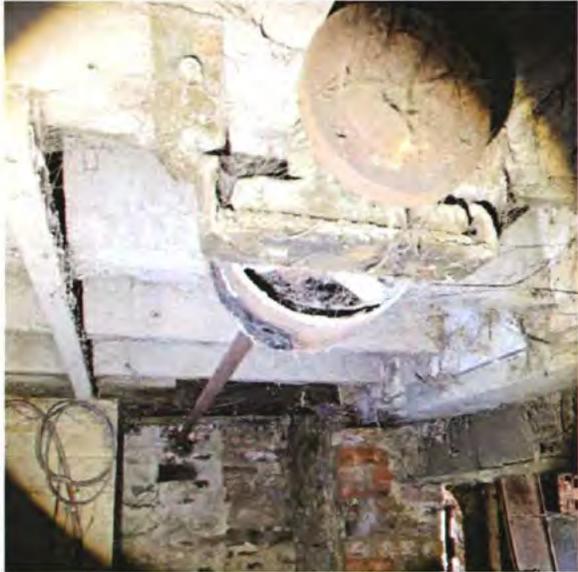
Figure 54 Fixed flywheel and turning shaft

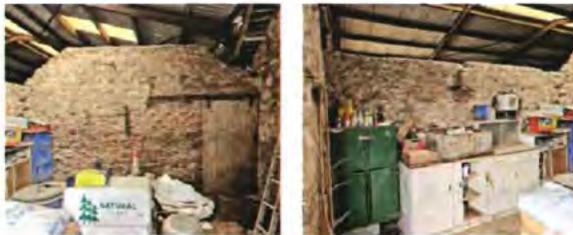
Figure 61 Internal shot of dilapidated outbuildings

The cow house and loosebox structures are in a dilapidated condition, their original roof coverings having been lost and their surviving form partially incorporated into the metal agricultural shed which covers this space. Whilst the buildings themselves hold limited evidence of former use aside from the character of the surviving openings, which remains appreciable from within the shed structure and, in part, via a single access door on the south-facing elevation, the primary significance of these buildings is derived from their spatial and historic association with the principal western range, resulting in a considerable amount of group value.

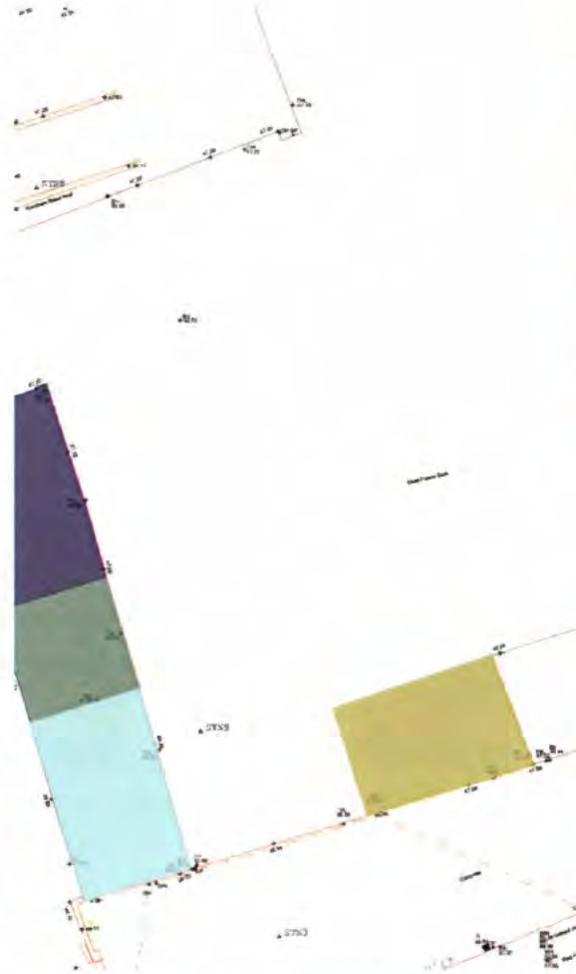
Figure 62 Location of historic dilapidated outbuildings (Olive Green)

To the east/south-east of the historic listed western range are a further series of stone-built outbuildings which, based on the typology of the surviving farmstead and evidence from surviving openings, are believed to comprise a cow house/loosebox and attached stabling/piggery, the latter of which does not form part of the proposed development and is excluded from further consideration. For the purposes of this assessment, it is considered that these structures are curtilage listed.

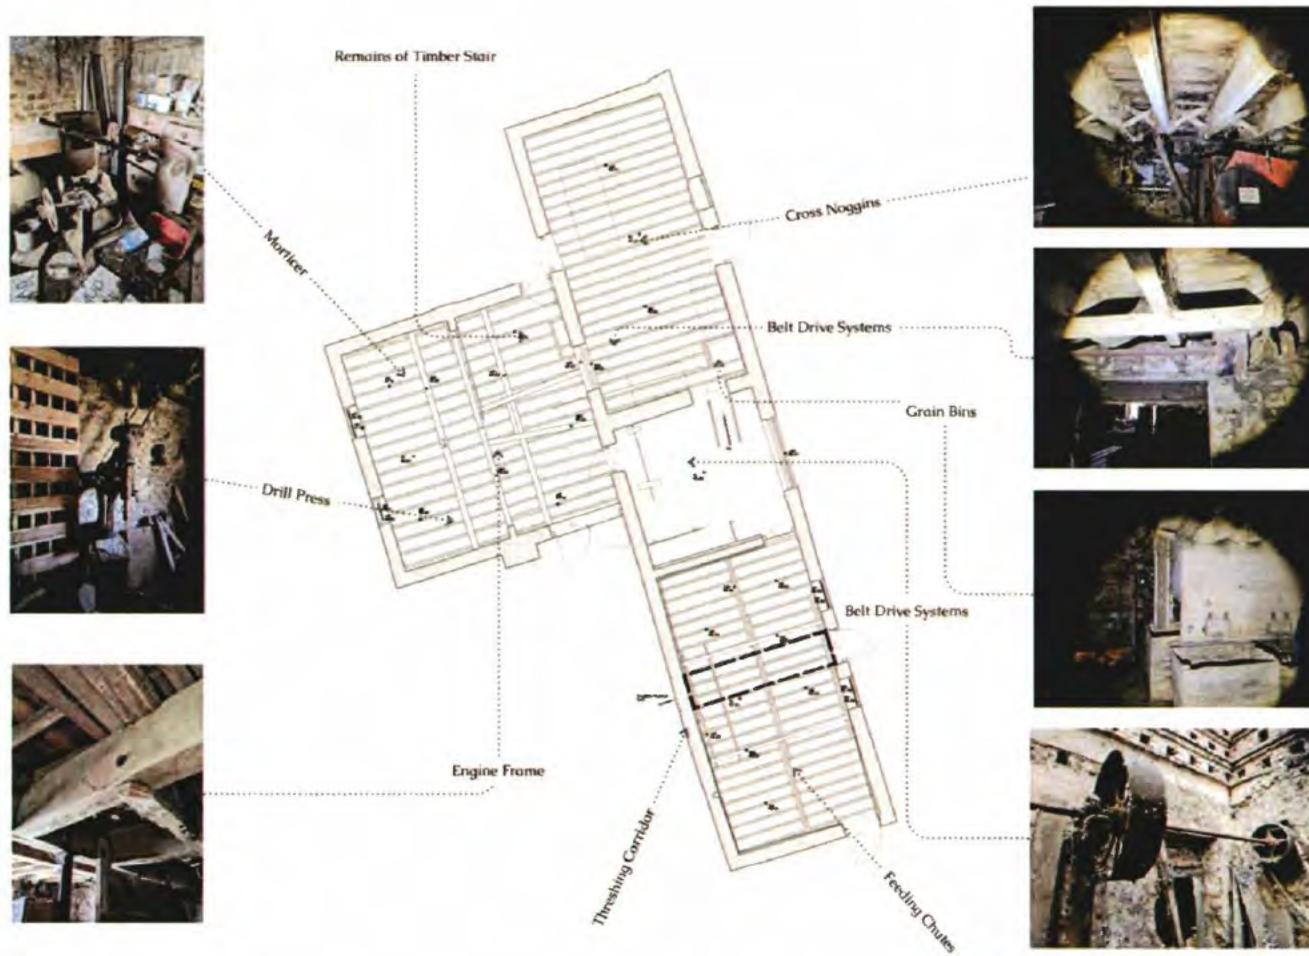
Figure 65 Ground Floor Features

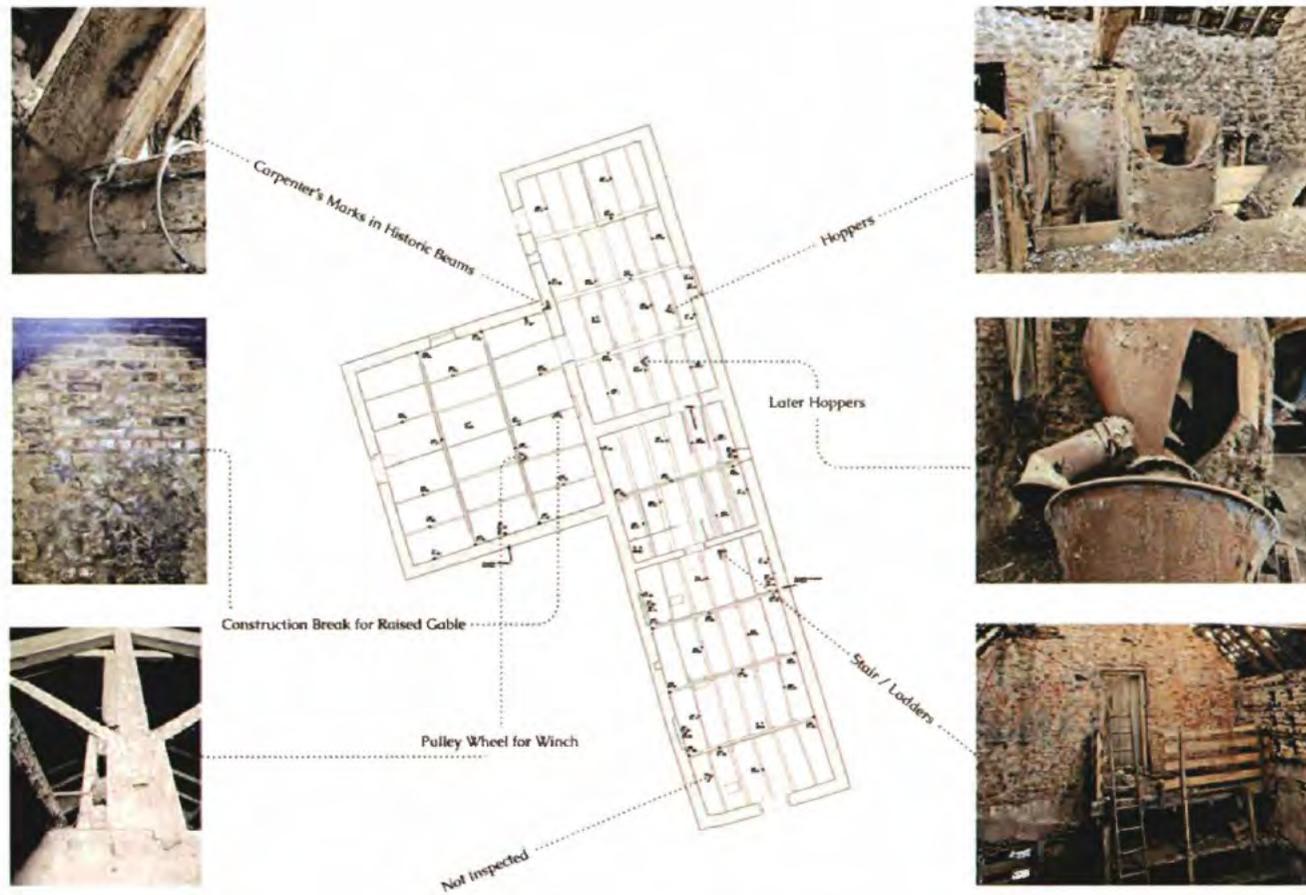
Figure 66 First Floor Features

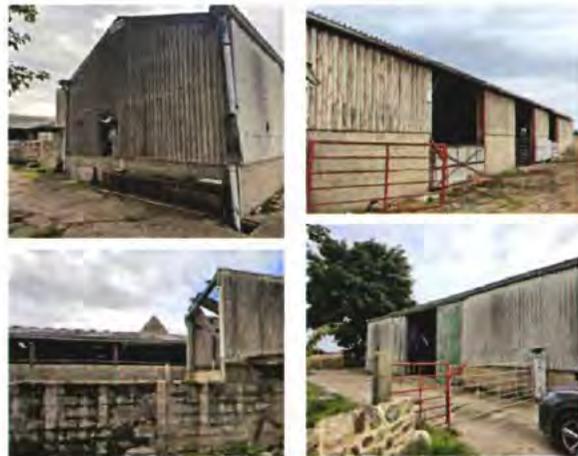
Figure 67 Example of modern agricultural sheds/outbuildings

As previously noted, the proposed development site features several modern agricultural outbuildings and sheds, constructed in a mix of breezeblock and metal framing, situated atop concrete footings. These structures are entirely modern, dating to the mid-to-late 20th century and as such, are considered to hold no heritage value. Indeed, given that they obscure the entirety of the east-facing elevation and the majority of the north-facing elevation of the historic barn, as well as the remains of the historic cow house/loosebox, the modern agricultural sheds are considered to detract from the character and appearance of the listed farm buildings, and consequently from their setting and significance, as well as that of the neighbouring Grade II listed Langthorne Hall.
