WEST PIER

RENOVATION AND IMPROVEMENT

BUILDING 1

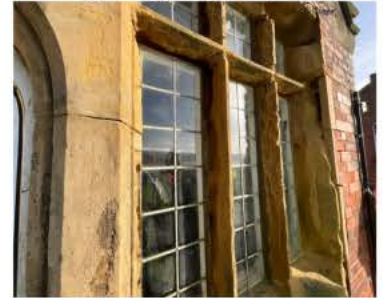
Building 1 Features - Existing weathered stone

- Repair and stabilise the building - notably the roof, windows and doors.
- Reinstatement of the original fenestration to improve the appearance of the North-East elevation and views of the harbour.
- Retain the historic character.
- Create flexible space for future use, accommodating commercial services.
- Improve resilience to coastal conditions - installing flood resilience measures.
- Relocate the toilets to a new purpose-built facility on the pier.

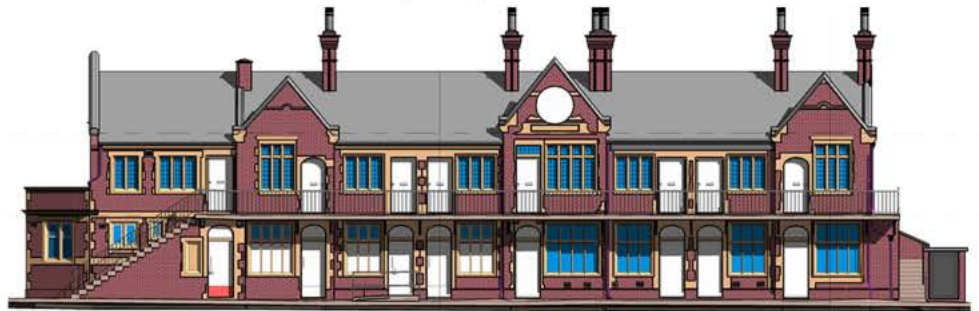
Existing South West Elevation

Existing windows to be reinstated
