Crack and Level Monitoring

Date of Issue: 18/07/2024

Address: 50 Dragon Parade, Harrogate, North Yorkshire, HG1 5DQ

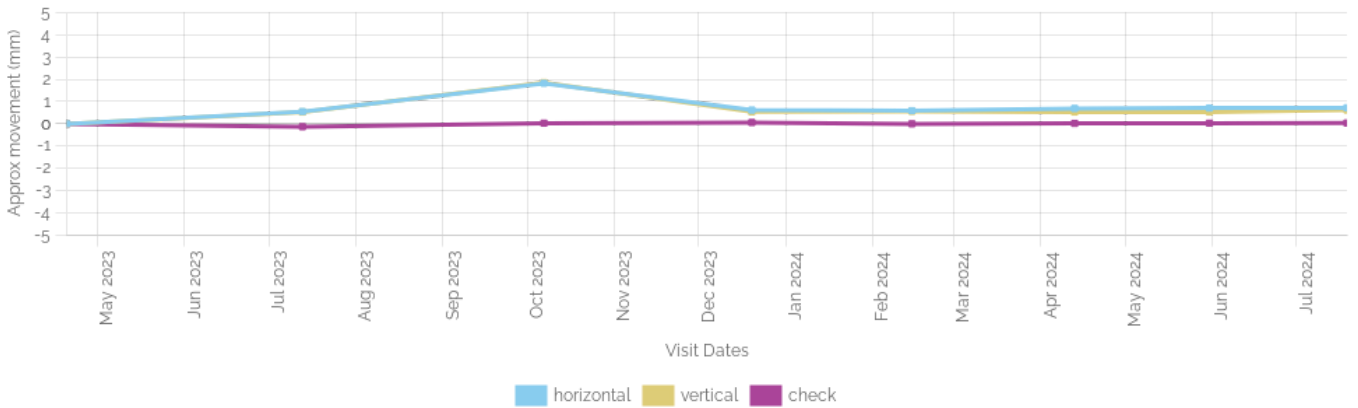
Internal right hand side party wall - Crack Readings Differences (Displayed in Millimetres)

Visit 1	Visit 2	Visit 3	Visit 4	Visit 5	Visit 6	Visit 7	Visit 8
	19/04/23	12/07/23	06/10/23	19/12/23	14/02/24	12/04/24	30/05/24	18/07/24
H	0	0.55	1.82	0.62	0.59	0.69	0.71	0.72
V	0	0.53	1.85	0.54	0.56	0.53	0.53	0.62
C	0	-0.13	0.03	0.06	0	0.02	0.03	0.04

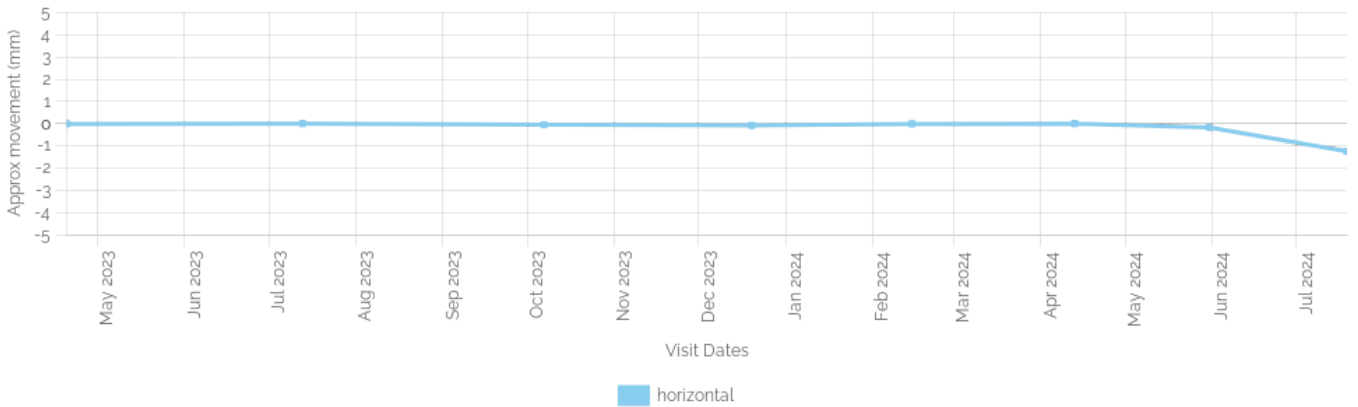
Internal front bedroom right hand side party wall - Crack Readings Differences (Displayed in Millimetres)

Visit 1	Visit 2	Visit 3	Visit 4	Visit 5	Visit 6	Visit 7	Visit 8
	19/04/23	12/07/23	06/10/23	19/12/23	14/02/24	12/04/24	30/05/24	18/07/24
H	0	0.01	-0.04	-0.07	0	0.01	-0.16	-1.23

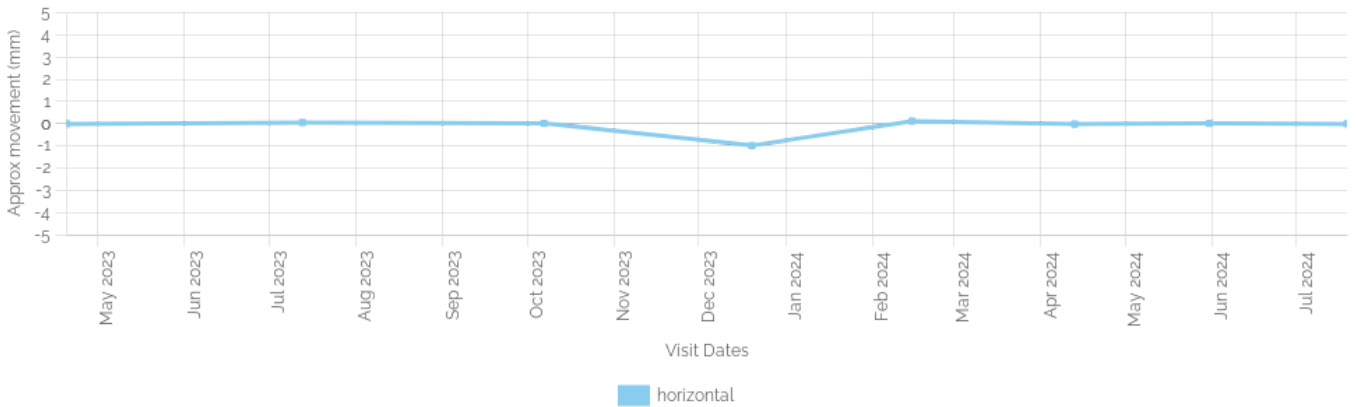
Internal front bedroom external wall left of window - Crack Readings Differences (Displayed in Millimetres)

Visit 1	Visit 2	Visit 3	Visit 4	Visit 5	Visit 6	Visit 7	Visit 8
	19/04/23	12/07/23	06/10/23	19/12/23	14/02/24	12/04/24	30/05/24	18/07/24
H	0	0.06	0.02	-0.97	0.12	-0.01	0.02	-0
