With reference to:
1823 Jurassic Limestone (extension of existing quarry): MJP12 (Whitewall Quarry) – CURRENTLY PREFERRED
Recycling for construction, demolition and soil waste for secondary aggregates:
1824 MJP13 (Whitewall Quarry) – CURRENTLY PREFERRED
1825 Materials Recycling: WJP09 (Whitewall Quarry) – CURRENTLY DISCOUNTED

MJP12; MJP13 and WJP09 – Whitewall Quarry

HYDROGEOLOGY REPORT
AT
WHITEWALL QUARRY
NORTON
FOR
MALTON RACING ASSOCIATION
REPORT REF: MRA 3150

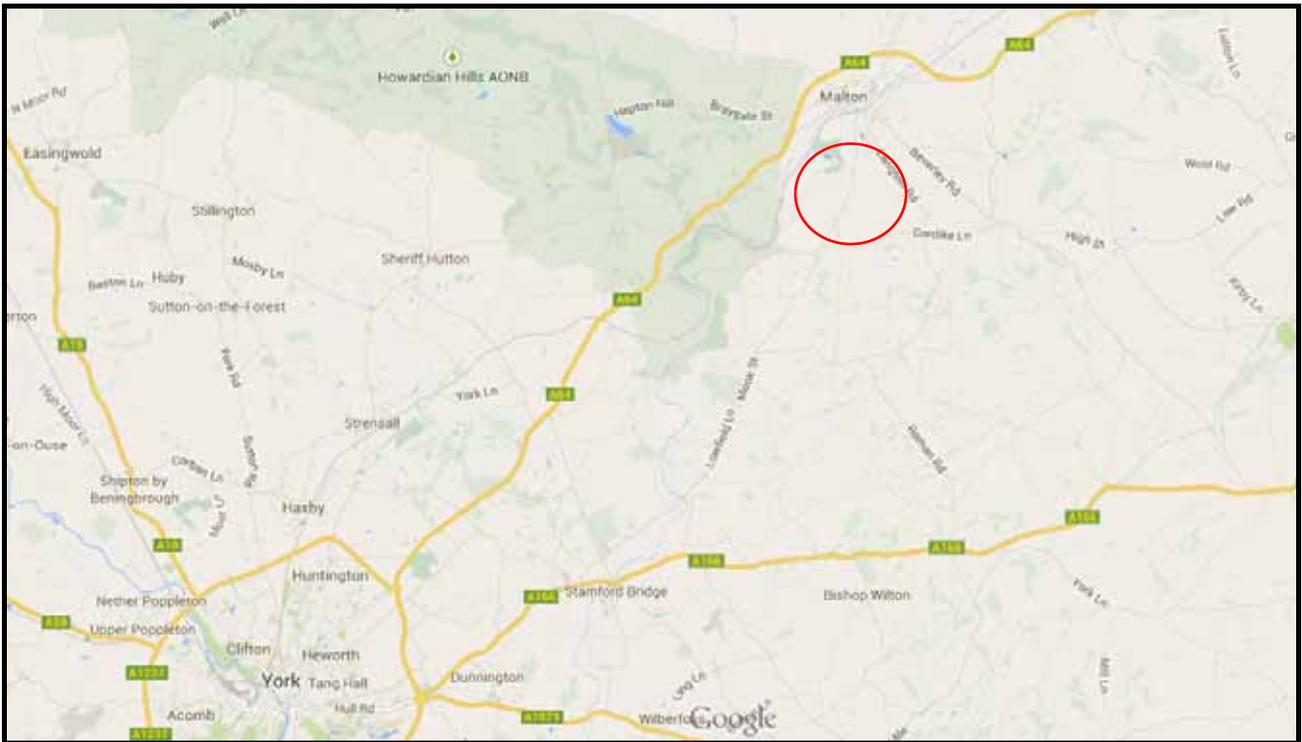
Figure 1 Site Location Plan

The entrance to the site for the proposed plant can be found off Whitewall Corner Hill south of the village of Norton on Derwent in North Yorkshire. The site of the quarry lies on the east side of the road which runs from Norton due south to Stamford Bridge and York.

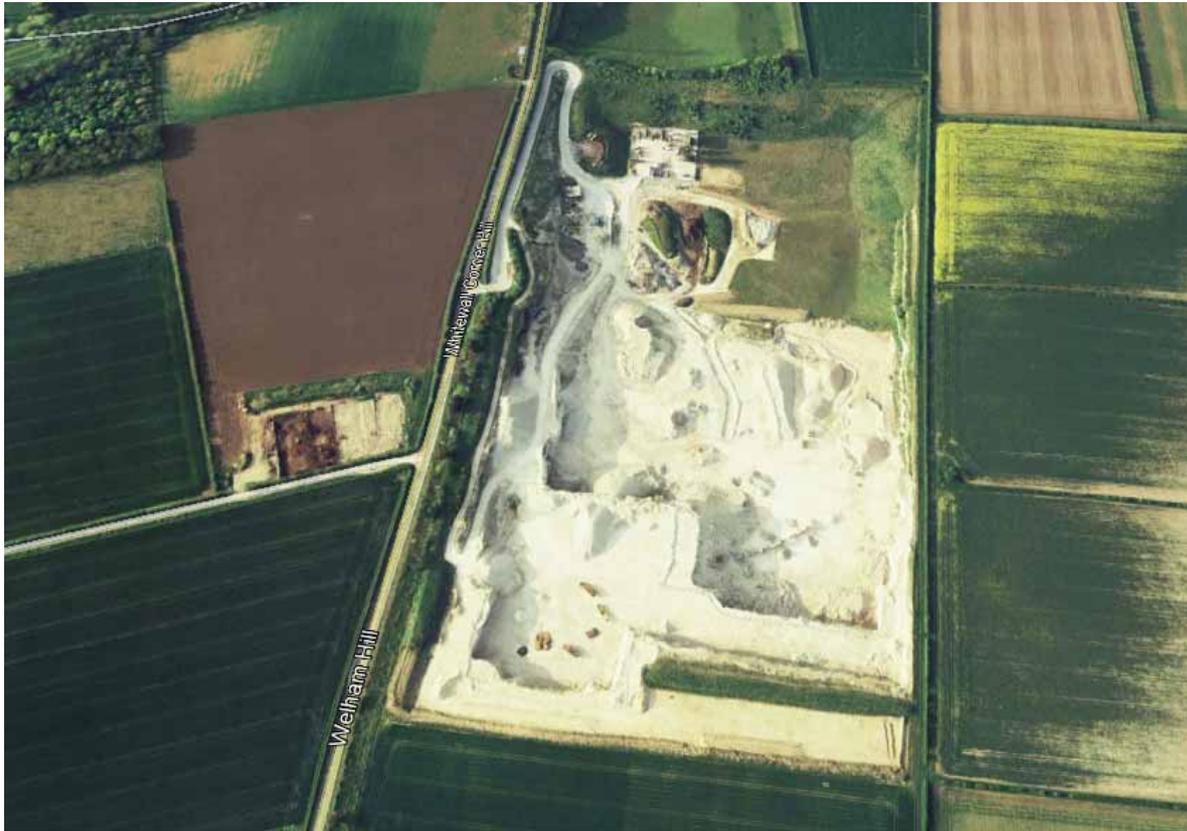
Figure 2 Site Plan

The site is bounded to the north by open fields, once quarried and Whitewall Stables. The site is bounded to the west by Whitewall Corner Hill and open fields with Welham Hall and fish ponds and golf courses to the west.

The site is bounded to the east by open fields with Wold House and other Stables beyond. The site is bounded to the south by open fields.

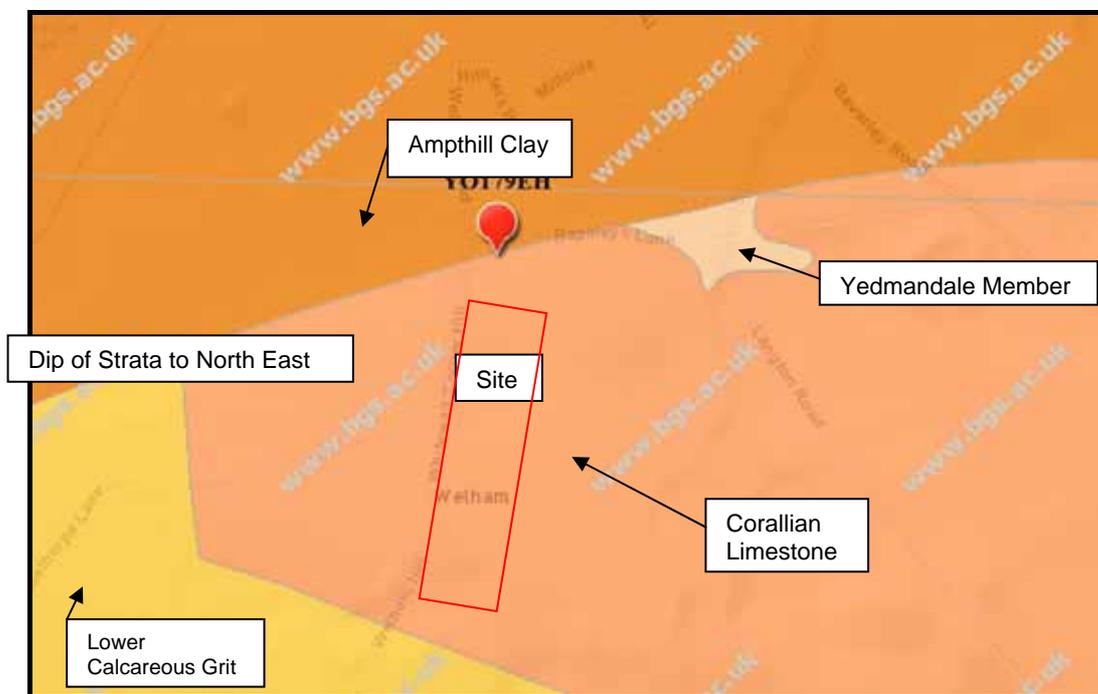
A simplified plan of the geology on and in the vicinity of the site is presented in Figure 4 Geology Plan of Bedrock and in Figure 5 Geology Plan of Superficial Deposits.

The Corallian Limestone is an oolitic calciferous strata of circa 30m in thickness underlain by the Calcareous Grit Sandstone also of 30m in thickness which is in turn underlain by the impermeable Oxford Clay which exceeds 110m in thickness in this area and forms an effective impermeable seal to the base of the permeable strata.

The Corallian Limestone is traversed by large and small joints generally in two directions at nearly right angles and it is thin to medium bedded both of which enhance flow of groundwater through the strata.

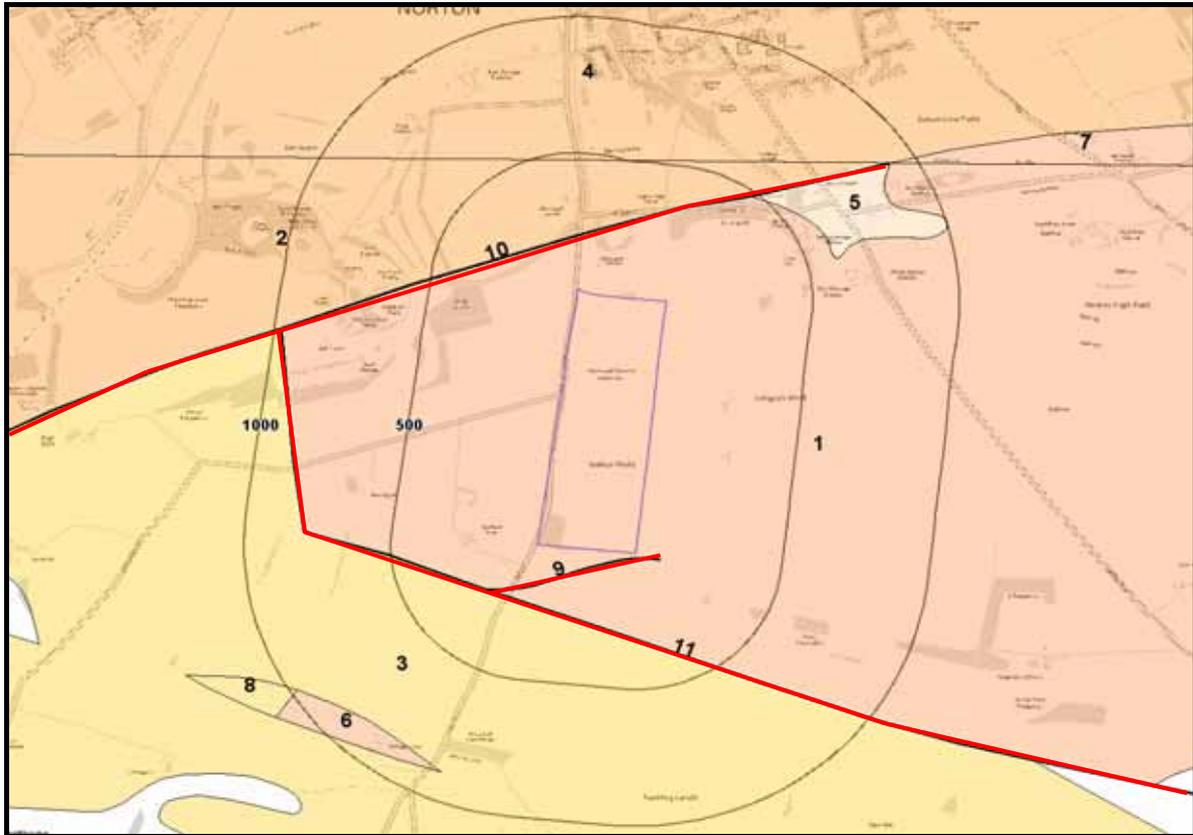
Figure 6 Local Geological Faults

There are three geological faults indicated by the BGS in the locality of the site as shown in Figure 6. These are substantial fractures in the strata that have displaced large volumes of younger strata against older strata during the Hercynian tectonic movements.

Fault 10 trends WSW to ESE and divides the Corallian Limestone from the Ampthill Clay to the north. Fault 11 trends N to S and then NW to SE dividing the Corallian Limestone from the underlying Lower Calcareous Grit. Fault 9 trends nearly west to east as an extension of Fault 11 and extends across the southern boundary of the quarry.

Further smaller faults may spur from these faults and some may cross the site. Geological faults are areas of broken ground and fractured strata caused by the ground movements and they facilitate the movement of groundwater through the strata.

"There are three geological faults indicated by the BGS in the locality of the site shown as Figure 6. These are substantial fractures in the strata ..."

"Geological faults are areas of broken ground and fractured strata caused by the ground movements and they facilitate the movement of groundwater through the strata"

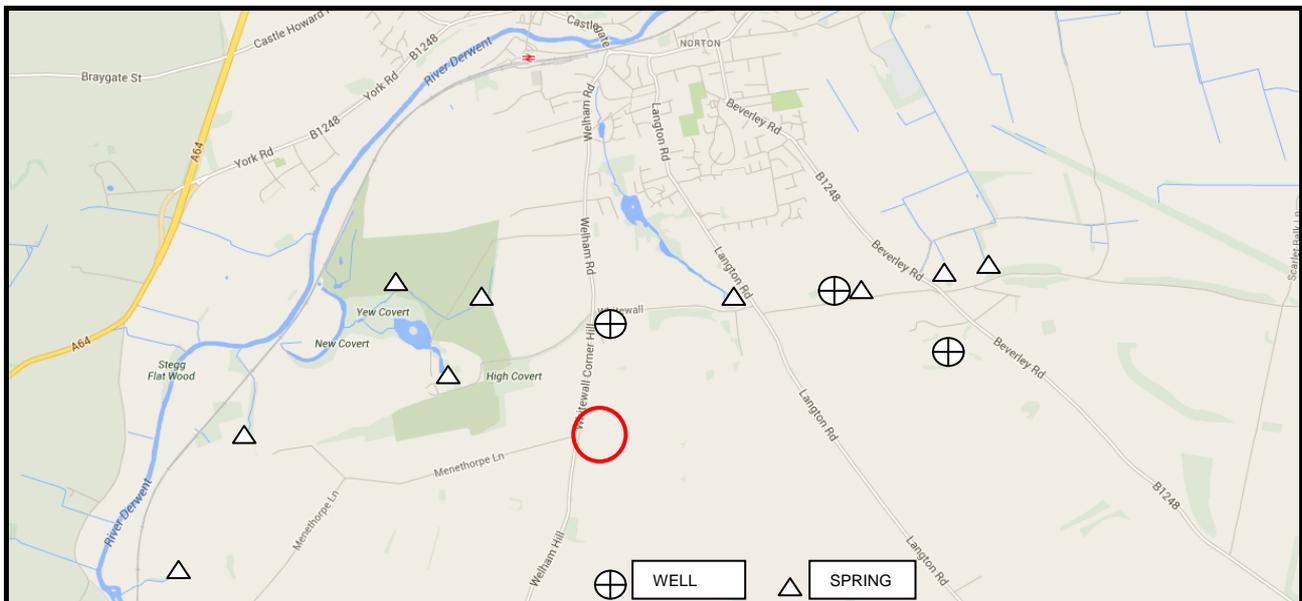
Figure 8 Hydrology Plan of Site and Environs

Surface Water Features close to the site are shown on Figure 8 and 9 and indicate the following:

The springs occur along the geological fault line that has caused impermeable strata to the north to be juxtaposed to the permeable Corallian limestone to the south. Groundwater flowing north through the Corallian therefore springs out of the ground when the impermeable strata is met.

Groundwater flow in the Corallian is to the north and west and therefore water entering the site, if polluted, may contaminate surface water which is recharged from groundwater in the Limestone and emerges as surface water as springs to the immediate north of the site.

"The springs occur along the geological fault line that has caused impermeable strata to the north to be juxtaposed to the permeable Corallian Limestone to the south. Groundwater flowing north through the Corallian therefore springs out of the ground when the impermeable strata is met."

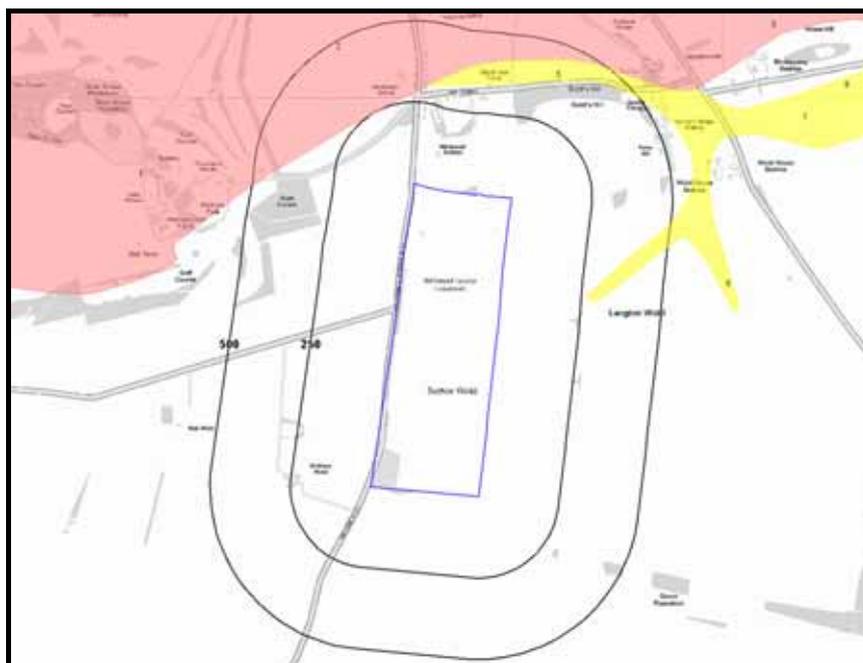
Figure 10 Secondary Aquifers in Superficial Deposits

The Environment Agency (EA) Groundwater Vulnerability maps indicate the superficial strata to the north of the site to comprise a 'Secondary (A) Aquifer'. Secondary (A) aquifers (formerly referred to as minor aquifers) are formations with permeable layers capable of supporting water supplies at local rather than strategic scale, and in some cases forming an important source of base flow to rivers. The permeable layers are the glacial sand and gravel and recent alluvium. These aquifers are unlikely to be affected by pollution from the site unless contaminated surface water flows over the aquifers.

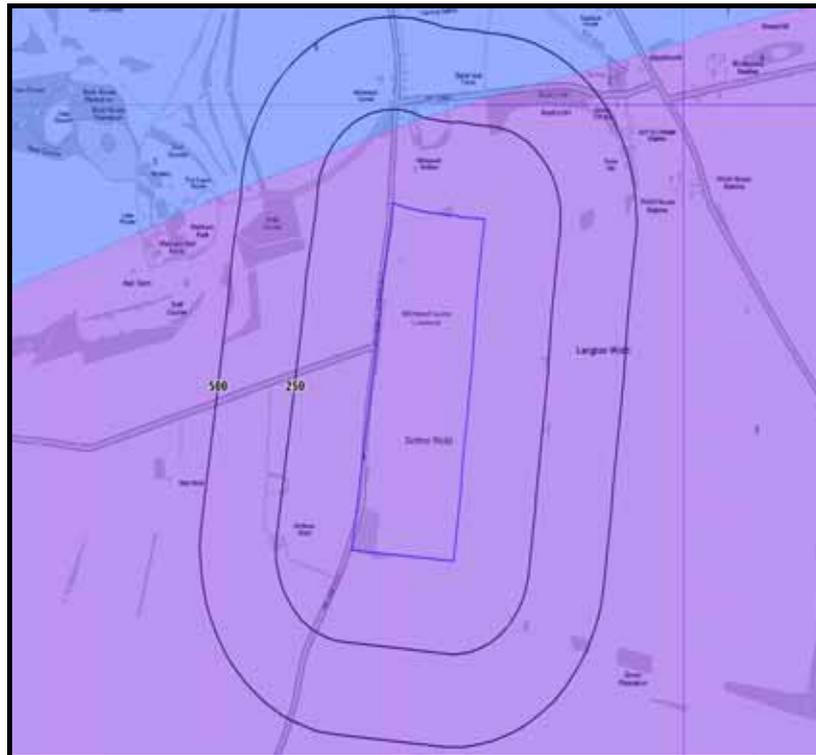
Figure 11 Principal Aquifer in Bedrock

The bedrock beneath the site is classified by the EA as a principal aquifer. These are areas of geology of high intergranular and/or fracture permeability, usually providing a high level of water storage and may support water supply/river base flow on a strategic scale.

The Corallian Limestone is highly permeable and highly fractured. Fracturing is expected to be very high in the quarry if explosives have been used for quarrying. Joints and fractures create easy pathways for surface water/groundwater to travel large distances.

"The bedrock beneath the site is classified by the EA as a principal aquifer. These are areas of geology of high intergranular and/or fracture permeability, usually providing a high level of water storage and may support water supply/river base flow on a strategic scale."

"The Corallian Limestone is highly permeable and highly fractured. Fracturing is expected to be very high in the quarry if explosives have been used for quarrying. Joints and fractures create easy pathways for surface water/groundwater to travel large distances."

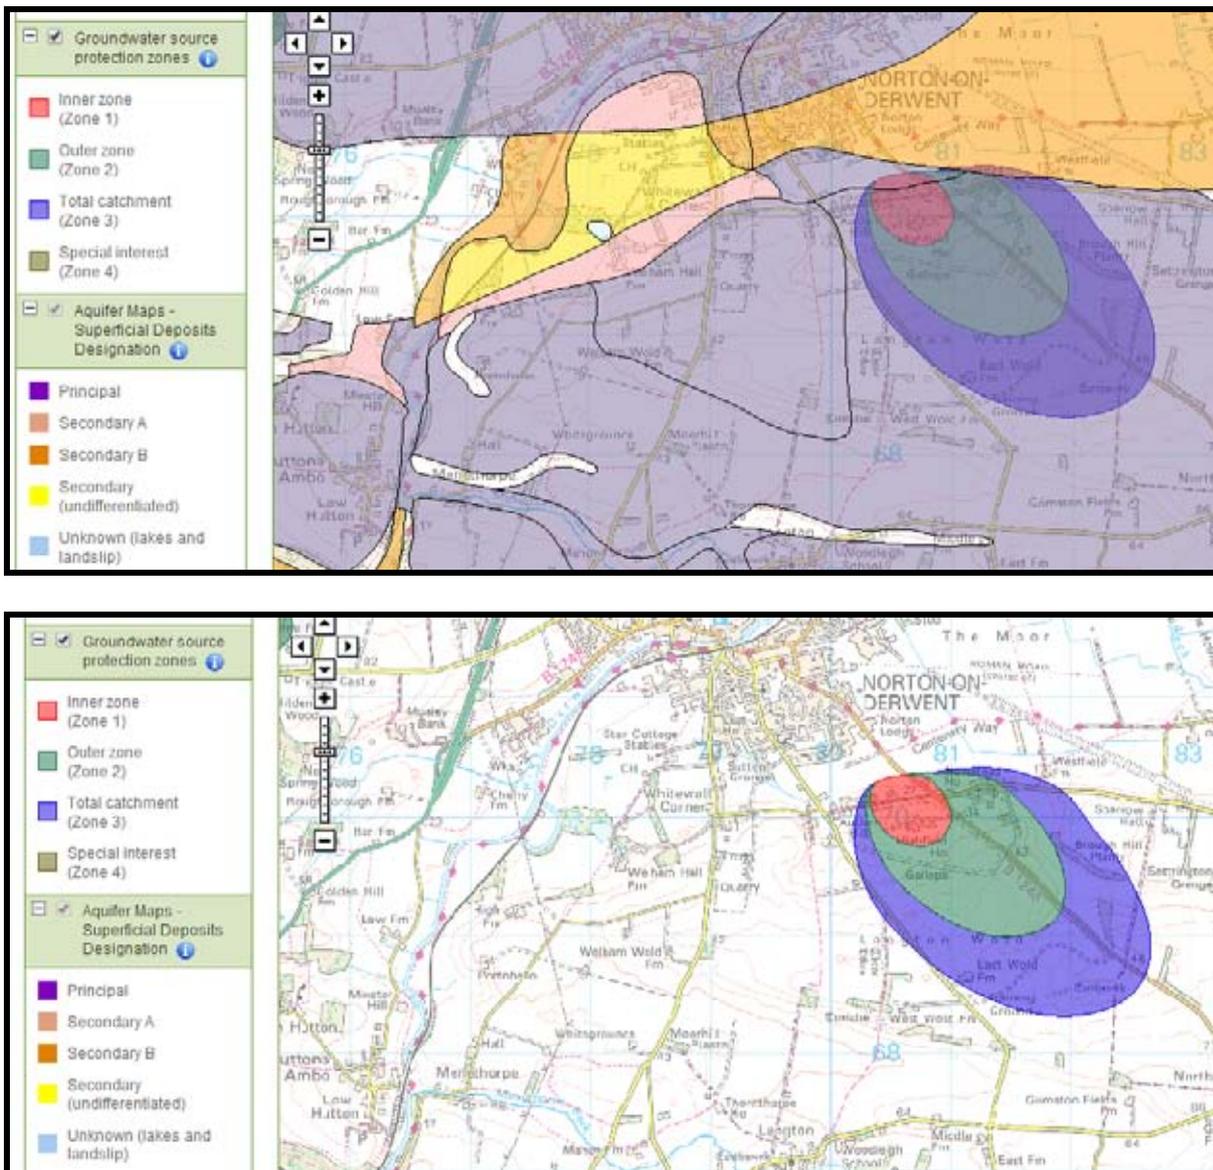
Figure 12 Source Protection Zone

The site is shown to lie within 800m of a Source Protection Zone. The protection zone extends southeastwards up hydraulic gradient from the Howe Hill public supply well, over an area that must not be used for a potentially contaminating use to protect the potable water.

The location of the Howe Hill well is close to the northern faulted edge of a large outcrop of Coralline Oolite which forms Langton Wold to the south east of Malton. The Corallian Oolite is nearly 30m in thickness and is underlain by the Calcareous Grit also 30m in thickness. These strata are water bearing and underlain by impervious Oxford Clay.

Due to the high level of abstraction from the well and the restricted recharge area to supply the well, the EA recommend that where abstraction exceeds 75% of the recharge, then the entire aquifer should be considered as a Source Protection Zone (SPZ). Due to the high vulnerability of the Principal Aquifer of Corallian Limestone it is considered that the entire outcrop of limestone should be considered a SPZ. This would include the site.

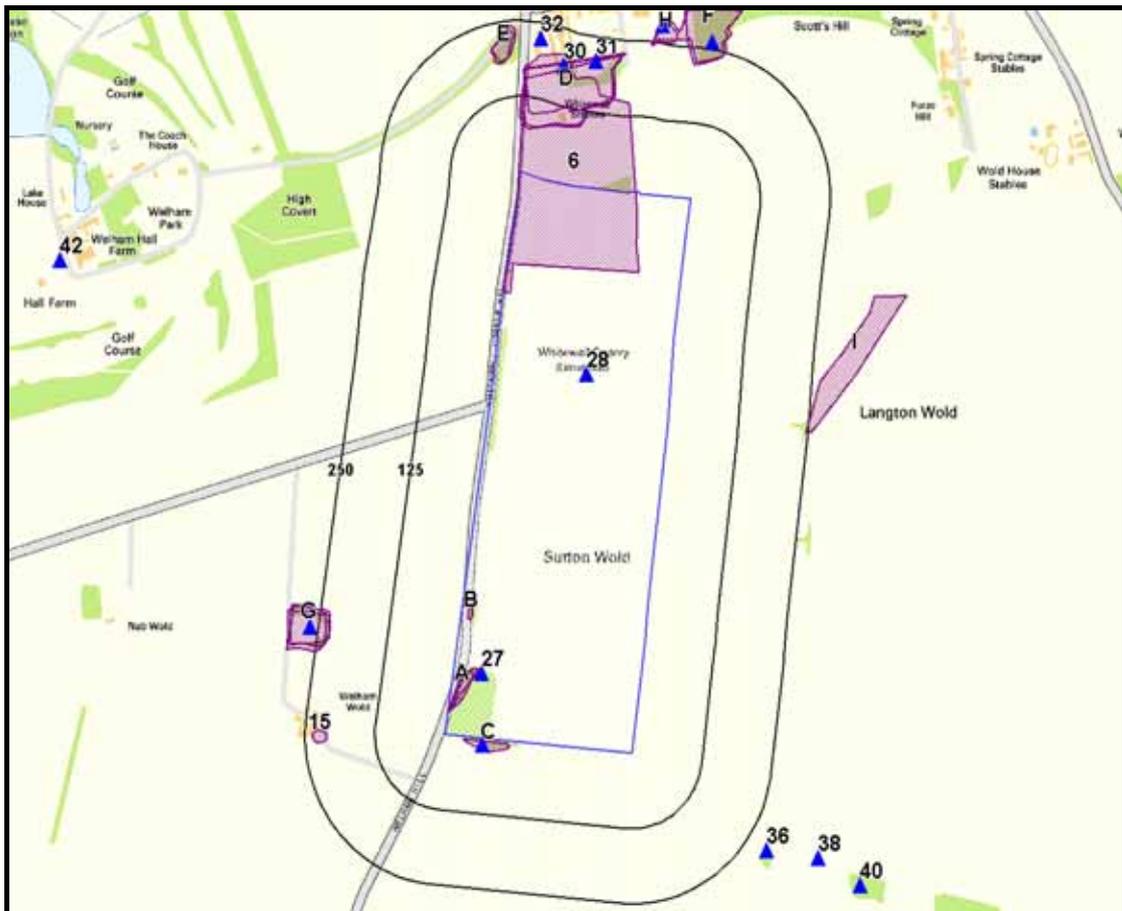
Figure 14 Local Quarried Areas

The site is used for the quarrying of limestone. Land to the north of the site has been quarried for limestone and infilled and there are a large number of former limestone quarries, smaller than Whitewall, in the district.

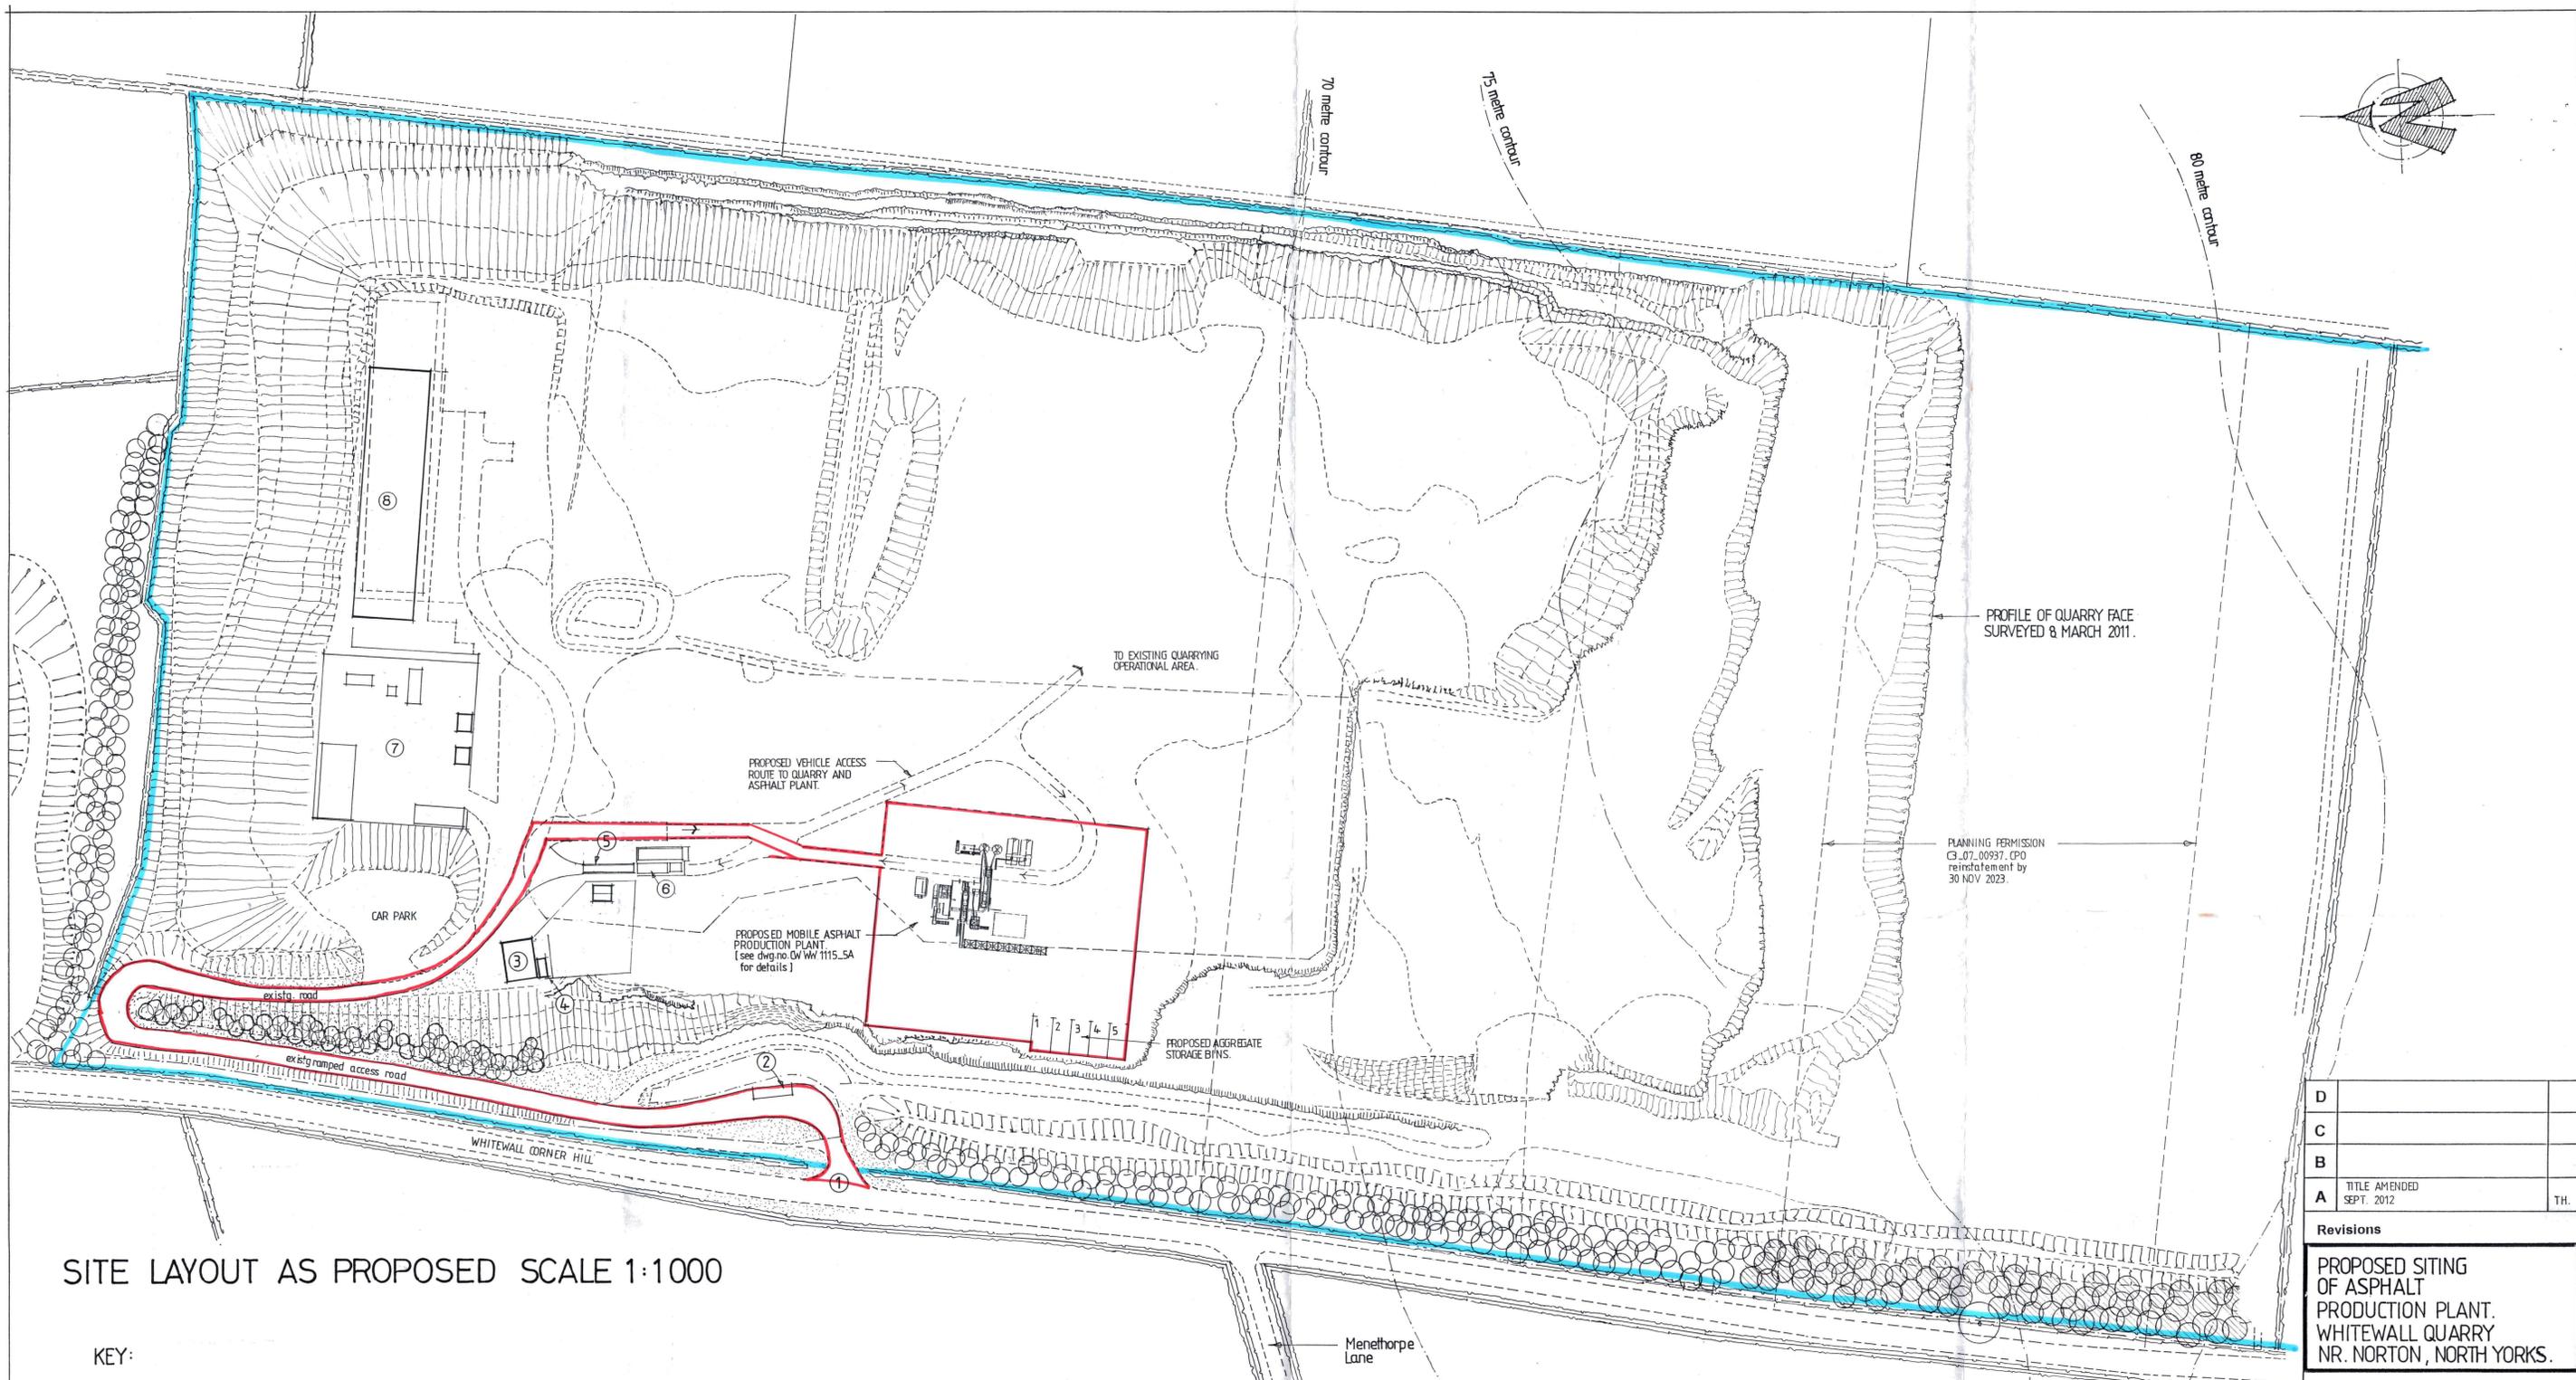
SITE LAYOUT AS PROPOSED SCALE 1:1000

- KEY:**
- area of land owned by W.Clifford Watts Ltd.
 - area of land proposed for the siting of mobile asphalt plant.
 - existing 10 metre wide tree belt to Northern margin.

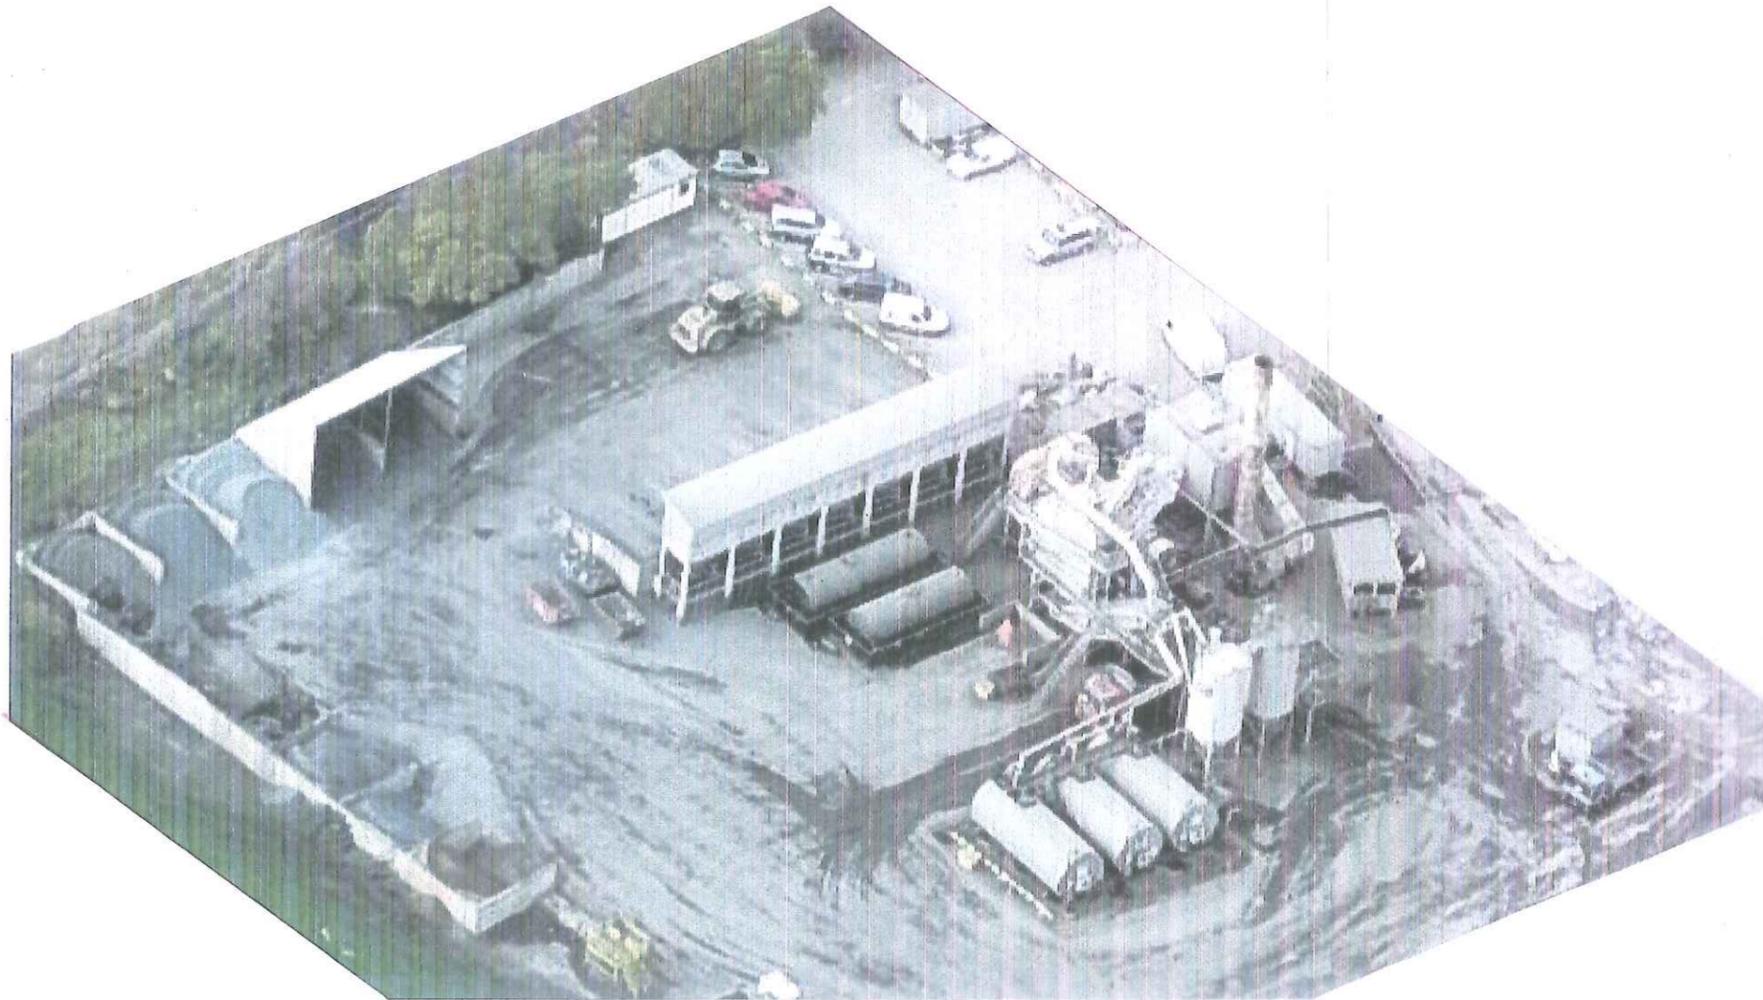
AERIAL VIEW.
 SHOWING A SIMILAR INSTALLATION
 PRESENTLY SITED IN SCOTLAND

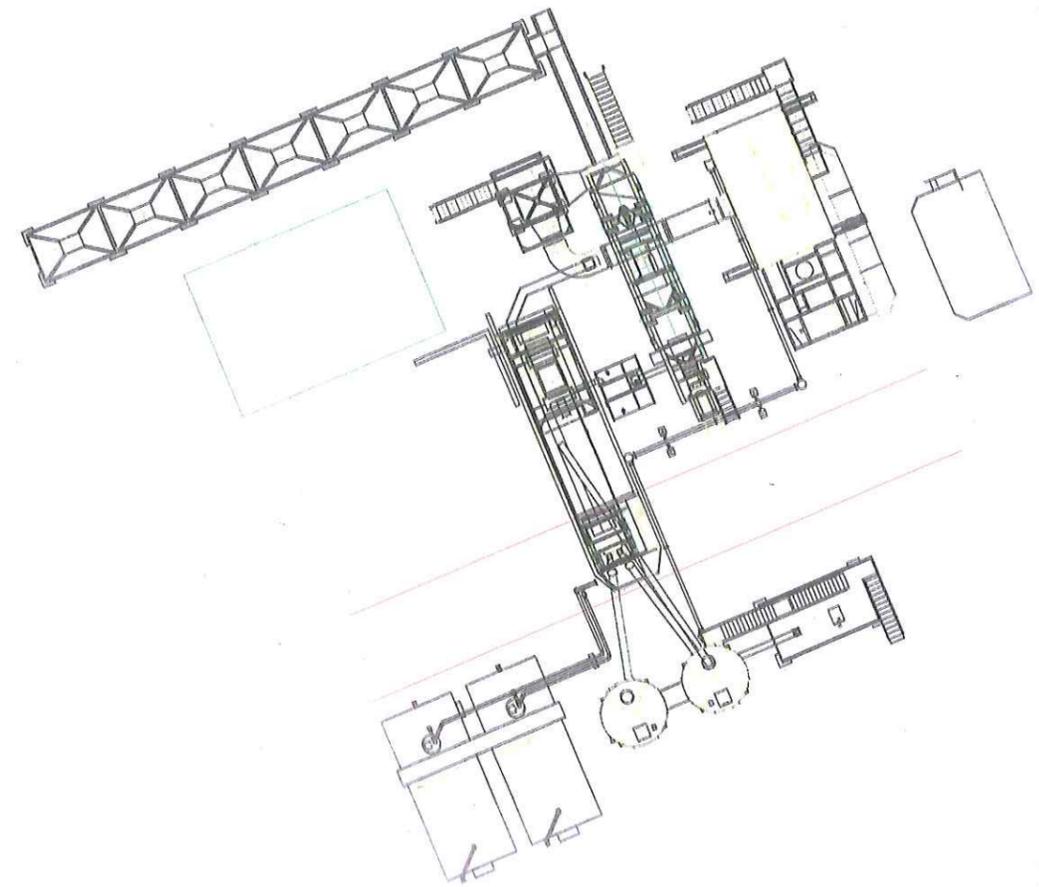
PLAN AT SAME ORIENTATION
 AS AERIAL VIEW n.t.s.
