Flood Investigation Report South Craven

This document has been prepared specifically for the purpose of meeting the requirements of Section 19 of the Flood and Water Management Act 2010.

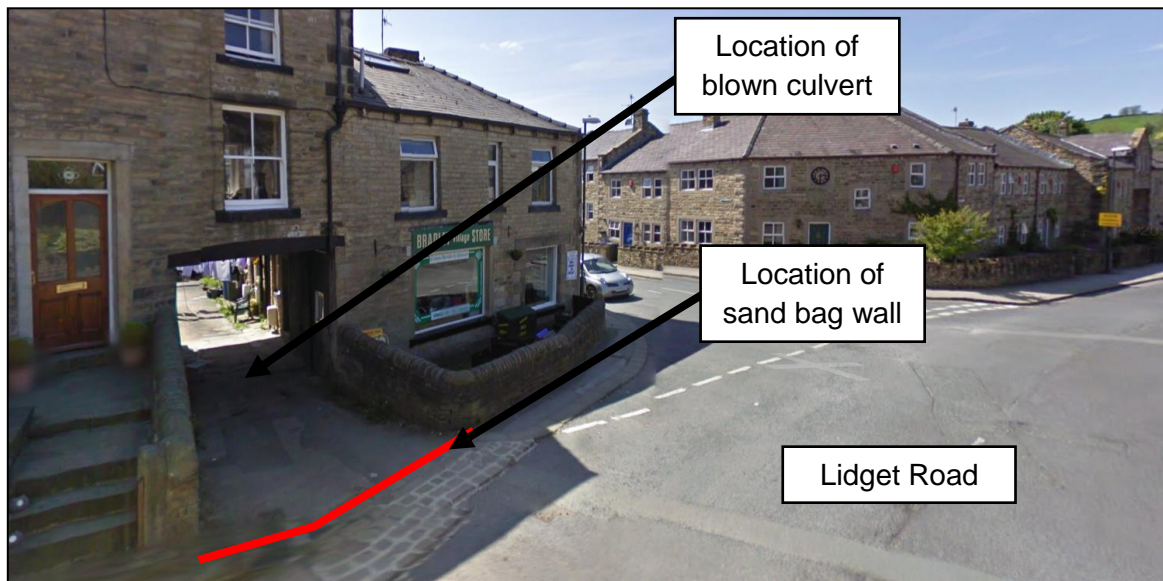
Figure 4.5 Moor View Courtyard access from Lidget Road (Source: Google Maps)

1. The rainfall event on the 25th December resulted in surface water flowing down Lidget Road from Low Bradley Moor. The residents built a wall out of sandbags at the entrance to the courtyard, to stop surface water entering the courtyard from Lidget Road, as shown in Figure 4.5.

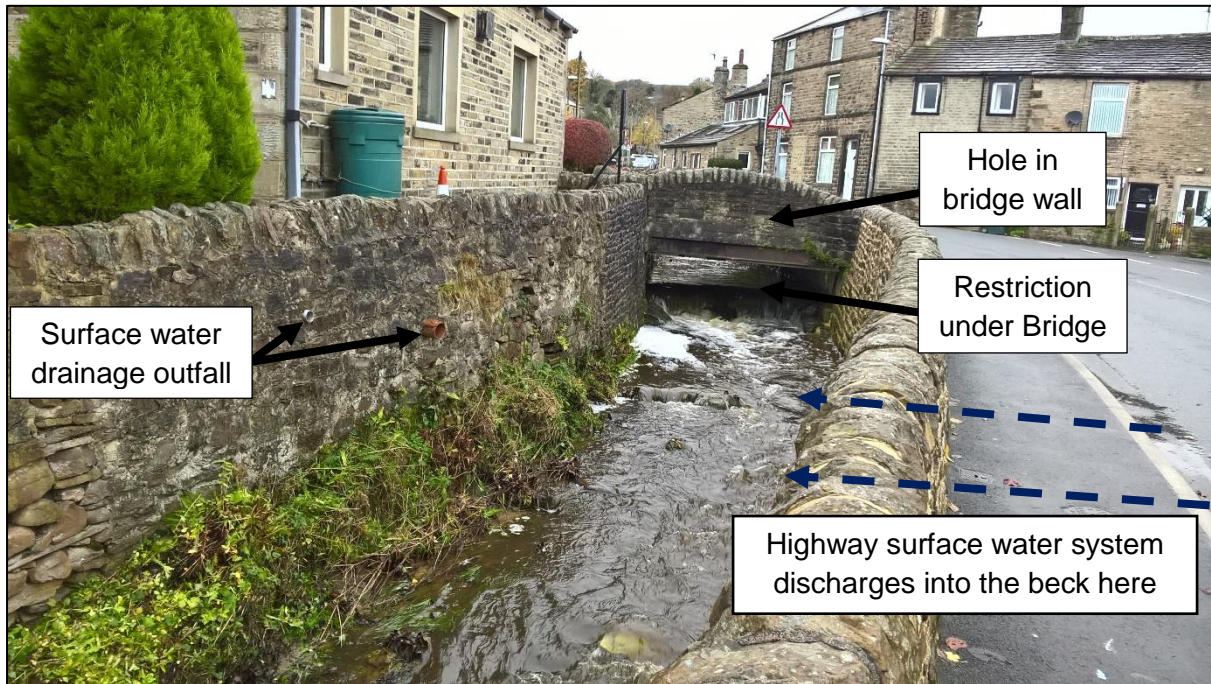
Figure 5.5 Photograph showing an example of the Cononley Beck channel

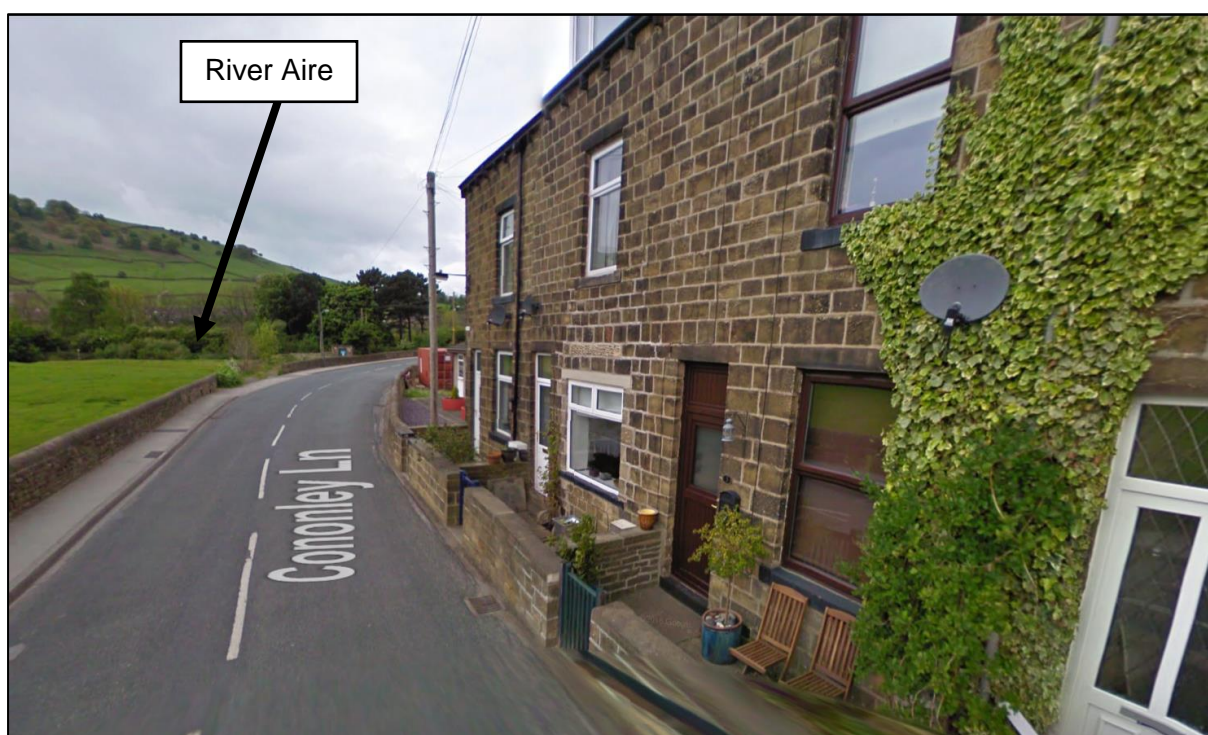
The flooded properties on Cononley Lane are located within 85m of the River Aire, as shown in Figure 5.7, Cononley Lane elevations in this area are between 93m and 95m above sea level.

Figure 5.7 Photograph showing properties on Cononley Lane (Source: Google Maps)

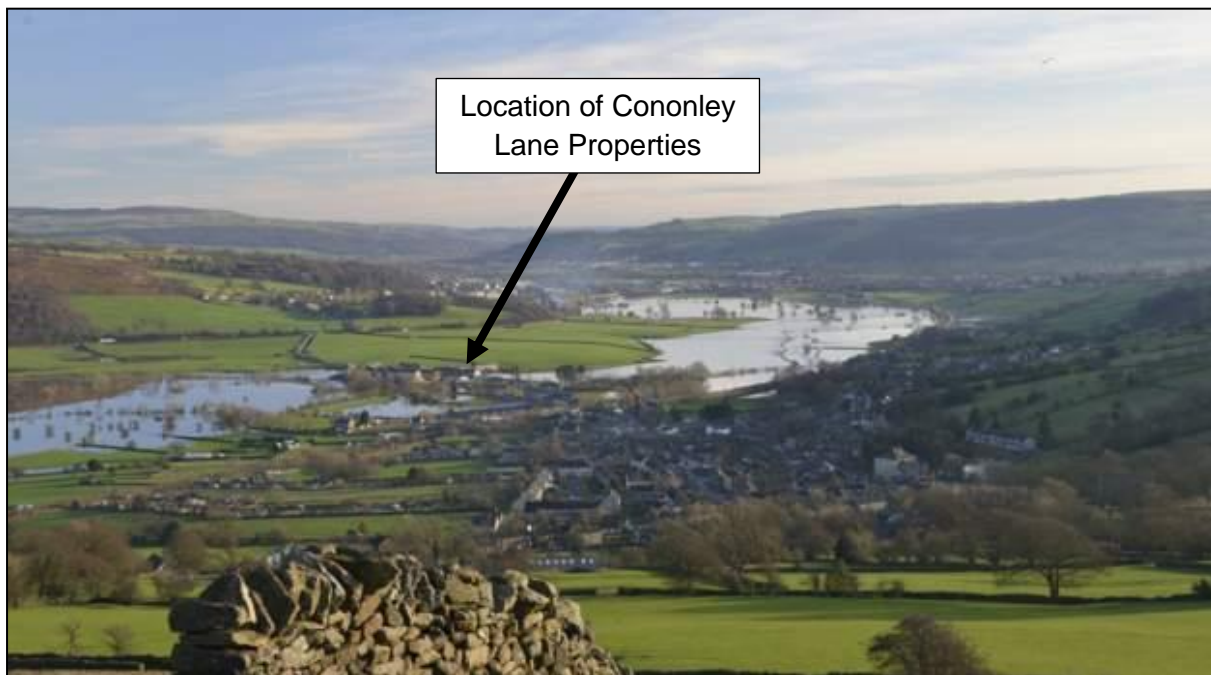
business park resulting in internal flooding from the rear, the extents of River Aire flooding on Boxing Day 2015 are shown in Figure 5.9 and Figure 5.10.

Figure 5.10 Photograph showing the extent of flooding in Cononley on the 26th December 2015

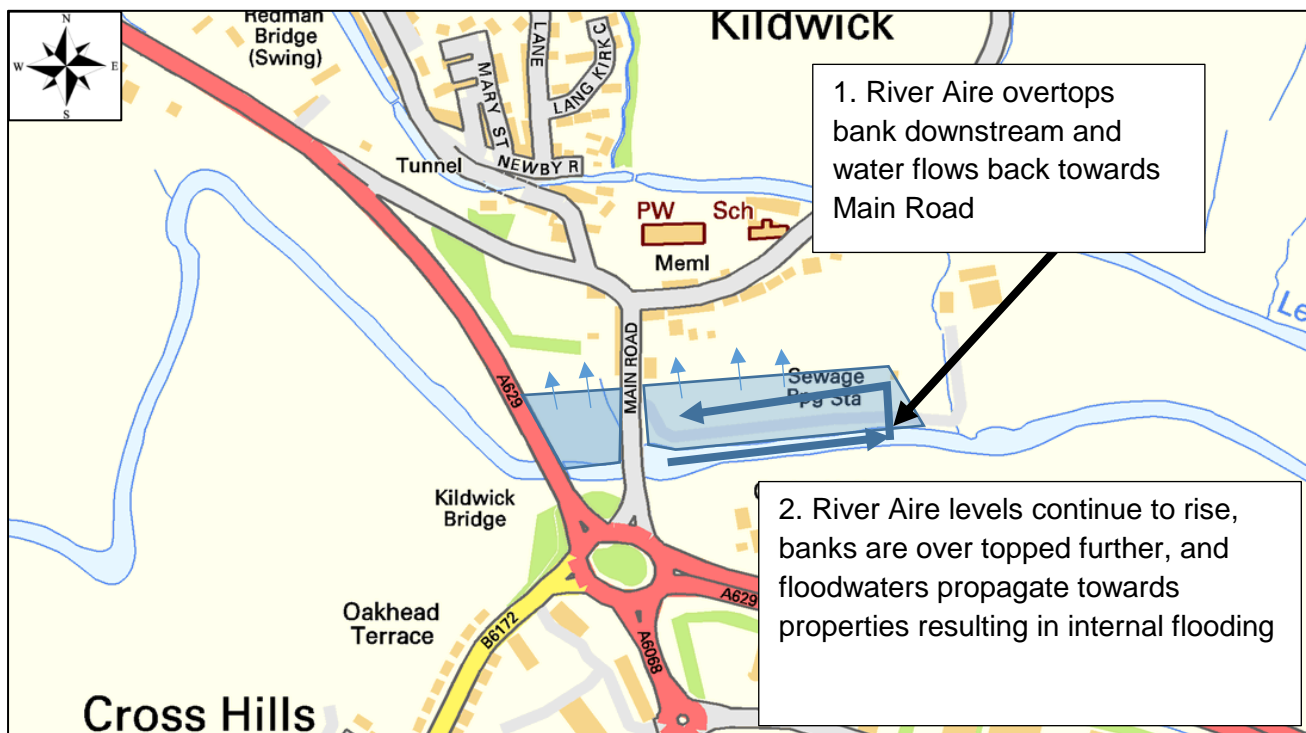
5. A flood warning was issued from the Environment Agency at 06:46 on the 26th December⁴⁴. (River Aire at Skipton Road, Kildwick – Ref 123FWFR108)
6. The River Aire levels continued to rise resulting in the banks being overtopped downstream of the Main Street Bridge the water flowed on to the flood plain and back towards Main Street, as shown in Figure 6.5.

Figure 6.5 River Aire flooding at Kildwick

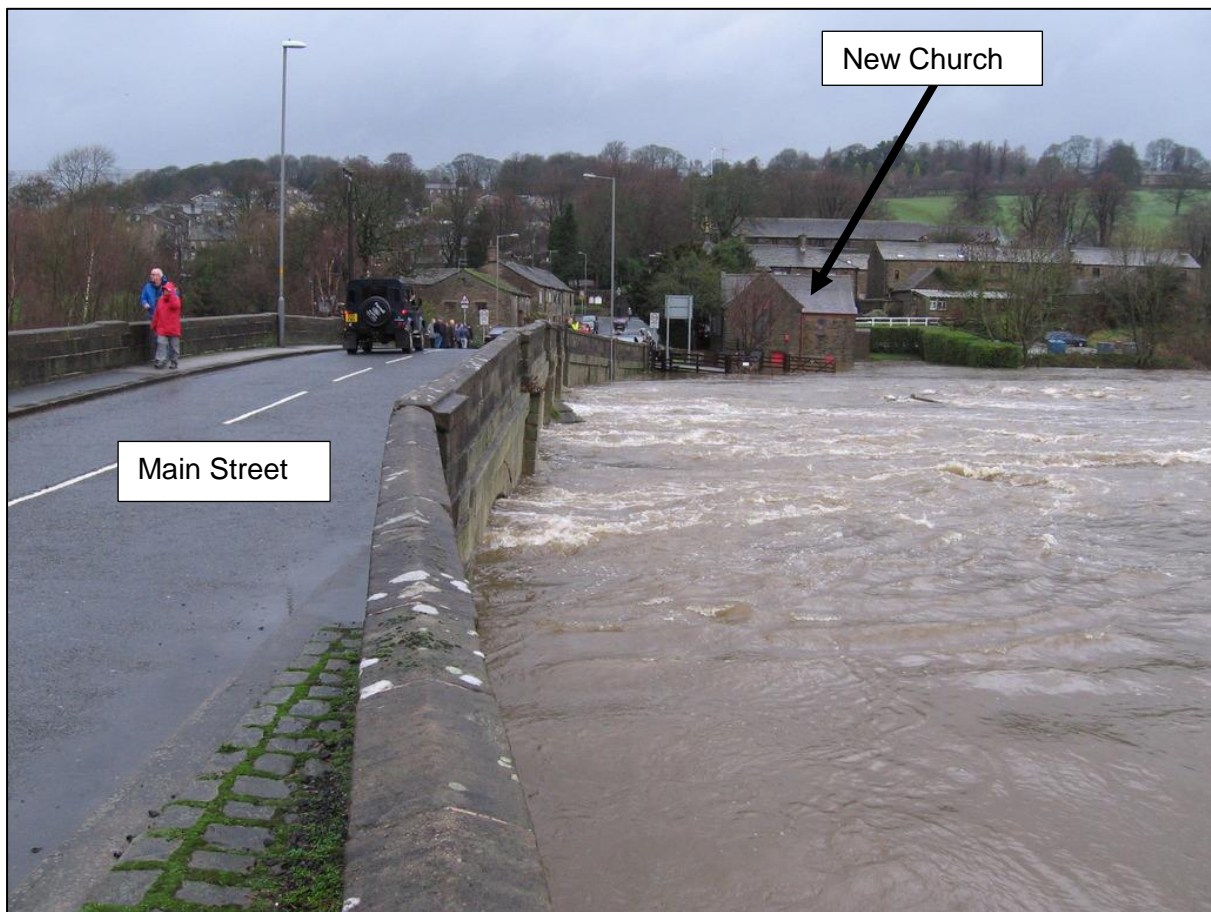
7. The river levels continued to rise flooding the properties on Main Street and Skipton Road, the River Aire levels rose to half the height of the New Church’s ground floor door⁴⁵.
8. The River Aire Levels downstream and upstream of Main Street can be seen in Figure 6.6 and 6.7.
9. The River Aire rose to a maximum level of 4.22m at 17:45 on the 26th December, the extent of the flood water can be seen in Figure 6.8.

Figure 6.6 Photograph showing the River Aire at Kildwick on the 26th December 2015

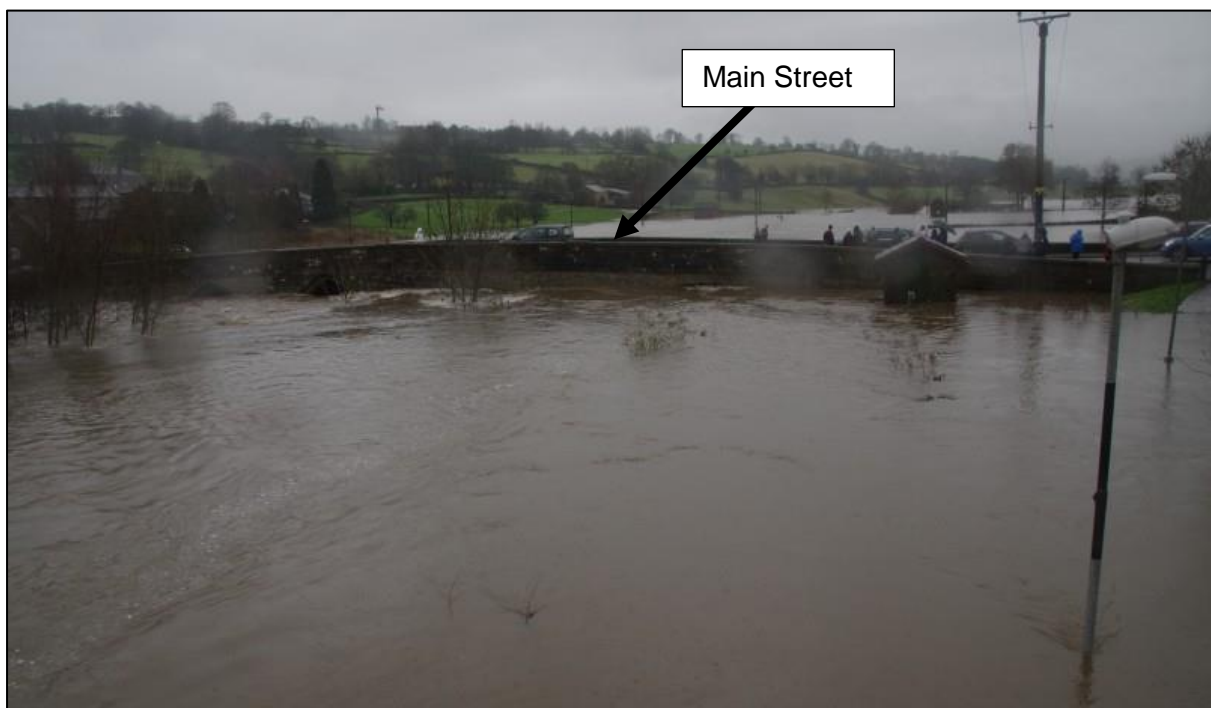
Figure 6.7 Photograph showing the depth of flood water against the Kildwick Bridge

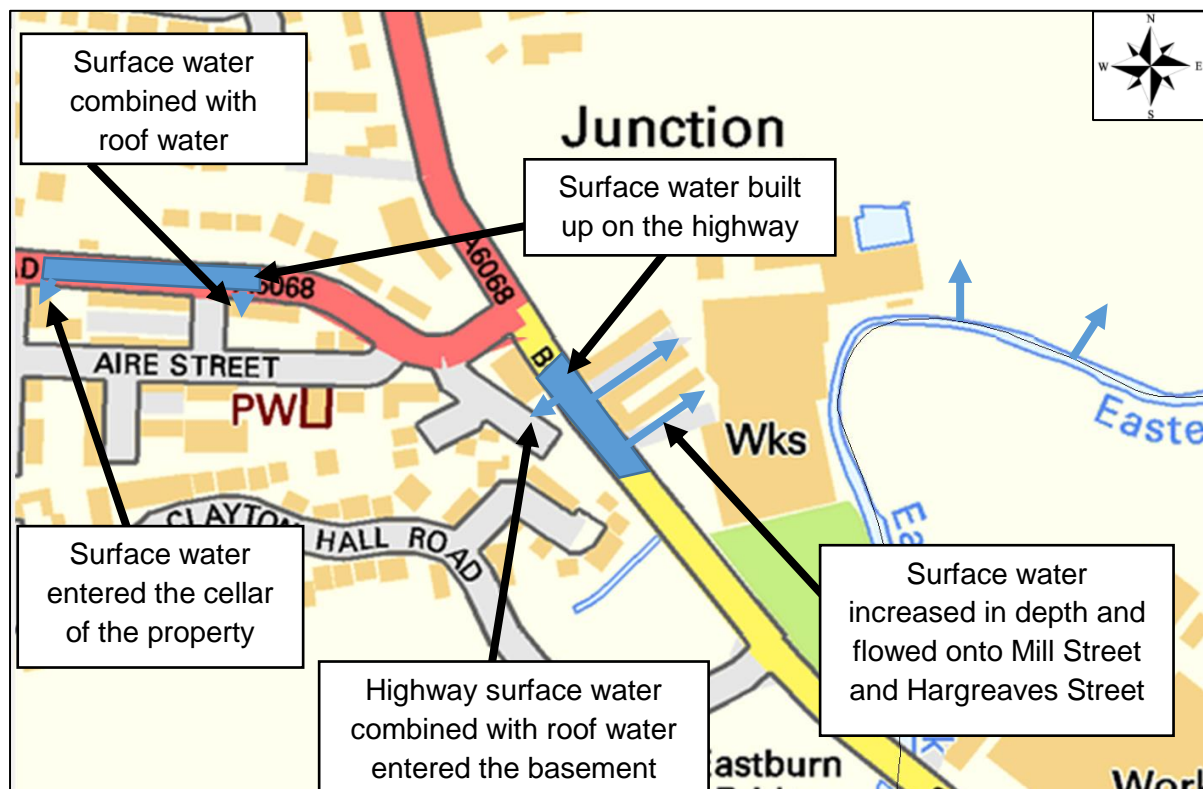
3. The surface water discharging onto the highway overwhelmed the highway drainage in the vicinity of the Keighley Road and Skipton Road junction.
4. The surface water increased in depth on both roads resulting in the flooding of one property on Keighley road and one on Skipton Road, were flooded via the cellar, as shown in Figure 7.9.

Figure 7.9 Plan demonstrating connection of flood plain to area of flooded properties

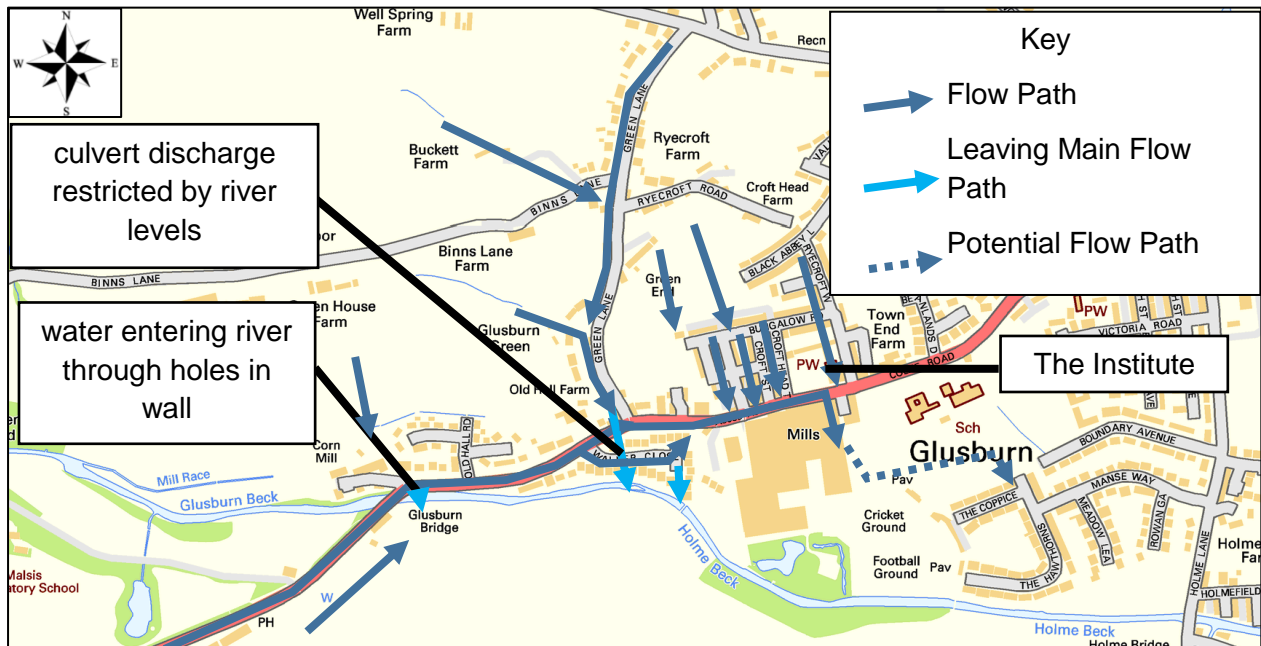
1. The rainfall event on the 25th and 26th December resulted in a large volume of surface water in the surrounding area and the rapid rise in river levels in the Glusburn Beck and Holme Beck⁵⁸.
2. The surface water from the steep agricultural land to the northwest flowed down hill towards the centre of the village through a number of different flow paths. The main flow paths are shown in Figure 8.5.

Figure 8.5 Surface water flow paths from residents' testimonies

15. The surface water on the A6068 crossed the Glusburn Bridge, south to north, and due to the camber of the road the majority of this flow missed the drainage system on the south side of the bridge and continued to flow over the bridge. Some of this water entered the Holme Beck on the east side of the bridge. However the remaining flows continued along Colne Road to combine with the surface water flows from Green Lane via Walker Place, as shown in Figure 8.5.

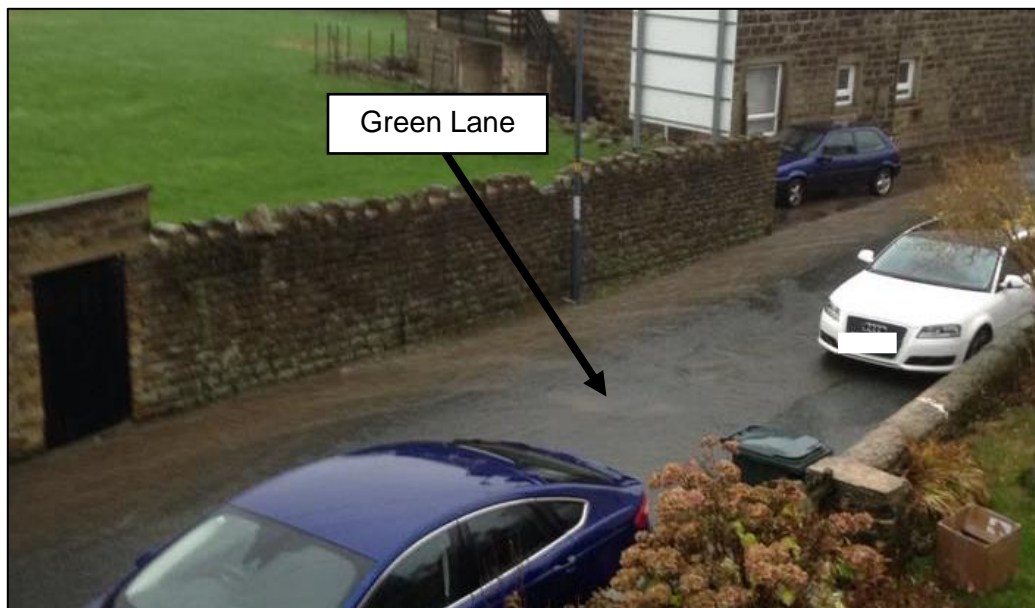
3. Rainfall falling on, and surface water discharging onto the highways in the local area overwhelmed the highway drainage systems.
4. High water levels in the local watercourses into which the surface water and highway drainage systems flow will have seriously restricted the ability of these systems to discharge.
5. Surface water was flowing off the agricultural land to the north west of Green Lane via the historic culvert system. In addition to this, surface water flowing over ground to the North West was being directly discharged onto the highway.
6. The historic culvert, which under normal circumstances receives highway drainage reached full capacity, resulting in large volumes of excess surface water flowing down Green Lane, Figure 8.6 shows excess surface water flowing down Green Lane from a previous much smaller event.

Figure 8.6 Surface water on Green Lane from a smaller rainfall event

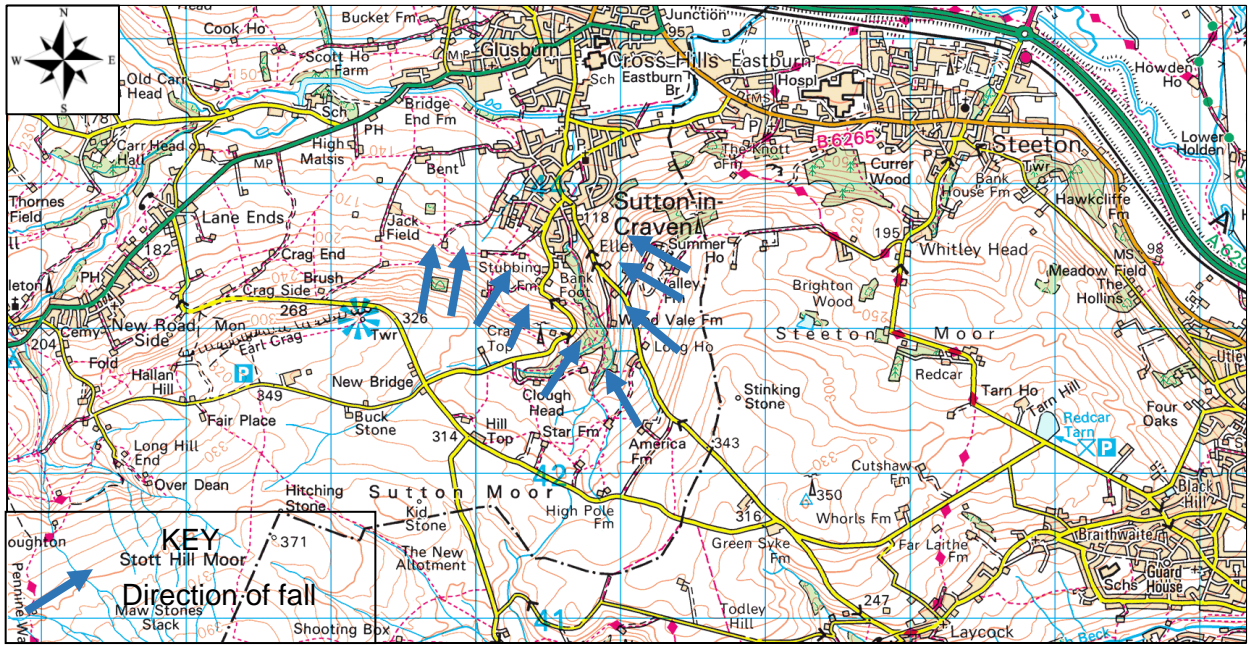
Figure 9.2 Sutton-in-Craven topography map

Sutton-in-Craven is situated in a valley surrounded by steep agricultural land that falls towards the village centre and Holme Beck, as shown in Figure 9.2. Due to the shape of the surrounding land after a rainfall event the surface water flows towards the village, the areas identified by the EA as at risk from surface water are shown in Figure 9.3.

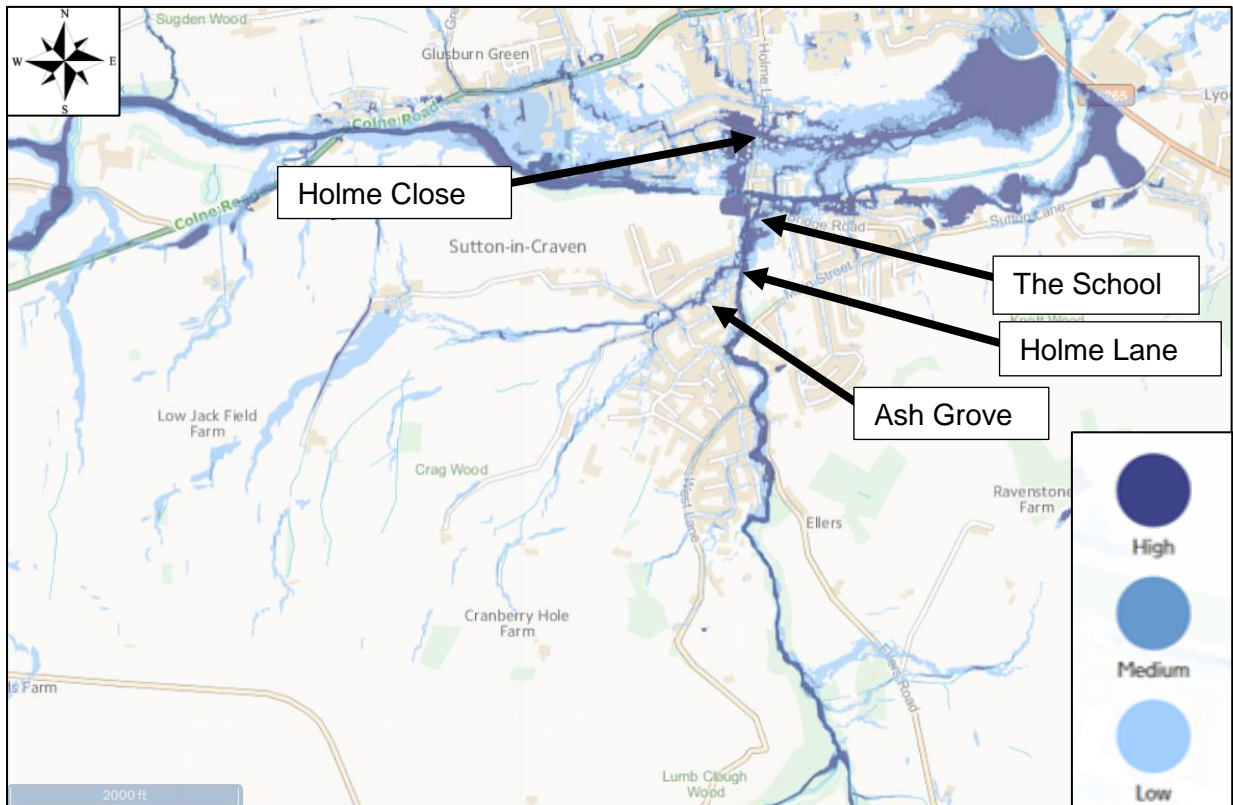
Figure 9.3 EA surface water flood risk map⁵⁹

Holme Close can be seen from the EA maps to be at a high risk from both river and surface water flooding (Figure 9.3 and 9.4 above). The river flooding is attributed to Holme Beck. There is a significant risk from surface water flooding at this location and a number of surface water sources which are shown in Figure 9.5.⁶³ This

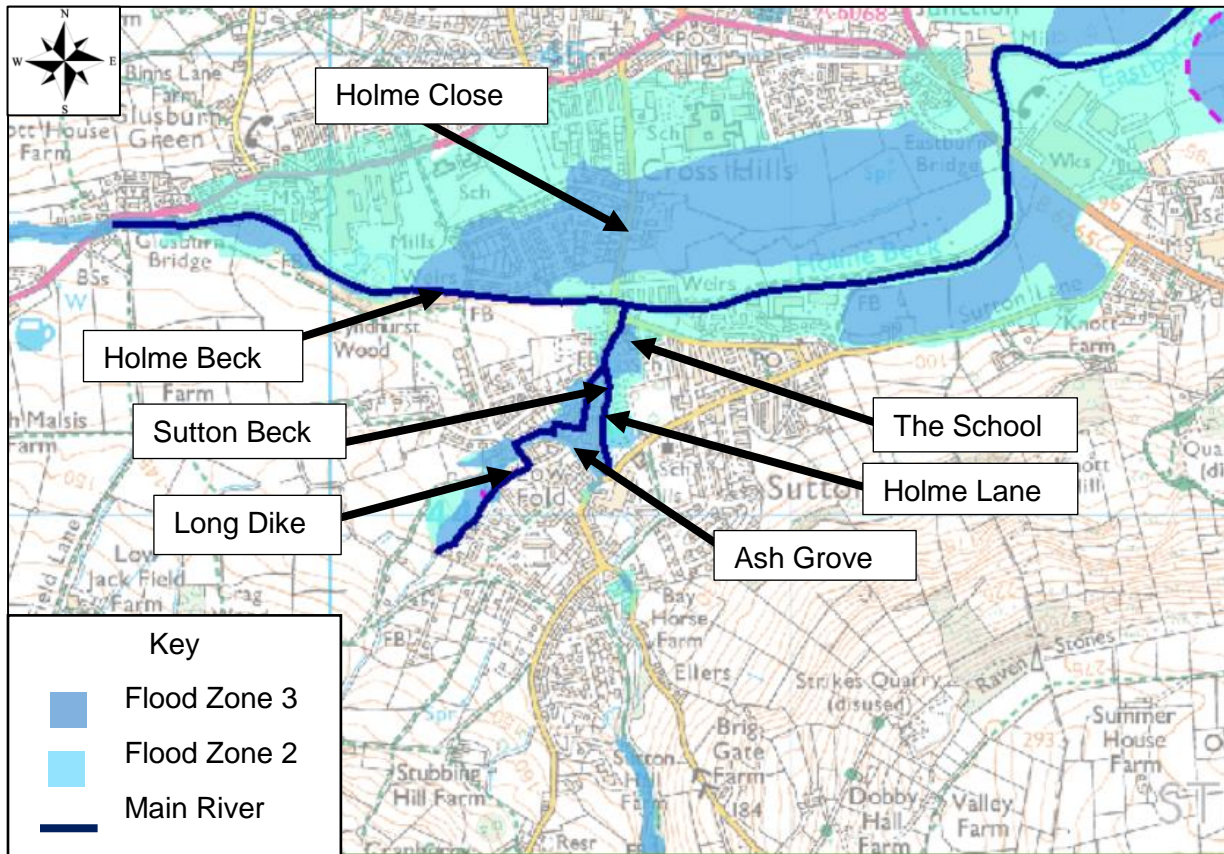
Figure 9.4 EA river flood risk map³

Beck, west of the bridge). Long Dike and Sutton Beck are fed by a much smaller but steeper catchments to the south. The flood risk associated with these rivers is shown in Figure 9.4.⁶¹

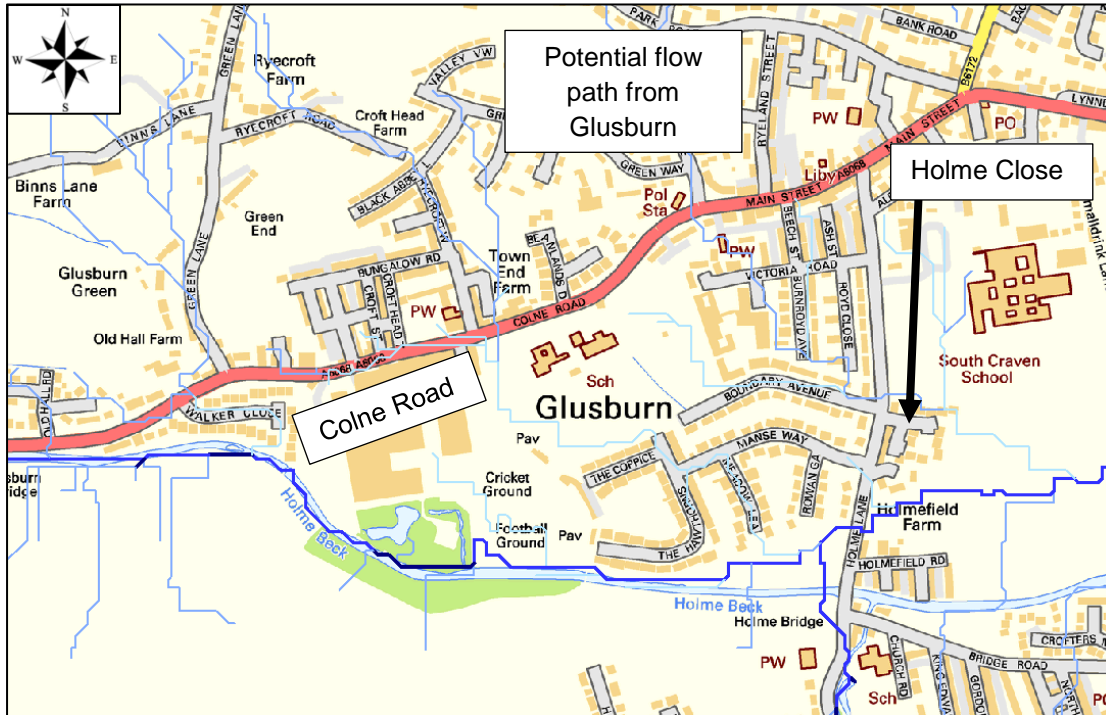
Figure 9.5 Rolling ball analysis for Holme Close area⁵

indicates that there is a potential flow path from Colne Road, Glusburn to the affected areas.

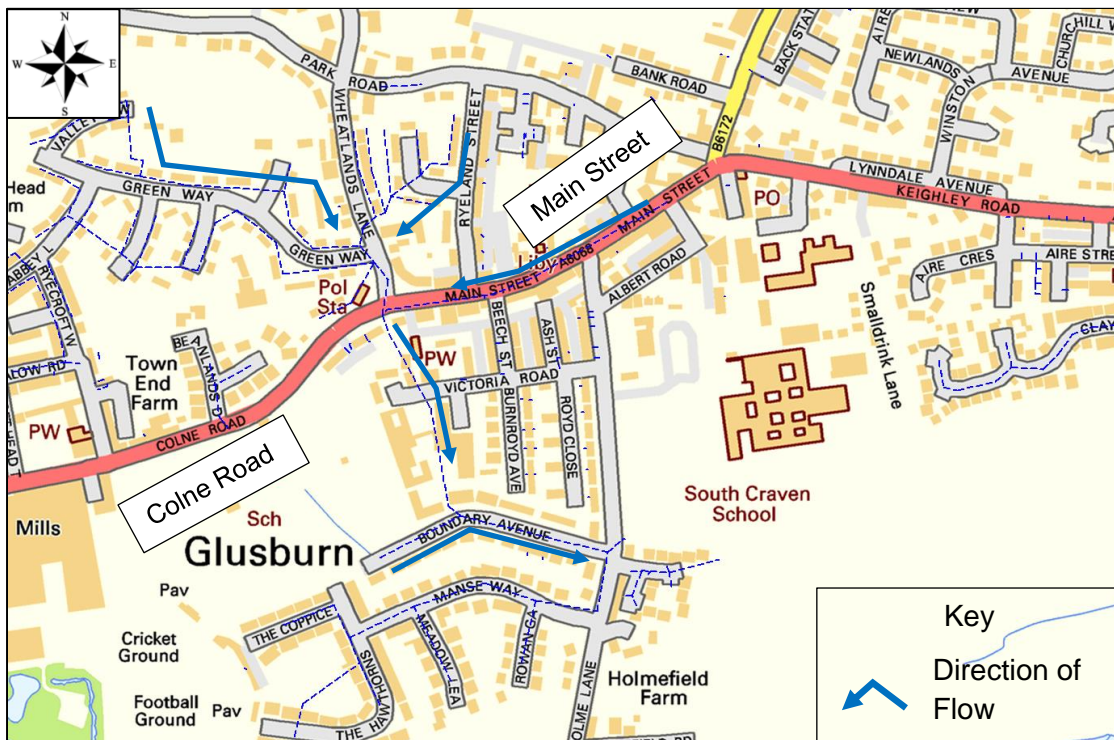
Figure 9.6 Surface water system in Glusburn and Sutton-in-Craven

In addition to the surface flows, the surface water sewer system runs from the north of the junction of Colne Road and Main Road in a southerly direction towards Sutton-in-Craven, as shown in Figure 9.6⁶⁴.

There are reports that surface water sewers in this area were bubbling up and discharging additional water onto the highway. The surface water sewers in this area are reported to be connected to that in Glusburn⁶⁸, being the natural flowpath to the discharge point into Holme Beck (see Fig 9.6). The resulting flow from the Colne Road area added to the existing flow and overwhelmed the system, discharging onto the highways in areas of Sutton-in-Craven⁶⁹.

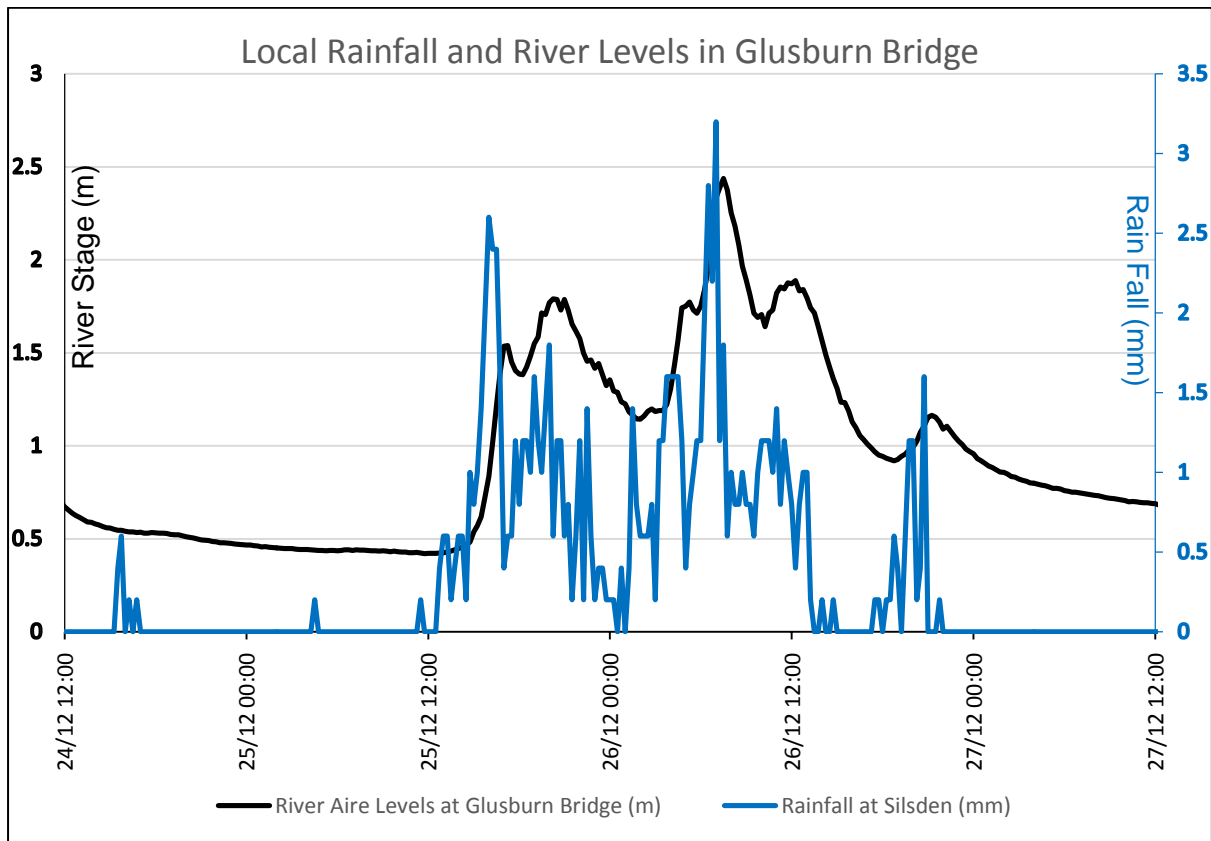
Figure 9.7 River levels at Glusburn Bridge

1. The rainfall event on the 25th December 2015 resulted in a sharp rise in Holme Beck levels, as shown in Figure 9.7⁶⁵, the river was reported to almost come out of bank⁶⁶.

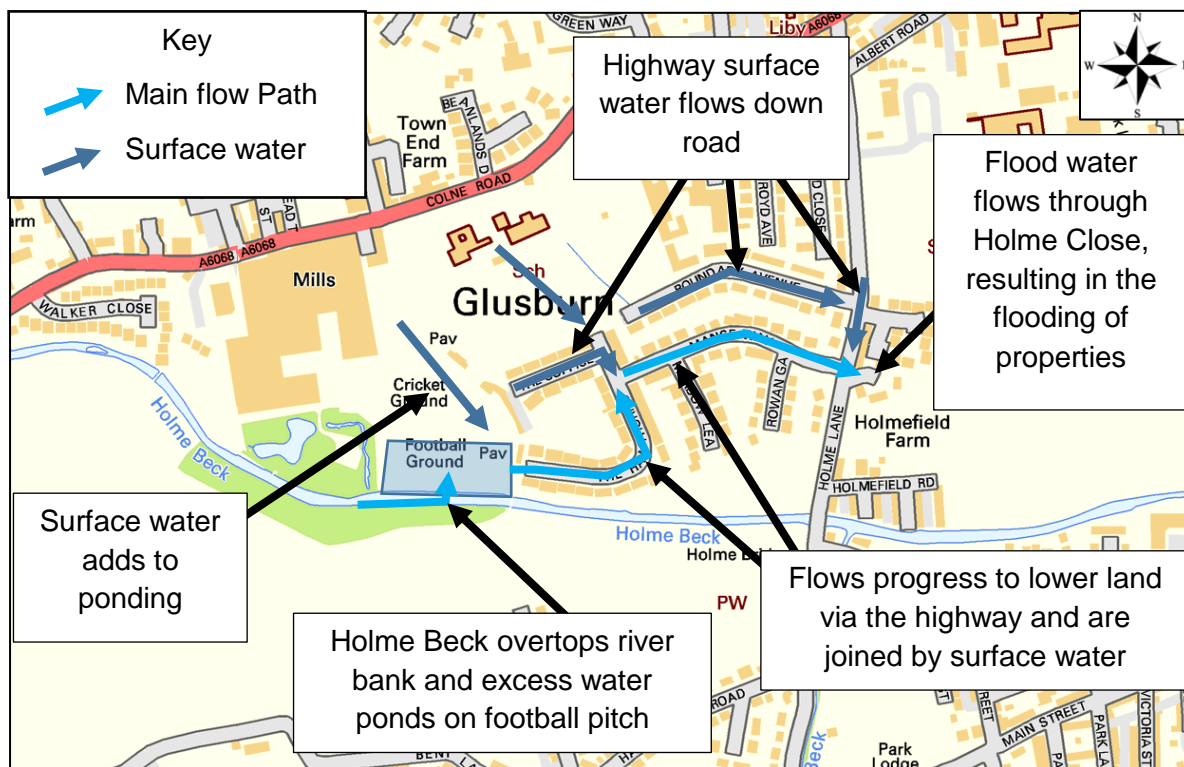
Figure 9.9 Flooding mechanism at Holme Close

7. Having exceeded the capacity of the existing highway and surface water systems, the surface water followed the gradient of the land, down Manse Way and onto Holme Close where flood waters internally flooded properties, as shown in Figure 9.9.

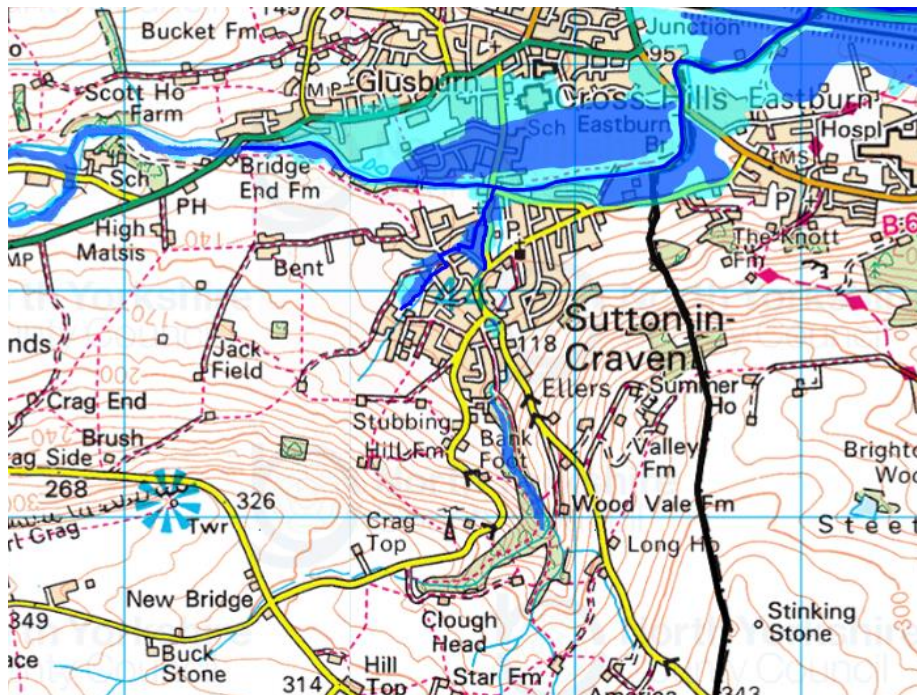
Figure 9.10 EA river flood risk map (Detail)⁷⁰

Ash Grove can be seen to be at risk from river and surface water flooding from the EA maps (Figure 9.3 and 9.4). The river flooding is attributed to Long Dike, but only some properties on the Ash Grove are shown to be at risk by the modelling.

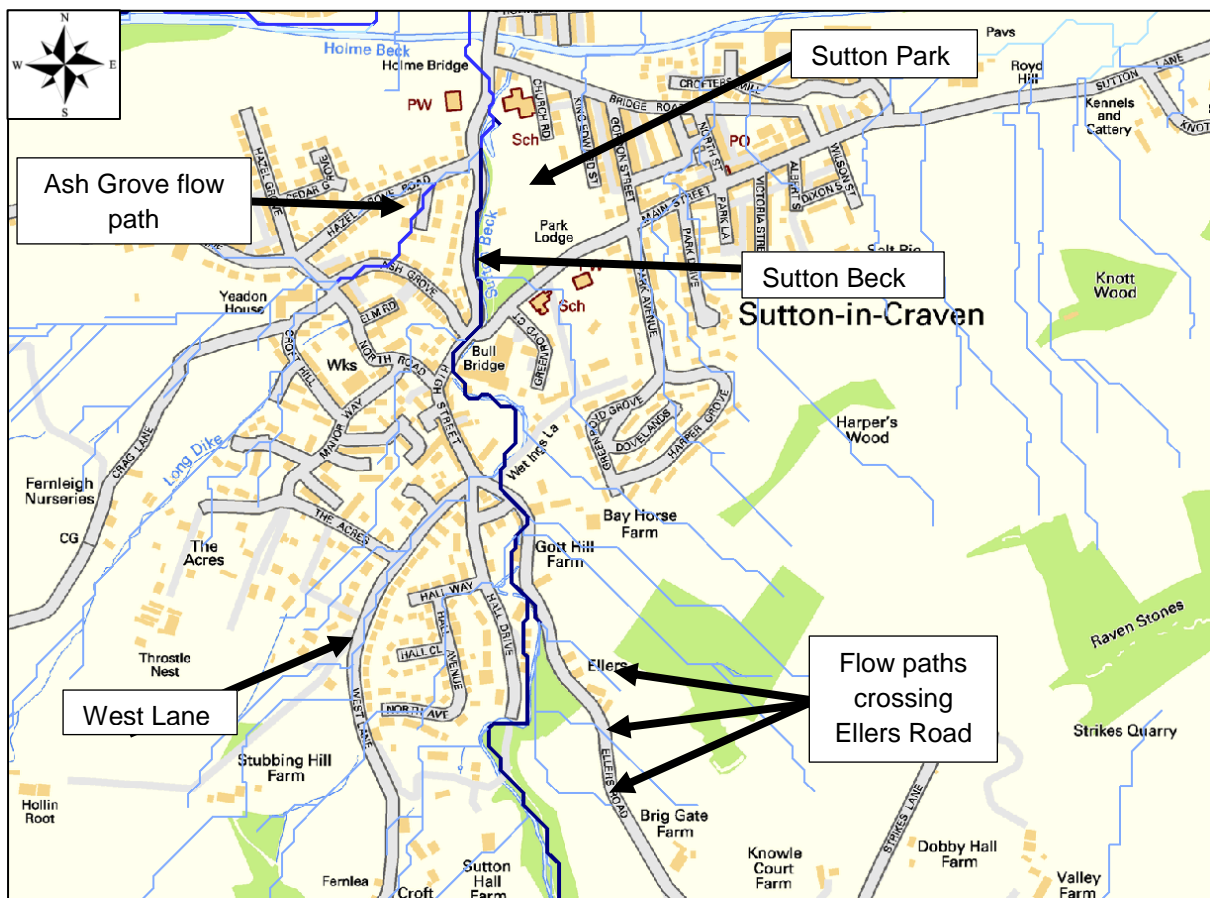
Figure 9.13 Rolling ball analysis for Holme Lane

There are three main flow paths converging on Holme Lane, as shown in Figure 9.13; the first being Sutton Beck, which collects large amounts of runoff from the steep sided valley, The Clough, to the south; the second the combination of Long Dike, Crag Lane and a historic culvert, west of Holme Lane, as discussed in the Ash Grove Section; the third is from West Lane flowing on to High Street then Holme Lane.

Local residents’ accounts from the flood event state that there was a large volume of surface water flowing down Ellers Road. It is thought that some of the surface water shown in Figure 9.13 as flowing over Ellers road and into the watercourse is in practice flowing down Ellers Road and not getting to Sutton Beck at all.

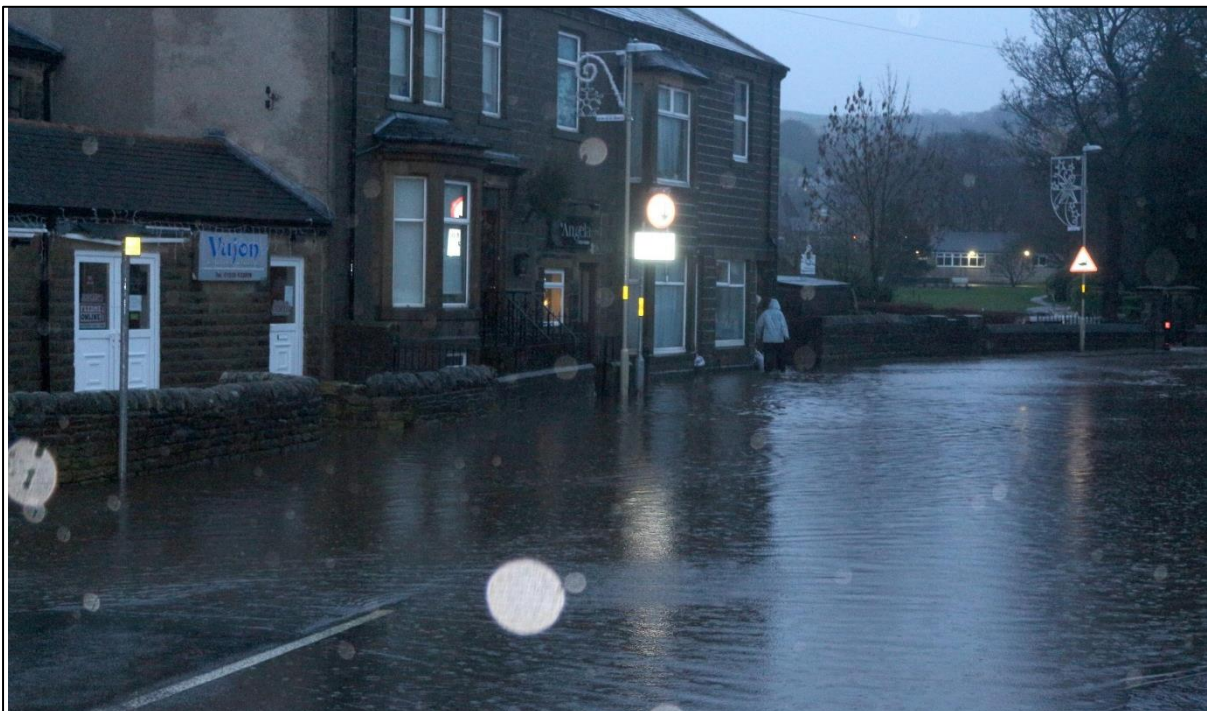
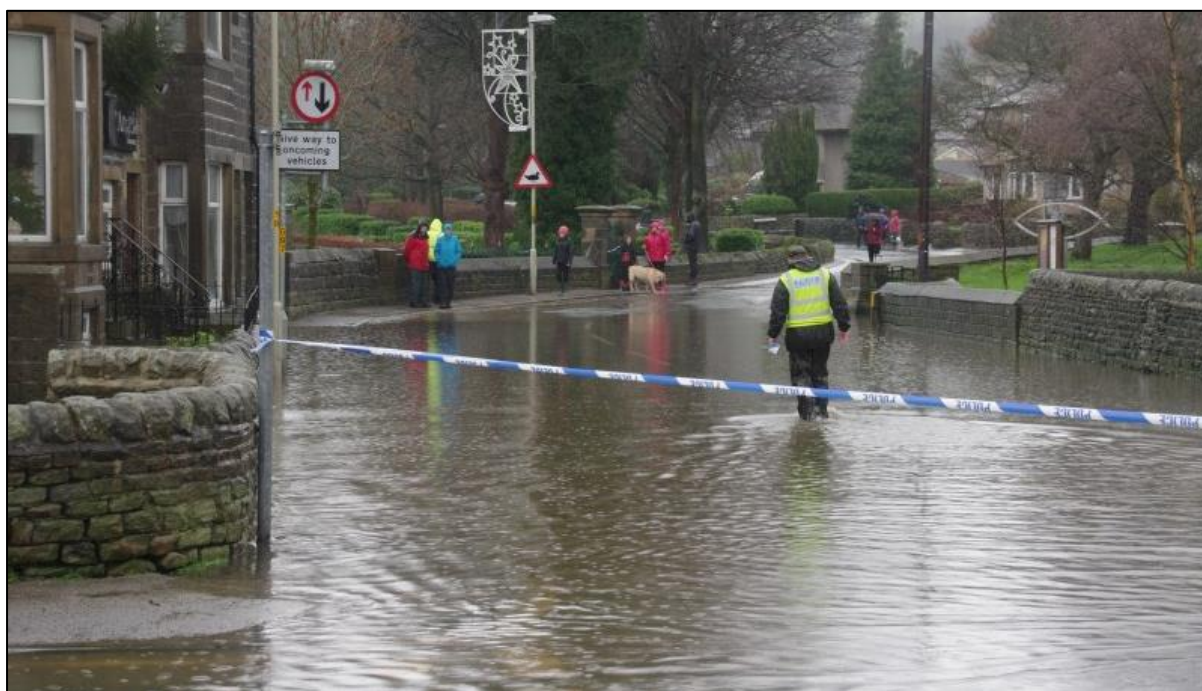
5. Many houses were protected by sandbags along High Street and Holme Lane, which directed the runoff into the Sutton Park.
6. The river levels of the Sutton Beck rose as the storm continued resulting in surcharging of the culverted section of the Sutton Beck under Bridge Road.
7. The water then backed up in Sutton Beck from this point. The levels rose resulting in river water flowing through a holes in the Beck wall along High Street and onto the highway. This water travelled down the road and pooled at the junction of Holme Lane and Bridge Road, as shown in Figure 9.14. This resulted in the closure of Holme Lane. It is considered that the extent of flooding may have been exacerbated by the runoff of adjacent agricultural land, however the impact of this is thought to be less significance in comparison to that of Sutton Beck.

Figure 9.14 Photographs showing water on the Holme lane close to its junction with Bridge Street

8. The extent of flooding on the junction of Holme Lane and Bridge Street increased resulting in the internal flooding of two adjacent buildings.
9. Additional flooding occurred from a culverted section of Long Dike believed to run down the back gardens of properties on the western side of High Street opposite the park. The water levels in Long Dike increased as the storm continued carrying the flow from the Croft Hill / Ash Grove area, exceeding the culverts capacity.

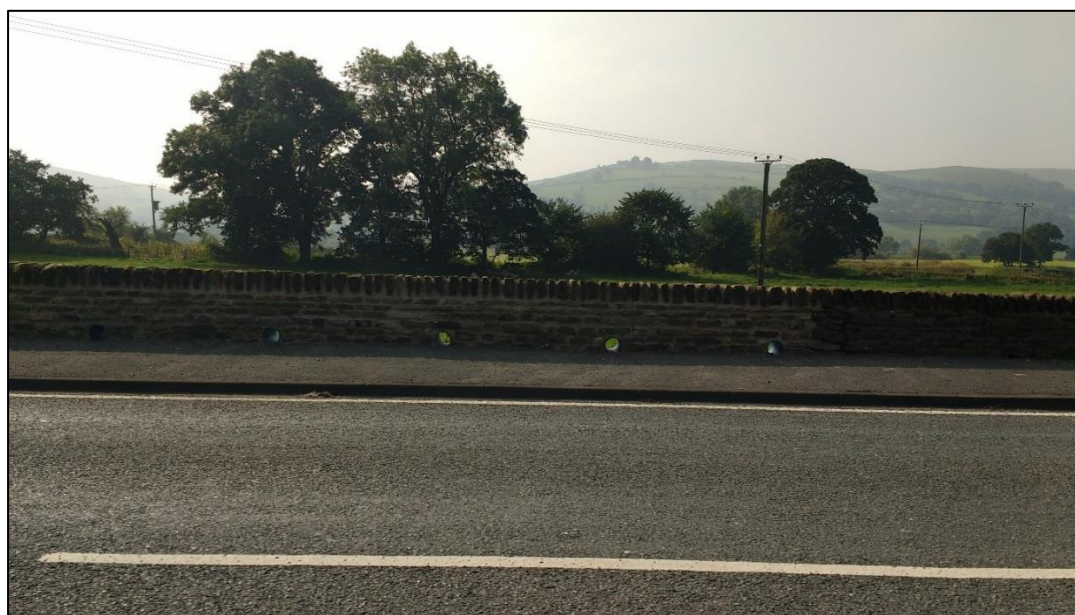
Figure 10.1 A629 at Ing Beck Bridge

- Installation of pipe work in the masonry walls of the A629 to allow surface water flow and overspill from Mill Ing Beck to drain onto the flood plain in extreme conditions. Fig 10.1.

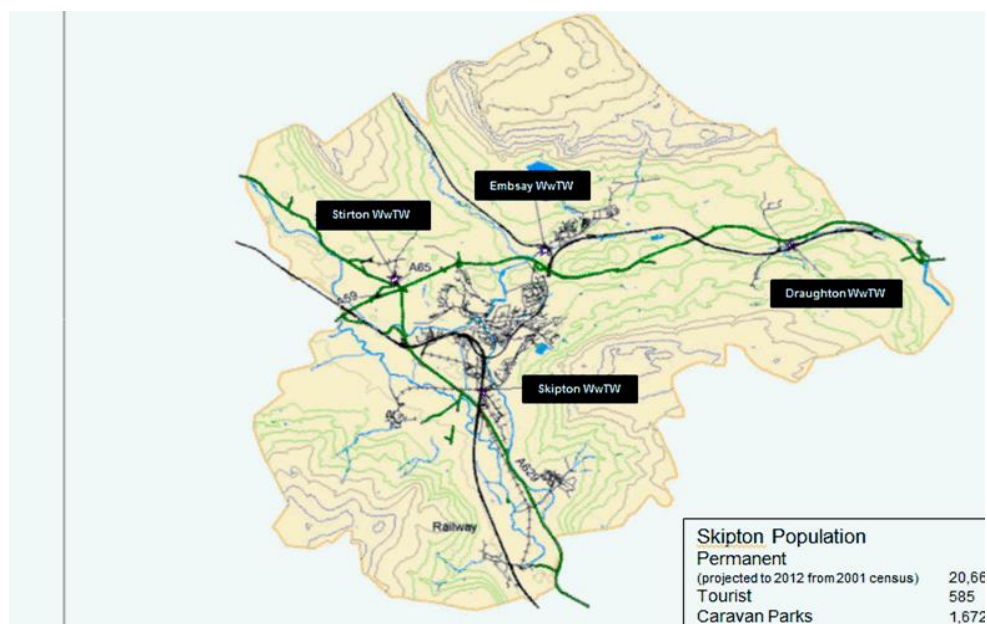
- Investigations have been carried out in a number of locations in Glusburn and Sutton-in-Craven. Some have been found to involve private rather than public sewers. In all cases sewers found to have been overwhelmed by sheer volume of water and Storm Sewer Overflows unable to spill due to high river levels.
- Yorkshire Water is currently conducting a catchment investigation into the public sewer network in the Skipton area. The area covered (Fig 10.2) extends as far South as Cononley and Low Bradley. Using the model of the sewer network, they will look at how systems will perform under climate change conditions and with predicted new developments.

Figure 10.2 Yorkshire Water Network Review Skipton Area
