North Yorkshire
County Council

Flood Investigation Report Tockwith

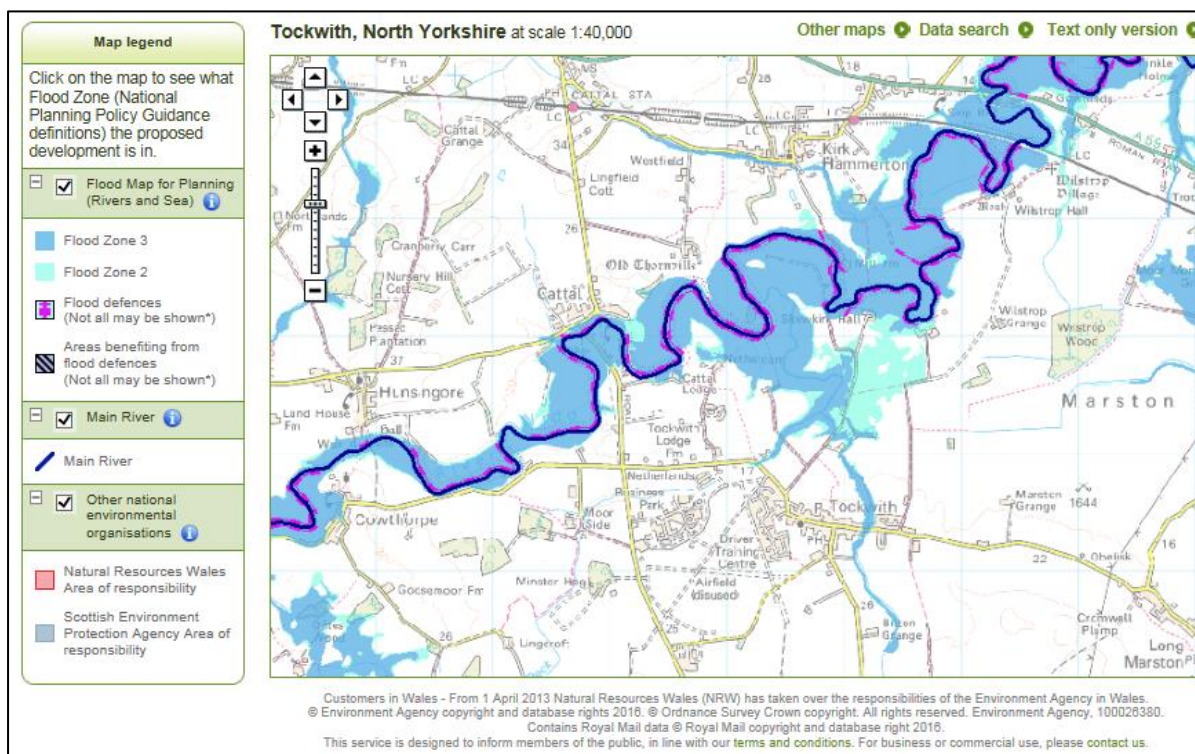
Figure 2.4 showing EA floodplain map⁸

The floodplain of Sike Beck is integrated with the floodplain of the River Nidd as shown in Figure 2.4. Owing to the extent of the floodplain and the flat, low lying nature of the topography, it is not possible to identify if the discharge of Sike Beck is likely to be restricted when water levels in the Nidd are high without detailed modelling.

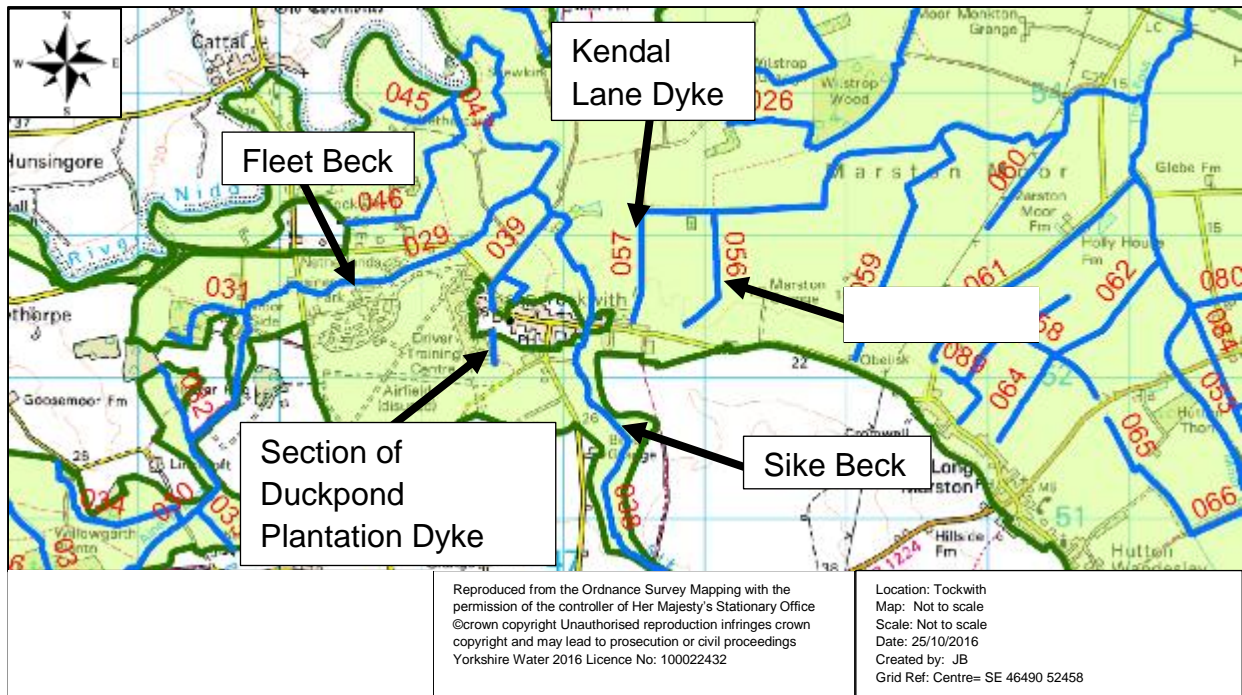
Figure 2.6 Ainsty Drainage Board Extents (Source: Ainsty Drainage Board)

Tockwith falls within the drainage district for Ainsty (2008) Internal Drainage Board⁹ (IDB). The board operates as the Land Drainage Authority within its district and is responsible for the management of water levels in respect of Flood Risk Management within the Area. The Board is also directly responsible for the maintenance of a number of local watercourses, with respect to this report the most important being Fleet Beck and Sike Beck, as shown in Figure 2.6. The section of Duckpond Plantation Dyke, is not an IDB maintained watercourse as shown on the IDB map in Figure 2.6. This was confirmed to be an error by Ainsty IDB¹⁰.

Through the interpretation of historic maps (Pre 1960), it has become clear that Duckpond Plantation Dyke has been culverted under developments constructed after 1968. It is this section that has been excluded from the IDB watercourse network, as shown in Figure 2.6.

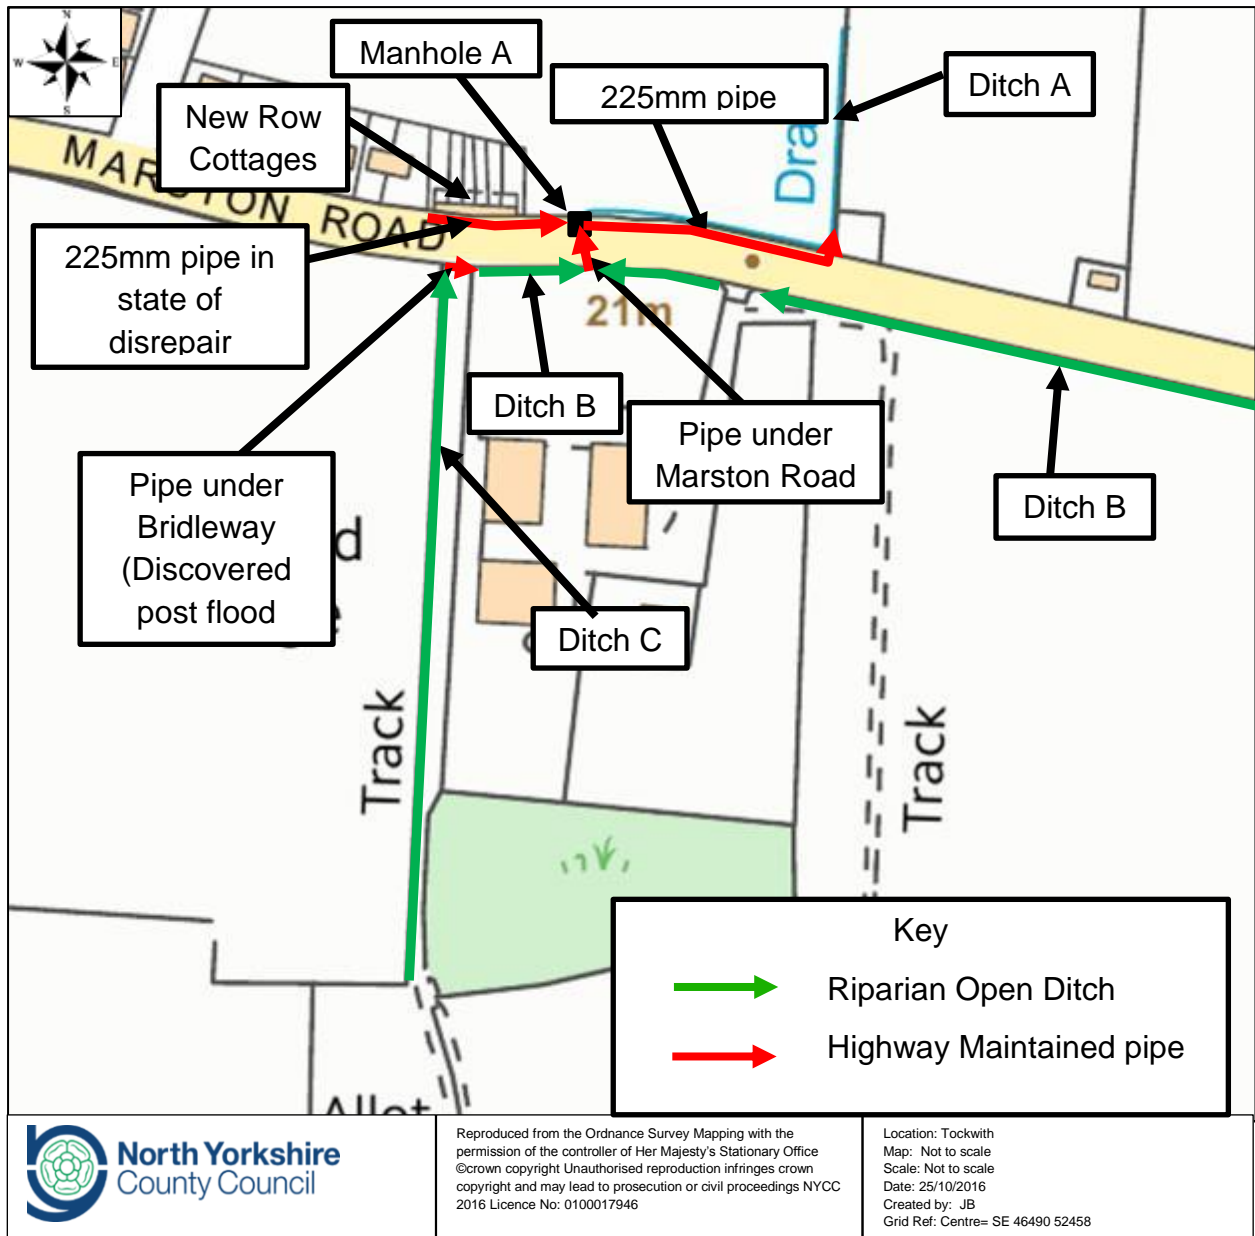
Figure 2.8 Drainage in vicinity of New Row Cottages

In the vicinity of New Row Cottages, which is located at the eastern end of the village, the surface water system discharges into Ditch A, as is represented in Figure 2.8. The majority of surface water is runoff from adjacent fields. The highway surface water system runs from west to east, the surface water is collected in gully pots and directed to Manhole A, as demonstrated in Figure 2.8.

From Manhole A the flows are carried via a 225mm diameter pipe to Ditch A ¹¹. Ditch A is then carried via a 225mm culvert across 2 further fields (B & C below), reducing to 200mm diameter. This then discharges into White Sikes drainage ditch, as shown in Figure 2.9 which is Ainsty IDB maintained.

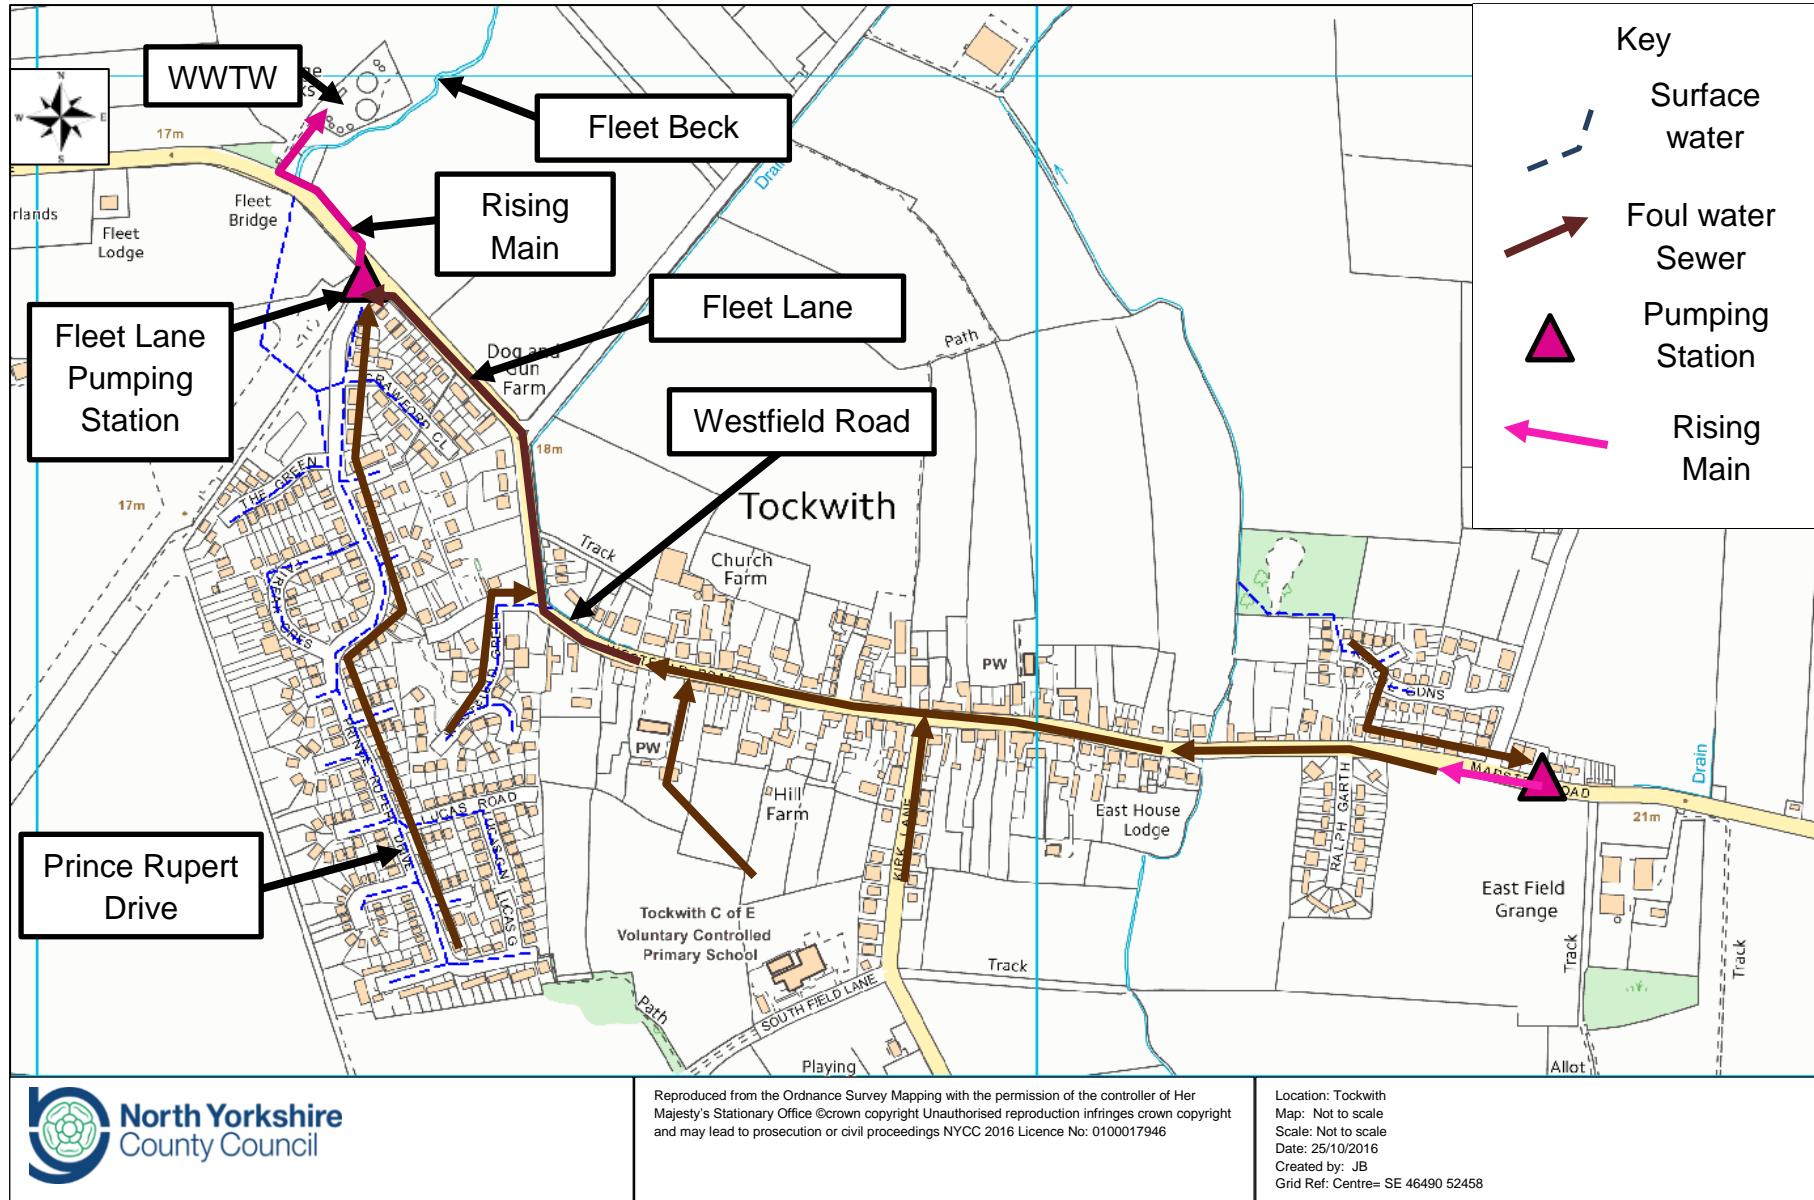
Figure 2.12 Prince Rupert Drive surface water system

Prince Rupert Drive has separate foul and surface water systems. The surface water system takes discharges north from Prince Rupert Drive, Lucas Grove North, Lucas Grove South and Lucas Road and discharges into Fleet Beck, as shown in Figure 2.12. The foul system in this area takes discharges from the same locations to the Fleet Lane Pumping Station where they are pumped via rising main to the Waste Water Treatment Works (WWTW)¹⁴.

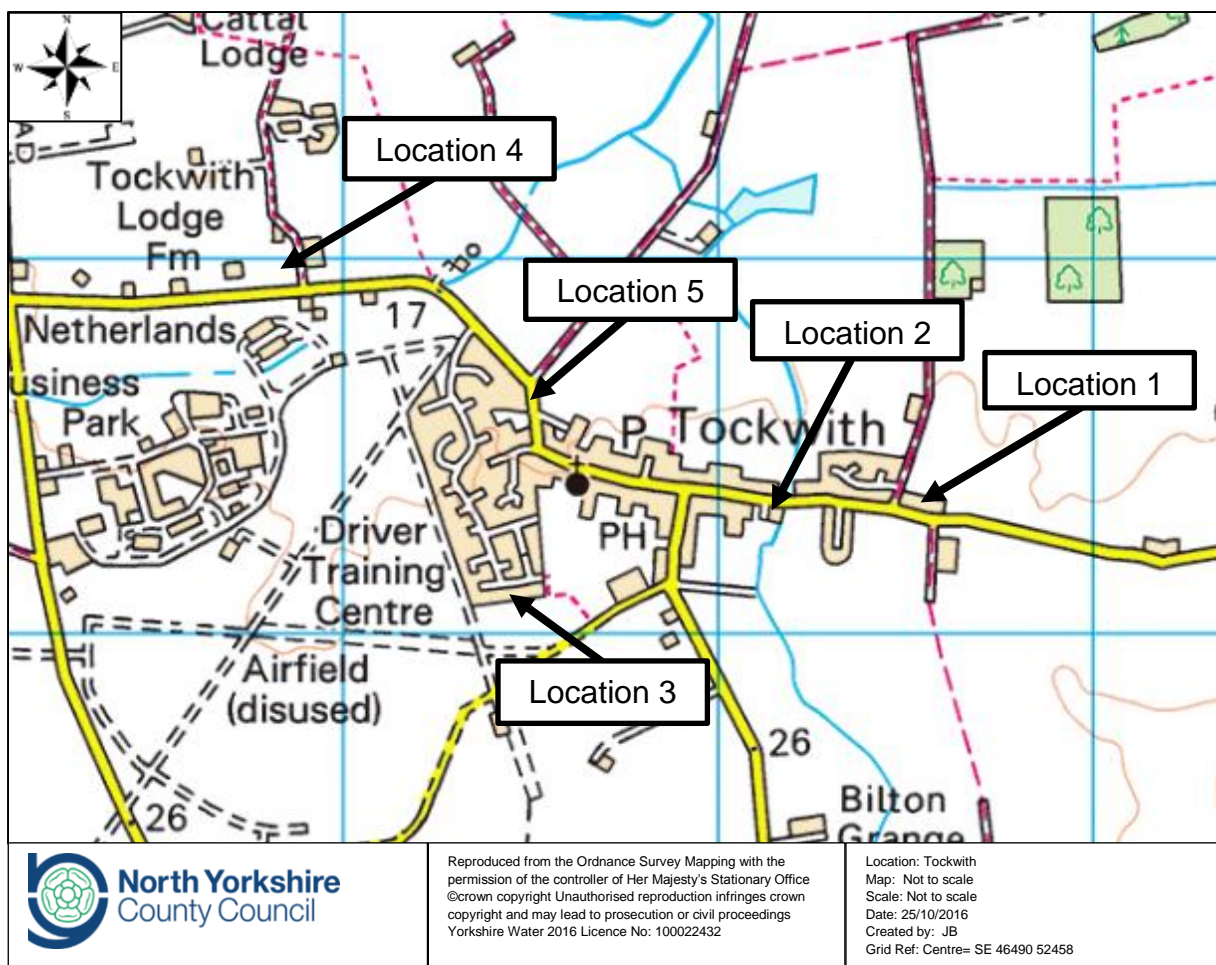
Figure 3.3 Locations of flooding in Tockwith

Heavy rainfall during the 25th and 26th December 2015, fell on already saturated ground¹⁸ which resulted in large volumes of surface water running off and overwhelming the drainage systems. During the event flooding occurred at properties on Marston Road, Price Rupert Drive, Ness Lane, Blind Lane, and Westfield Road, as shown in Figure 3.3. The extent and severity of flooding are discussed in this section.
