Flood Investigation Report

Sleights

1 Executive Summary

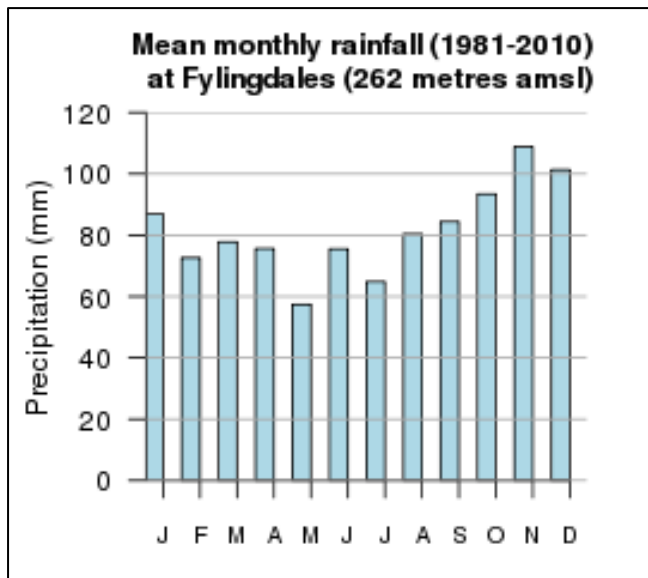
Figure 3.1 Mean Monthly Rainfalls for Fylingdales (Source: Met Office Data)

The mean monthly rainfall data for Fylingdales demonstrates that the average November rainfall is close to 110 mm.

During the event in November 2016, 26mm of water fell in the most intense 6 hours of the storm.

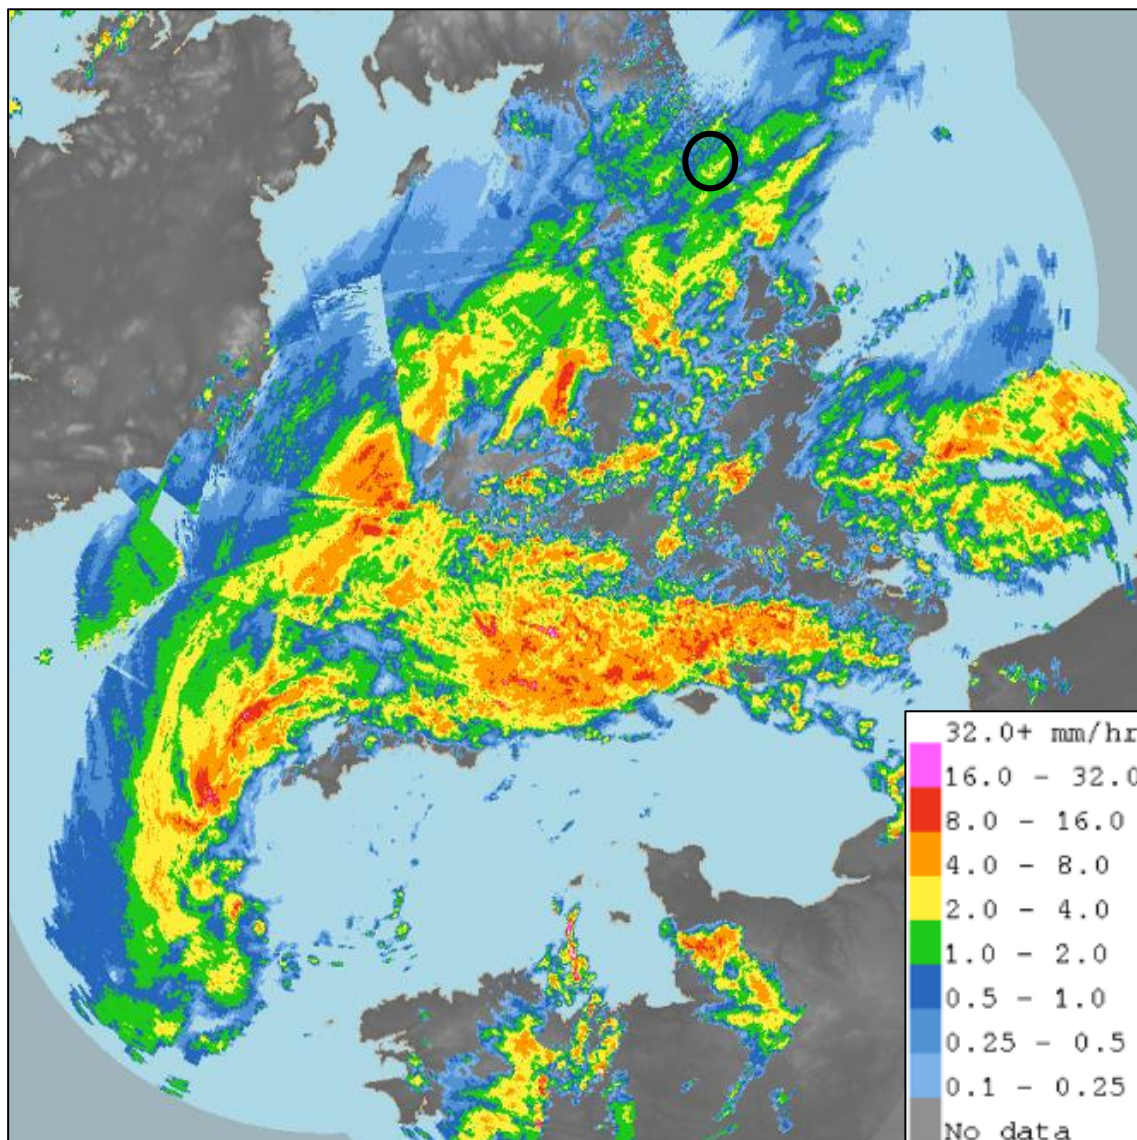
Figure 3.3 Rainfall radar map of the Storm (Source: Met Office Data)

The black circle on figure 3.3 demonstrates the study area around Sleights. This radar data shows that the storm around Sleights was patchy and not as intense as in other parts of the county, which did not experience flooding events.

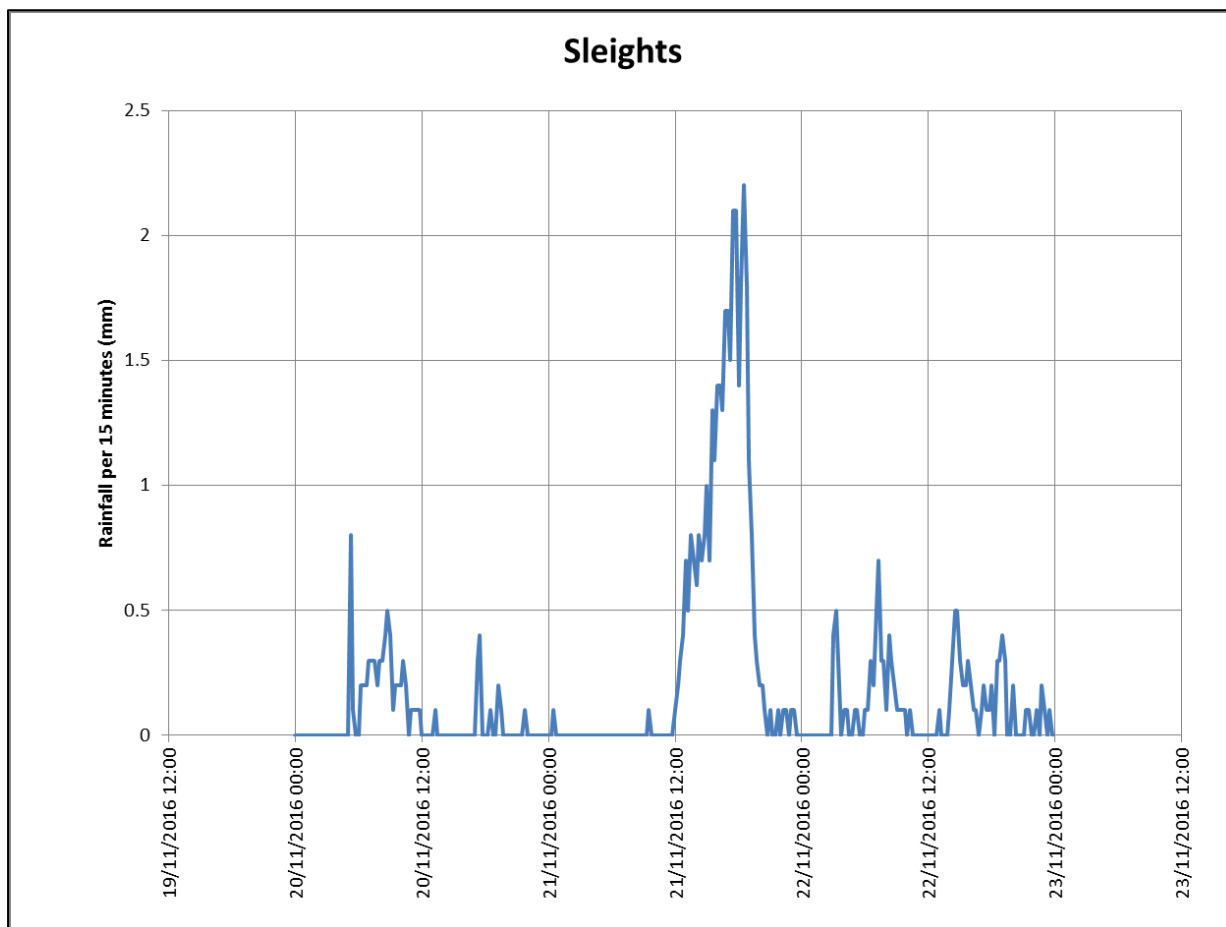
Figure 3.5 Sleights Rainfall Event (Source: EA Data)

Figure 3.5 clearly demonstrates a significant peak in the rainfall, between midday, continuing through to approximately 10pm on the 21st November 2016. This peak tallies with the events unfolding in Sleights. 26mm of water fell in the most intense 6 hours of the storm.
